MINERALS PROGRAM INSPECTION REPORT
PHONE: (303) 866-3567

MINE NAME: Lariat Pit	MINE/PROSPECTING ID#: M-1977-251	MINERAL: Clay (general)	COUNTY: Jefferson
INSPECTION TYPE: Monitoring	INSPECTOR(S): Michael A. Cunningham	INSP. DATE: March 22, 2018	INSP. TIME: 12:30
OPERATOR: General Shale Brick, Inc.	OPERATOR REPRESENTATIVE: Jason McGraw	TYPE OF OPERATION: 112c - Construction Regular Operation	
REASON FOR INSPECTION: Normal I&E Program	BOND CALCULATION TYPE: Partial Bond	BOND AMOUNT: \$156,670.00	
DATE OF COMPLAINT: NA	POST INSP. CONTACTS: None	JOINT INSP. AGENCY: None	
WEATHER: Clear	INSPECTOR'S SIGNATURE:

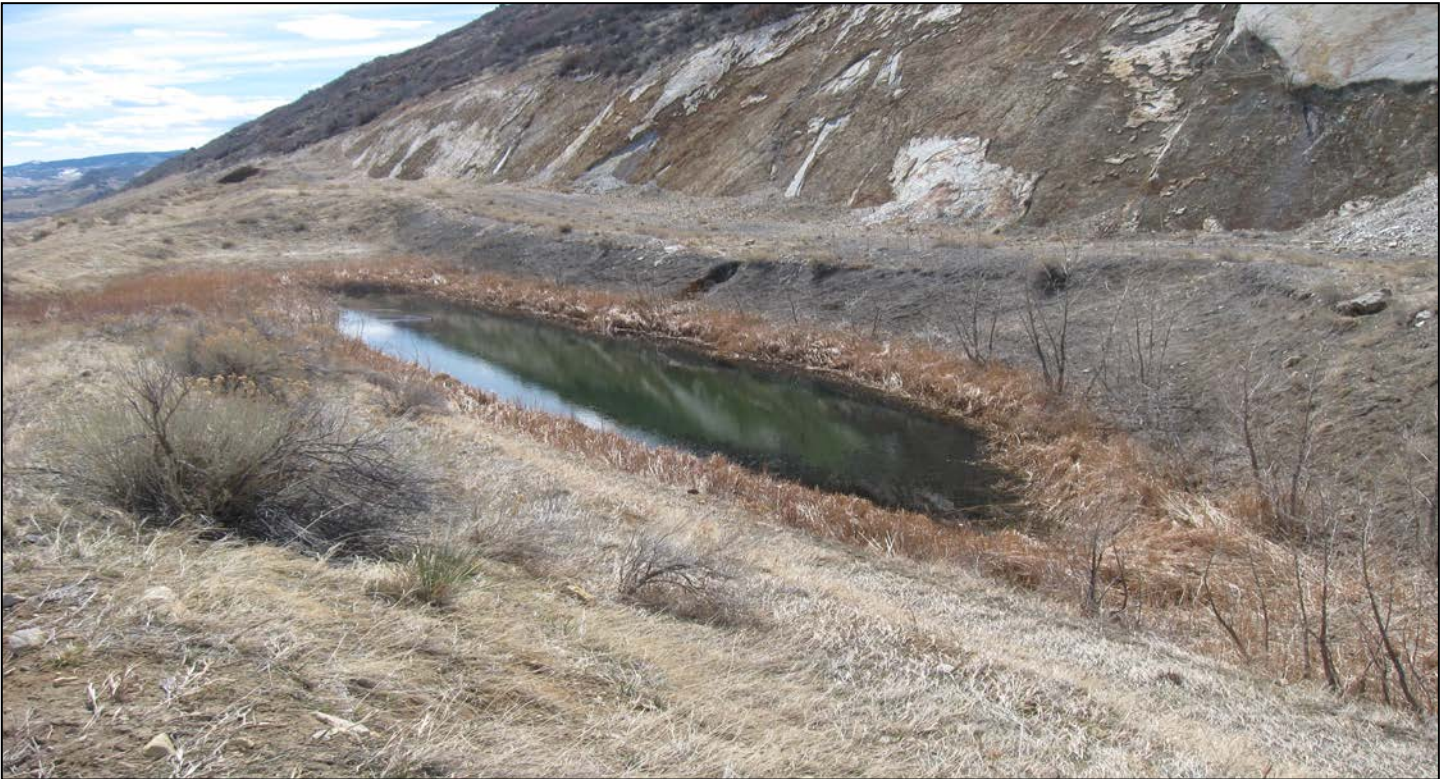
The Operator received approval under Technical Revision No. 2 to capture stormwater in a small pit created by the mining operation. The Operator is allowed to detain stormwater in the pond and is not required to release the stormwater to the natural drainage system within 72 hours. A second stormwater detention pond is located at the south end of the lower affected area. The Division observed water in both of the stormwater ponds during the inspection.

1. Upper stormwater detention pond.

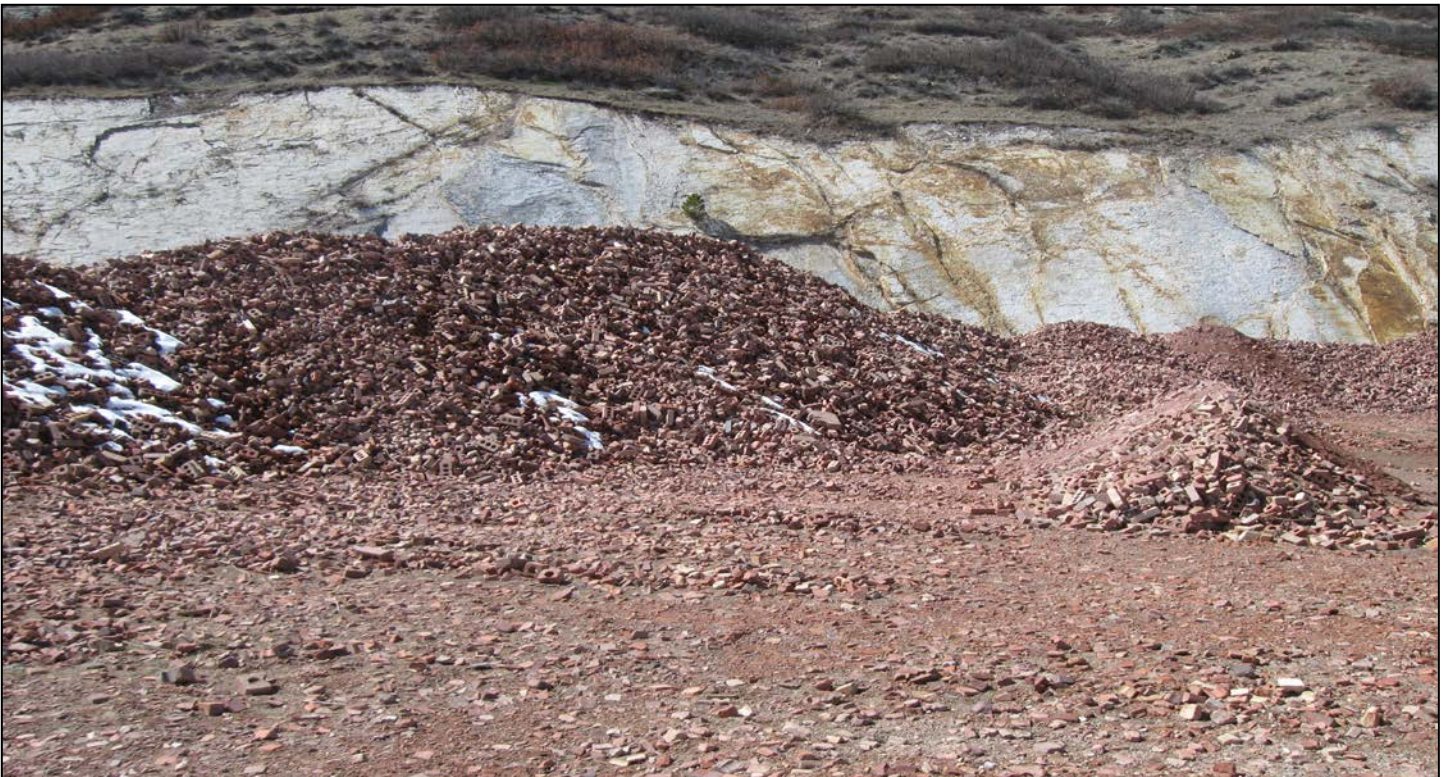
2. Grog stockpile.

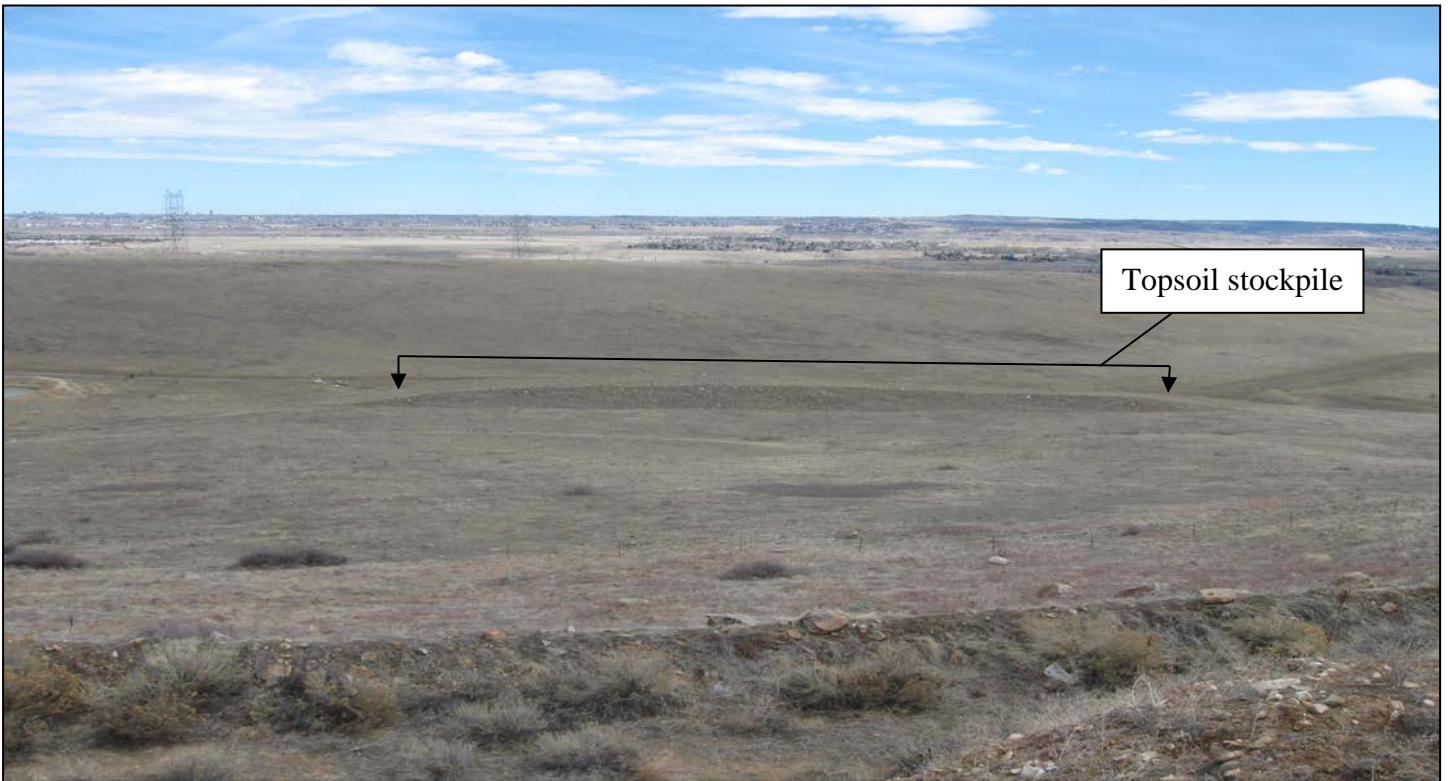
The Operator has received approval to operate intermittently, the site was not active at the time of the inspection. According to the Operator, mining at the Lariat Pit last occurred in 2007. There are several stockpiles on site which the Operator routinely pulls material from. A review of Google Earth aerial photographs of the site shows the size of the stockpiles changes annually. The Operator is mining clay, claystone, shale and sand from the South Platte and Graneros Shale formations. The clay beds dip to the east at approximately 58 degrees. The affected area is currently divided into two separate areas; the upper affected area consists of 16 acres and is located at the base of the formations being mined and a lower affected area of 6.5 acres is located 600 ft. to the east of the upper area. Both affected areas have been leveled and contain product stockpiles. The Operator has salvaged and stockpiled topsoil; the topsoil stockpile was stable and no signs of erosion were noted.

3. Topsoil stockpile.

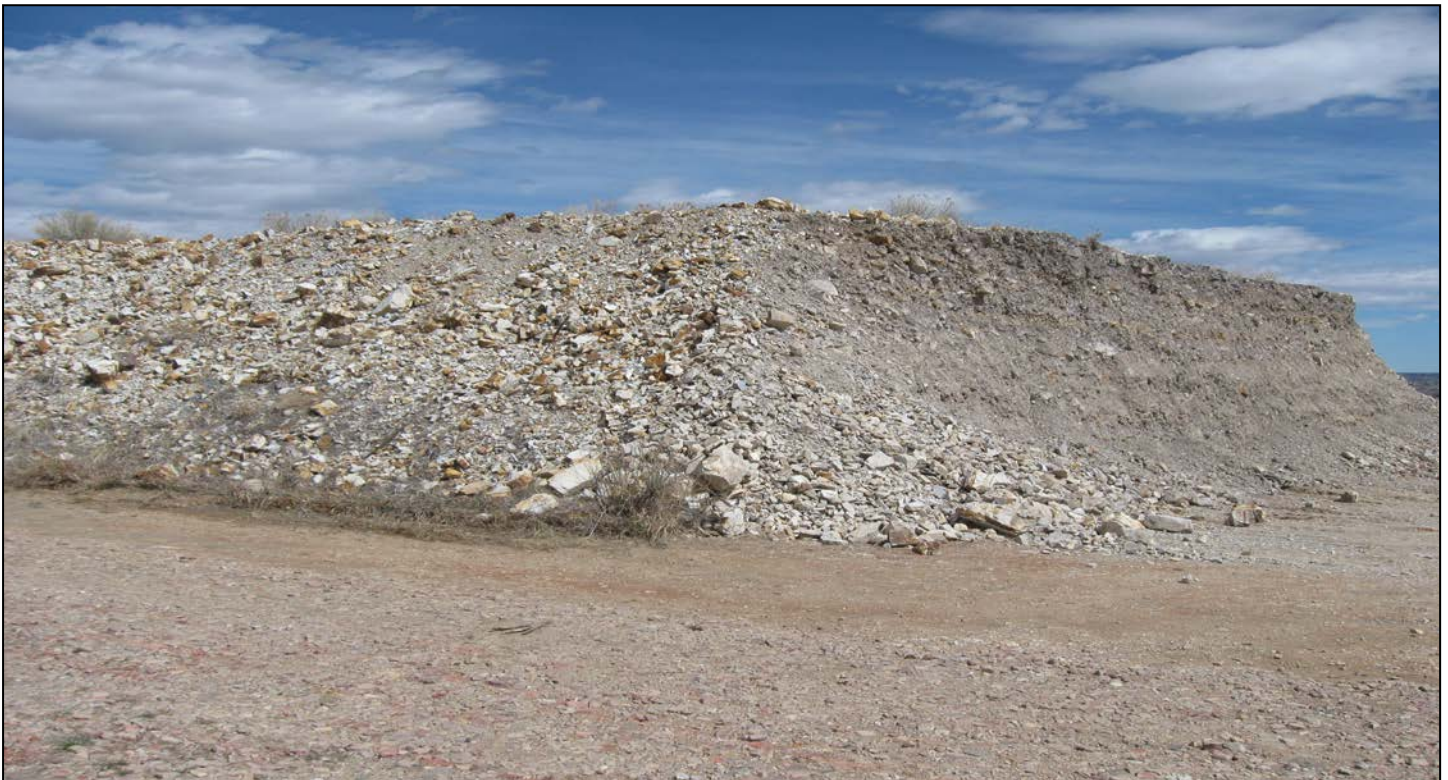
4. Product stockpile.

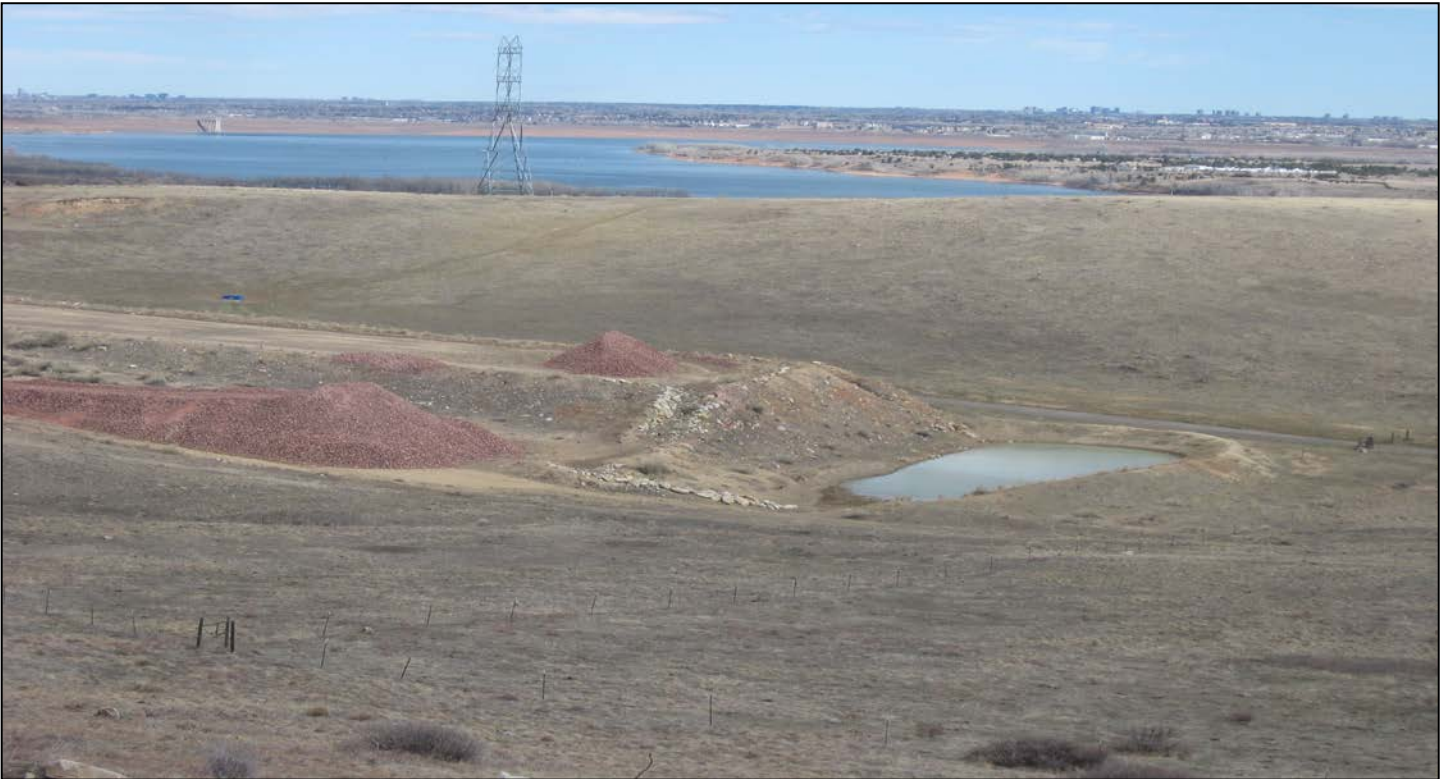
5. Overview of lower affected area.

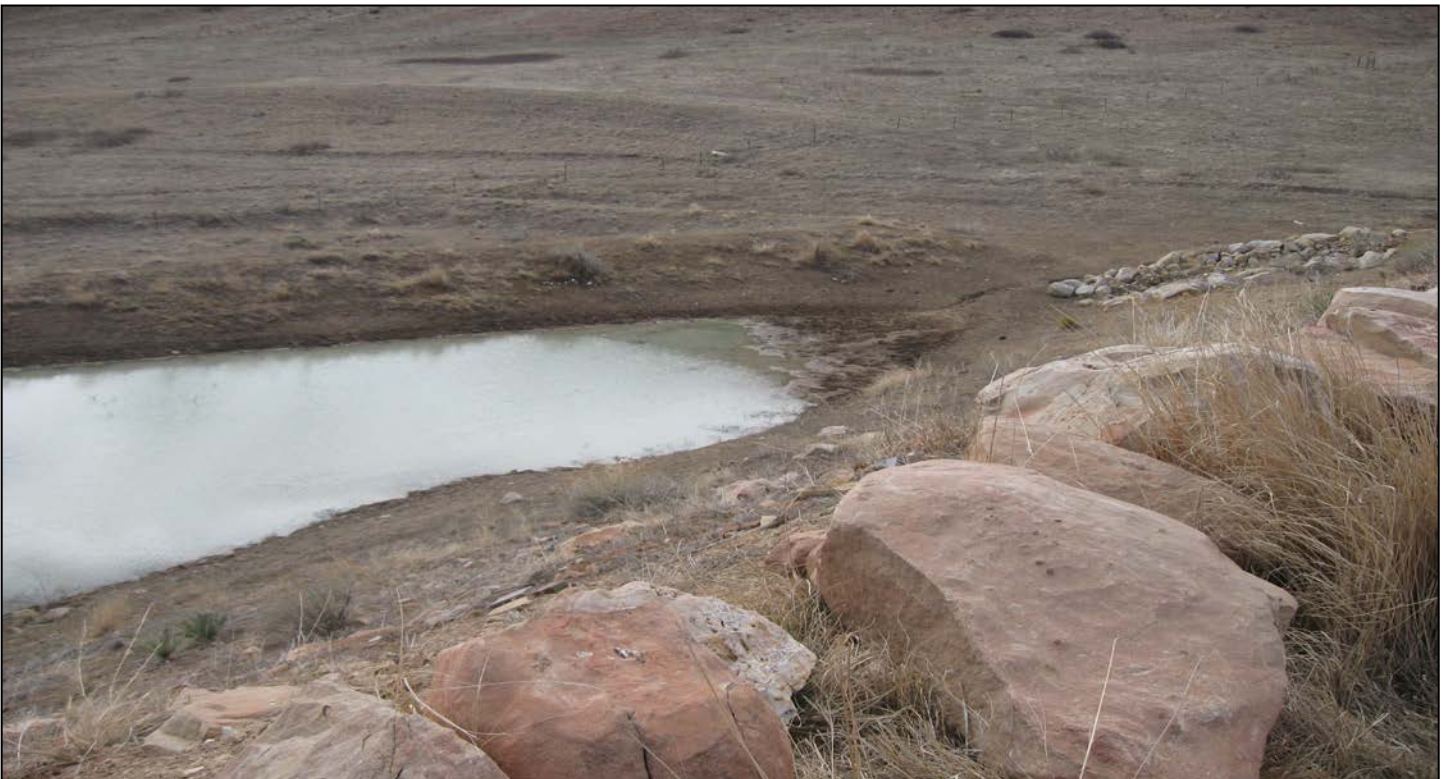
6. Lower stormwater detention pond.
