MINERALS PROGRAM INSPECTION REPORT**PHONE: (303) 866-3567**

MINE NAME: LGPD2-2	MINE/PROSPECTING ID#: P-2015-021	MINERAL: Quartz ,fluorine, fluorite	COUNTY: Park
INSPECTION TYPE: Monitoring	INSPECTOR(S): Michael A. Cunningham	INSP. DATE: April 10, 2018	INSP. TIME: 11:30
OPERATOR: JC Minerals LLC	OPERATOR REPRESENTATIVE: John Crowley	TYPE OF OPERATION: MP - Mineral Prospecting	
REASON FOR INSPECTION: Normal I&e Program	BOND CALCULATION TYPE: Complete Bond	BOND AMOUNT: \$2,625.00	
DATE OF COMPLAINT: NA	POST INSP. CONTACTS: None	JOINT INSP. AGENCY: None	
WEATHER: Clear	INSPECTOR'S SIGNATURE:

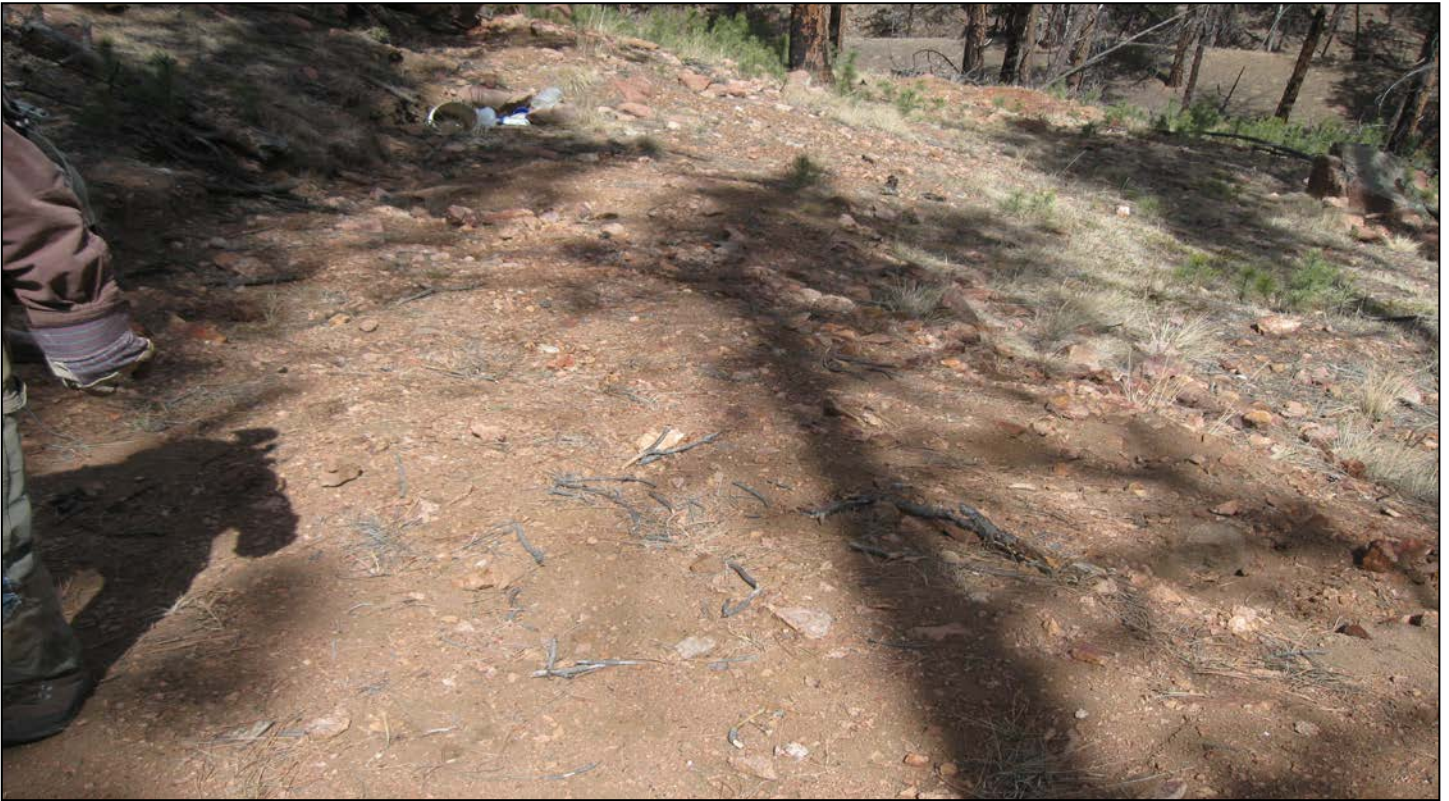
The Operator has completed prospecting and the site is in the final stage of reclamation. The Operator and the Division visited the five prospecting trenches approved for this operation. As noted in the previous inspection report, one of the five prospecting trenches was created by un-permitted prospectors. However, the Operator has performed reclamation at all five of the excavated areas. The reclaimed prospecting trenches have been graded to the natural slopes and have been broadcast seeded. The Division observed germination of some of the planted grass species. However, additional time will be required to establish vegetation which is capable of self-regeneration without further aid from the Operator. The Operator should continue to monitor the success of the vegetation. If additional grass has not germinated by the fall, the Operator should consider a late season reseeding of the prospecting sites.

1. Reclaimed prospect site, disturbance created by un-permitted prospectors.

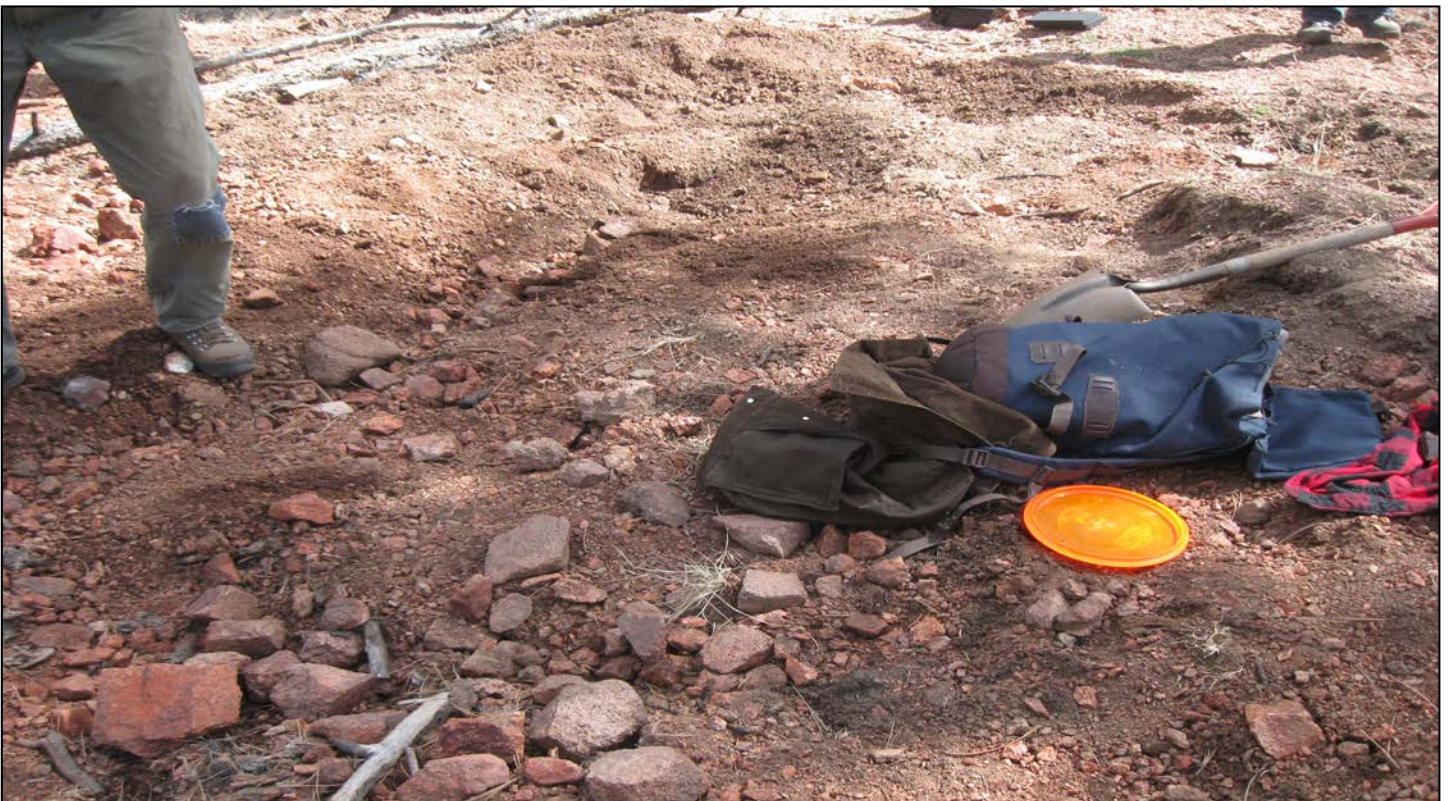
During the inspection, the Division encountered two men who were digging in one of the Operator's reclaimed excavation areas. The men identified themselves as Mr. Justin Odryna and Henry (no last name provided). The men were using hand tools and had created a small excavation, approximately three feet wide and one foot deep. The Division informed the men they were trespassing on the Operator's unpatented claim. In addition, they were informed of the requirements for prospecting and mining. Mr. Odryna and Henry agreed to fill in the hole they had excavated before they vacated the premises.

2. Reclaimed prospect site, where un-permitted prospector were encountered.

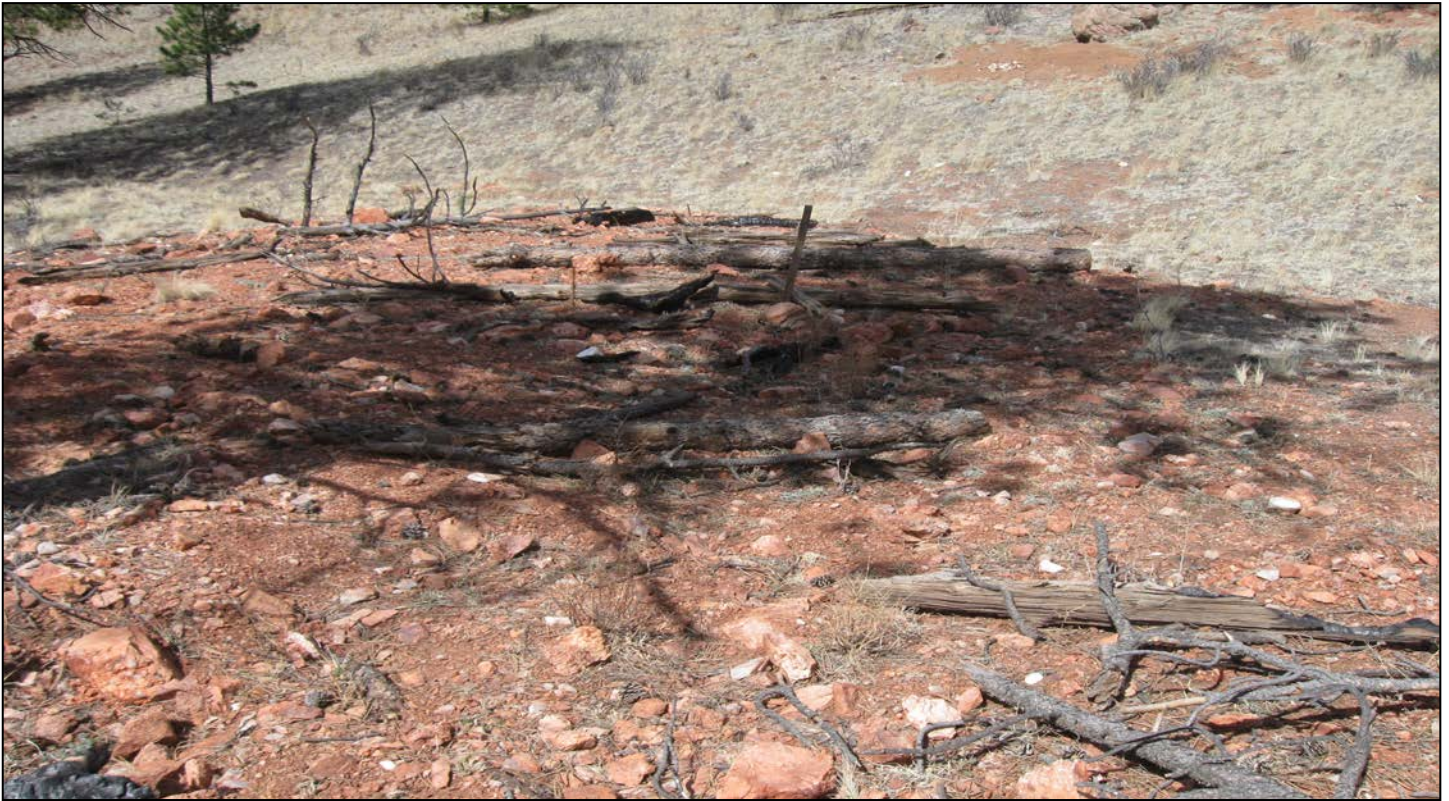
3. Reclaimed prospect site, early establishment of vegetation.

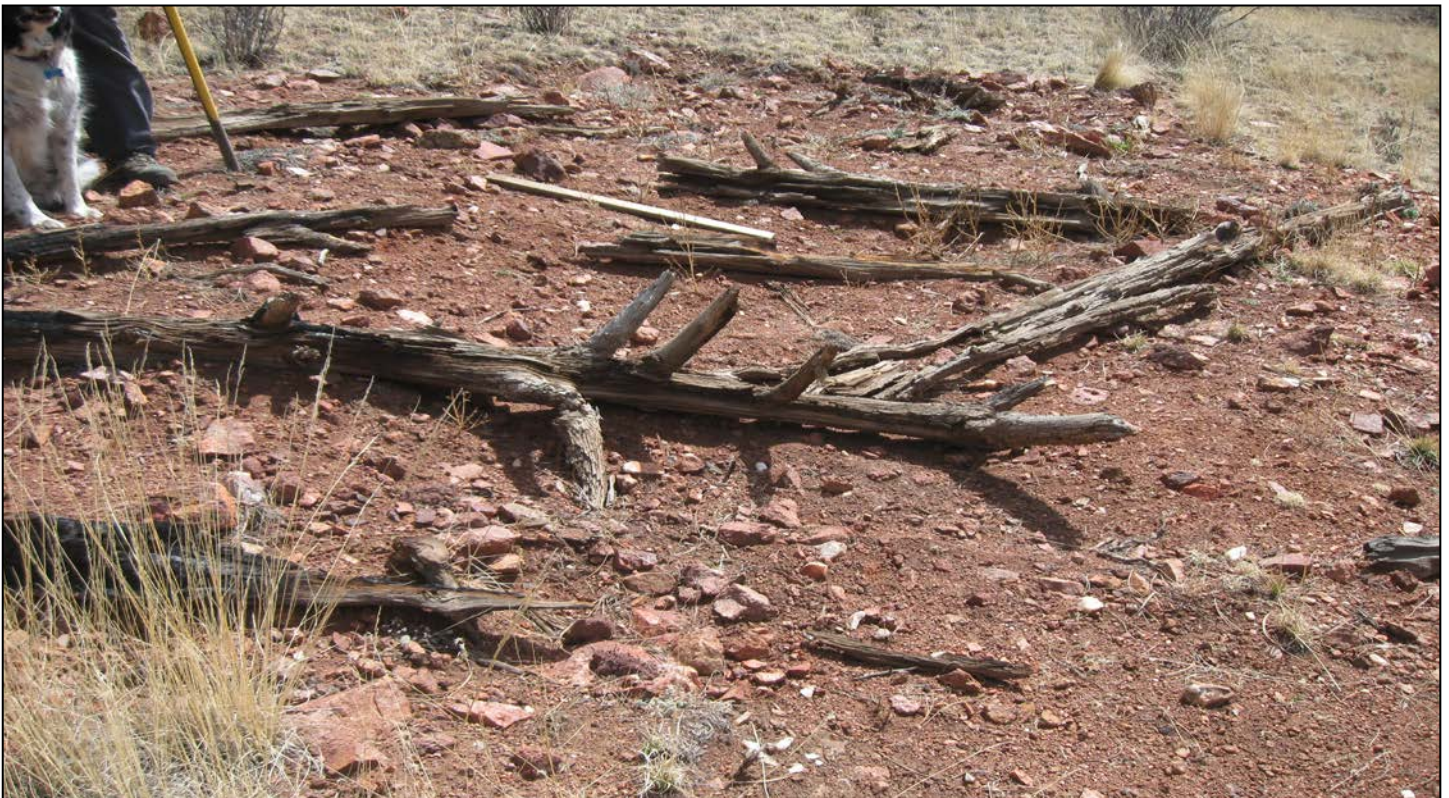
4. Reclaimed prospect site, early establishment of vegetation.
