**MINERALS PROGRAM INSPECTION REPORT**  
**PHONE: (303) 866-3567**

<b>MINE NAME:</b> Eagle Mine	<b>MINE/PROSPECTING ID#:</b> M-2011-029	<b>MINERAL:</b> Gold	<b>COUNTY:</b> Moffat
<b>INSPECTION TYPE:</b> Monitoring	<b>INSPECTOR(S):</b> Amy C. Yeldell	<b>INSP. DATE:</b> May 30, 2018	<b>INSP. TIME:</b> 10:30
<b>OPERATOR:</b> Jubilee Venture, Inc.	<b>OPERATOR REPRESENTATIVE:</b> Blayne Dennis & Staff	<b>TYPE OF OPERATION:</b> 112 - Hard Rock Regular Operation	
<b>REASON FOR INSPECTION:</b> Normal I&E Program	<b>BOND CALCULATION TYPE:</b> Complete Bond	<b>BOND AMOUNT:</b> \$35,086.00	
<b>DATE OF COMPLAINT:</b> NA	<b>POST INSP. CONTACTS:</b> DRMS	<b>JOINT INSP. AGENCY:</b> U.S.BLM	
<b>WEATHER:</b> Clear	<b>INSPECTOR'S SIGNATURE:</b>

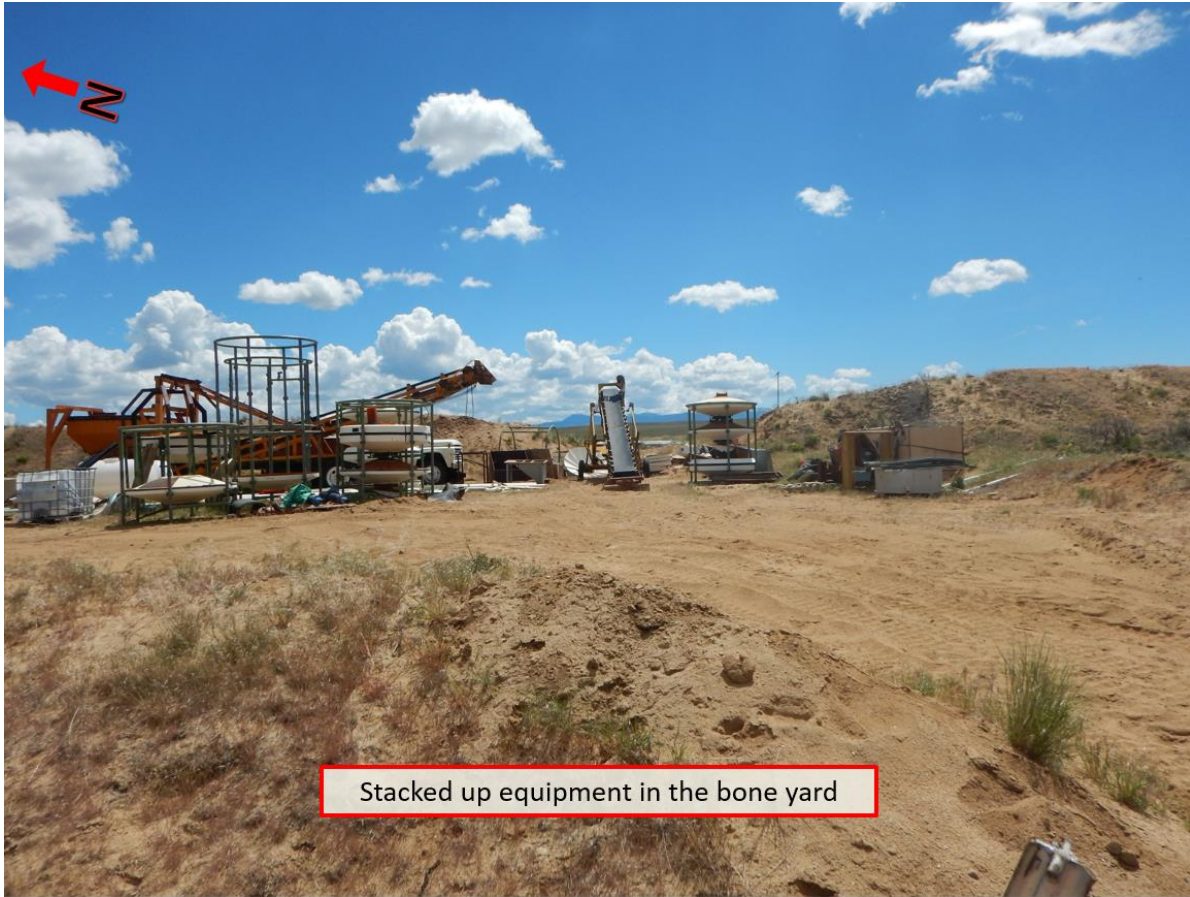
The two lined ponds remain in place and in the same condition as observed during previous inspections. They remain fenced in. Excess parts and equipment are stored in the bone yard to the east of the ponds. All items are stored neatly. An elevated fuel tank is stored within secondary containment.

Stacked up equipment in the bone yard

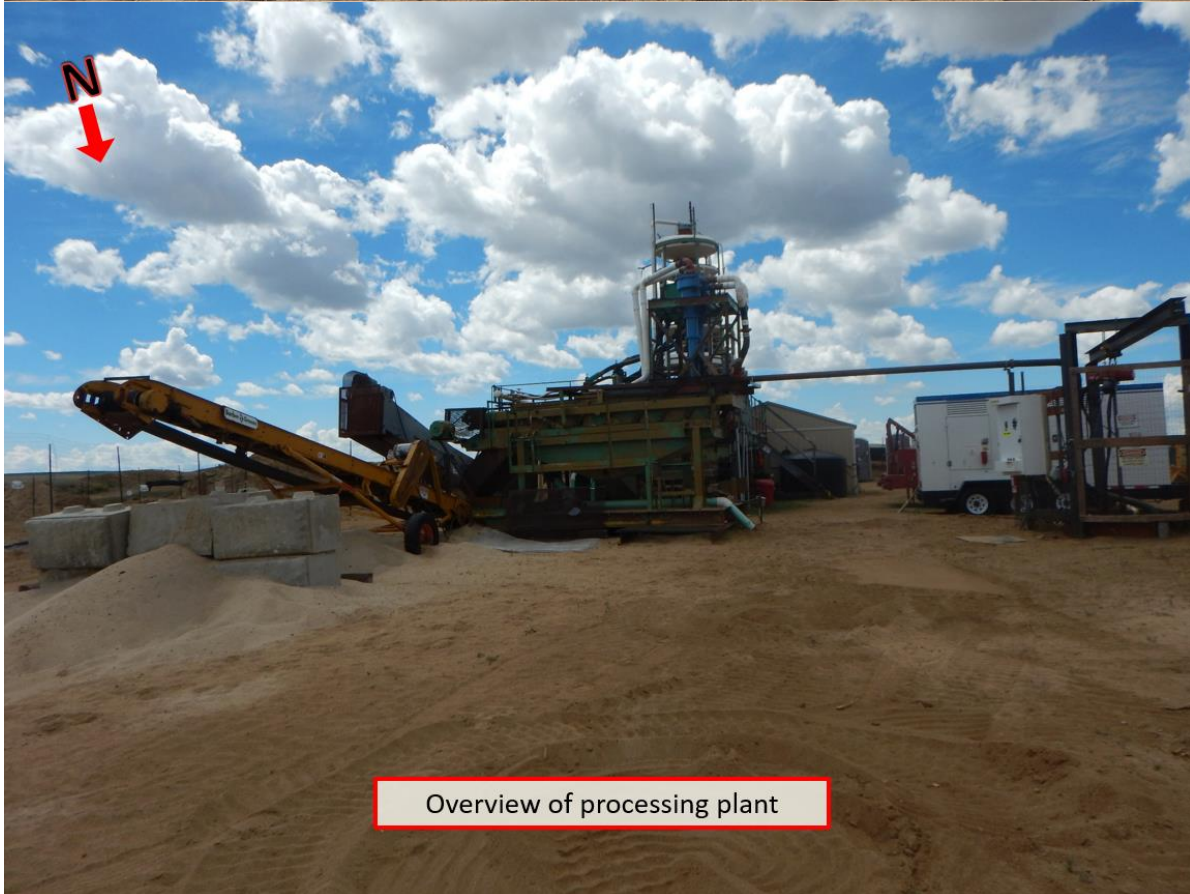
There is a production facility on site equipped with pumps, shakers, screens and cyclones. In addition to the processing plant there was a skid steer, front end loader, generator and water tank trailer on site. The three buildings/sheds of varying sizes remain on site.

Overview of processing plant
