**MINERALS PROGRAM INSPECTION REPORT****PHONE: (303) 866-3567**

<b>MINE NAME:</b> Climax Mine	<b>MINE/PROSPECTING ID#:</b> M-1977-493	<b>MINERAL:</b> Molybdenum	<b>COUNTY:</b> Summit
<b>INSPECTION TYPE:</b> Monitoring	<b>INSPECTOR(S):</b> Dustin M. Czaplá	<b>INSP. DATE:</b> June 5, 2018	<b>INSP. TIME:</b> 10:00
<b>OPERATOR:</b> Climax Molybdenum Company	<b>OPERATOR REPRESENTATIVE:</b> James Haag	<b>TYPE OF OPERATION:</b> 112d-3 - Designated Mining Operation	
<b>REASON FOR INSPECTION:</b> Normal I&E Program	<b>BOND CALCULATION TYPE:</b> None	<b>BOND AMOUNT:</b> \$78,246,088.00	
<b>DATE OF COMPLAINT:</b> NA	<b>POST INSP. CONTACTS:</b> None	<b>JOINT INSP. AGENCY:</b> None	
<b>WEATHER:</b> Clear	<b>INSPECTOR'S SIGNATURE:</b>

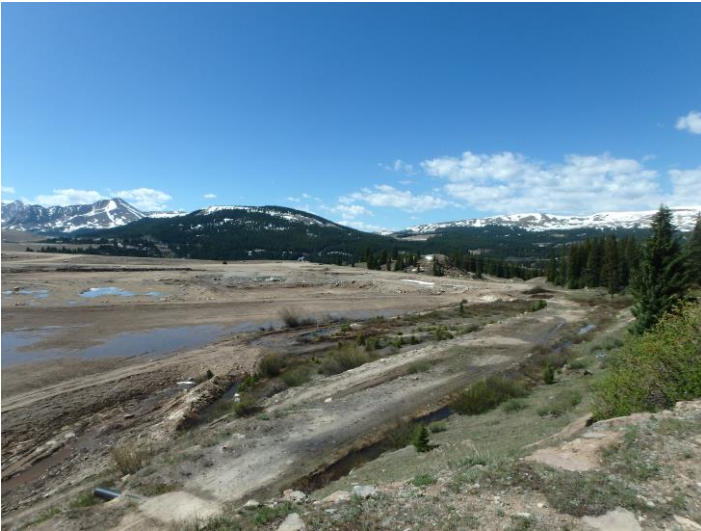
Lake Irwin Wetlands Mitigation

Grading is currently underway in the Lake Irwin wetlands mitigation area. A dewatering sump and berm are constructed around the north side of the wetlands area. Water is pumped to Ten Mile Pond. Pumps were running during this inspection. Phase 1 and 2 areas are being built up to final grade. No problems were noted in this area.

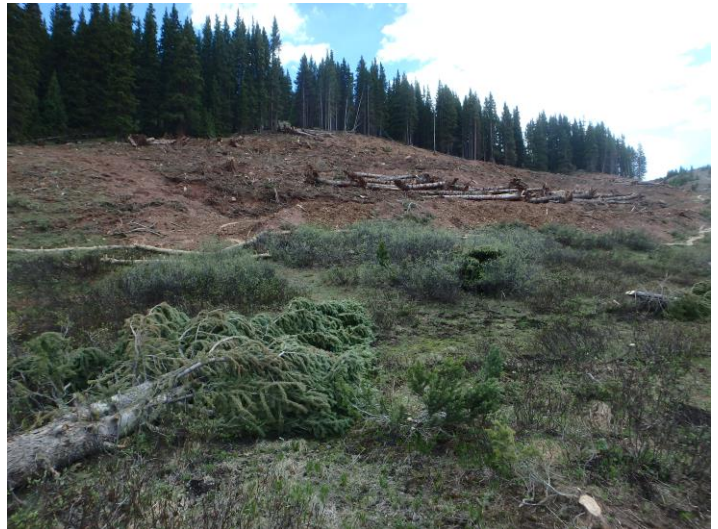
McNulty OSF Expansion

Clearing has occurred in the McNulty Gulch expansion area. During this inspection contractors were at work salvaging wetland species by collecting cuttings to be used in the Lake Irwin area. Stormwater controls (berms and straw wattles) are in place in this area and appear effective. Cleared trees are stockpiled for transport to the Robinson area for grinding and composting. Trees are not to be buried in the OSF expansion area. Problems were not noted in this area.
