**MINERALS PROGRAM INSPECTION REPORT****PHONE: (303) 866-3567**

<b>MINE NAME:</b> Topaz Mt. Gem Mine	<b>MINE/PROSPECTING ID#:</b> M-2002-003	<b>MINERAL:</b> Gemstones	<b>COUNTY:</b> Park
<b>INSPECTION TYPE:</b> Monitoring	<b>INSPECTOR(S):</b> Michael A. Cunningham	<b>INSP. DATE:</b> April 10, 2018	<b>INSP. TIME:</b> 10:30
<b>OPERATOR:</b> Glacier Peak Art, Gems & Minerals	<b>OPERATOR REPRESENTATIVE:</b> Joe Dorris	<b>TYPE OF OPERATION:</b> 110(2) - Hard Rock Limited Impact	
<b>REASON FOR INSPECTION:</b> Normal I&E Program	<b>BOND CALCULATION TYPE:</b> Complete Bond	<b>BOND AMOUNT:</b> \$8,447.00	
<b>DATE OF COMPLAINT:</b> NA	<b>POST INSP. CONTACTS:</b> None	<b>JOINT INSP. AGENCY:</b> None	
<b>WEATHER:</b> Clear	<b>INSPECTOR'S SIGNATURE:</b>

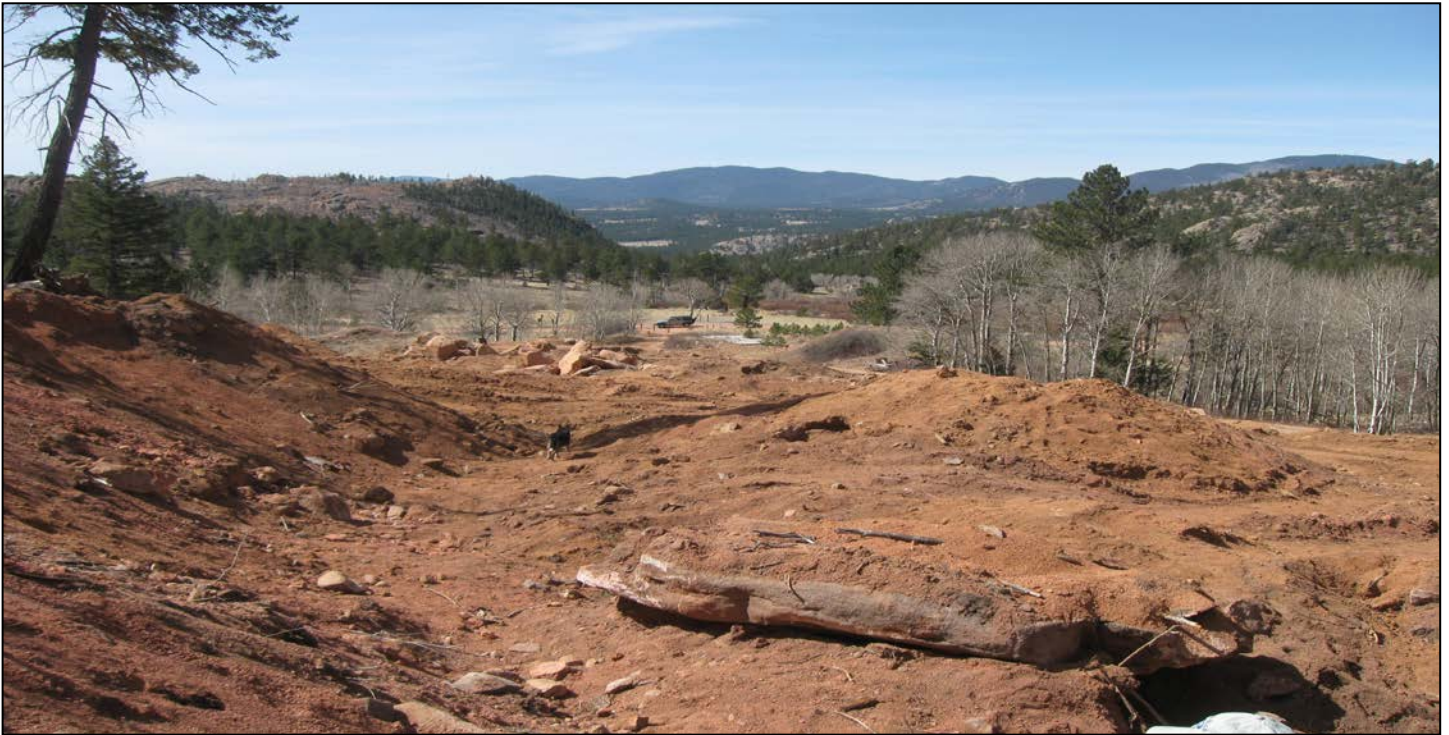
1. Overview of site, photo taken facing south.

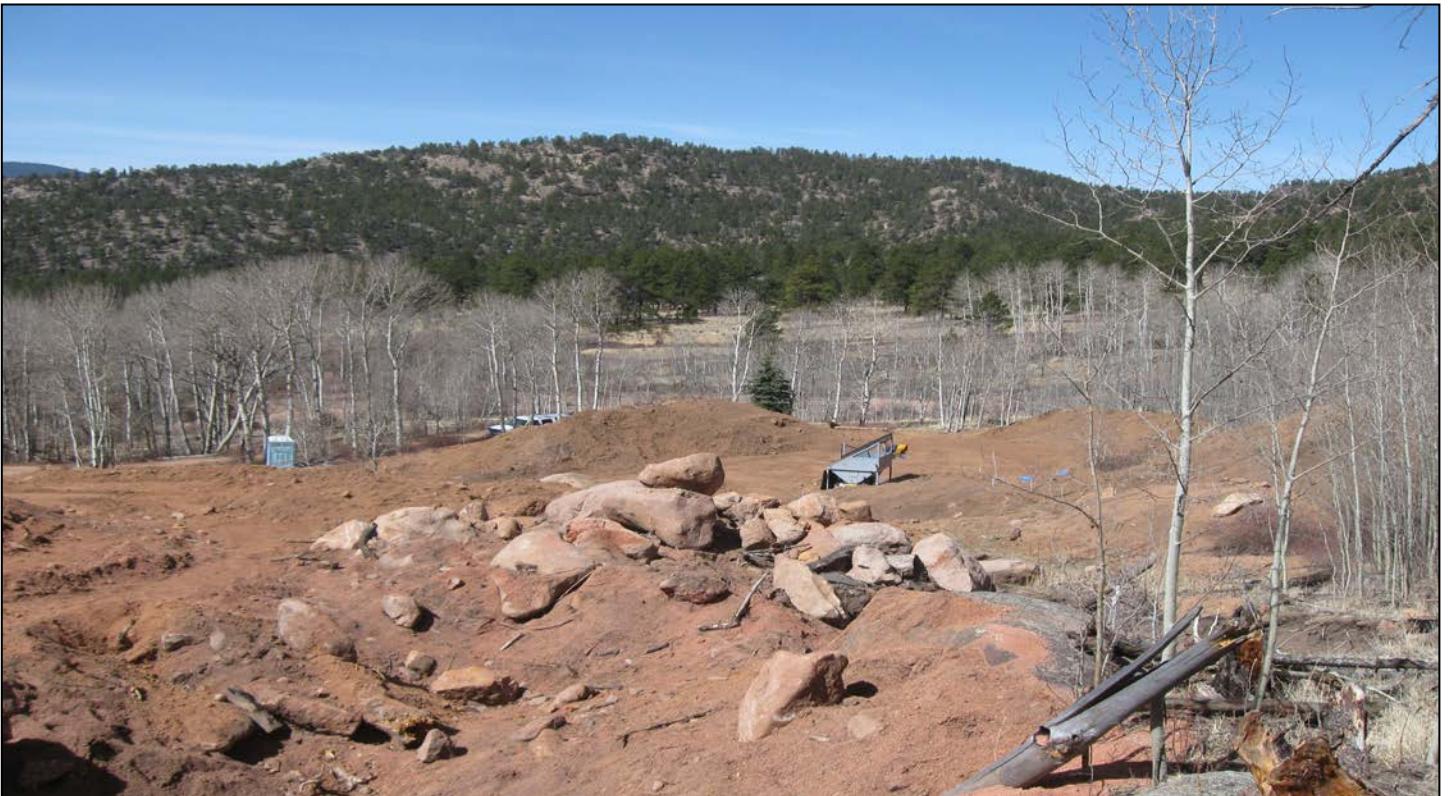
2. Overview of site, photo taken facing north.

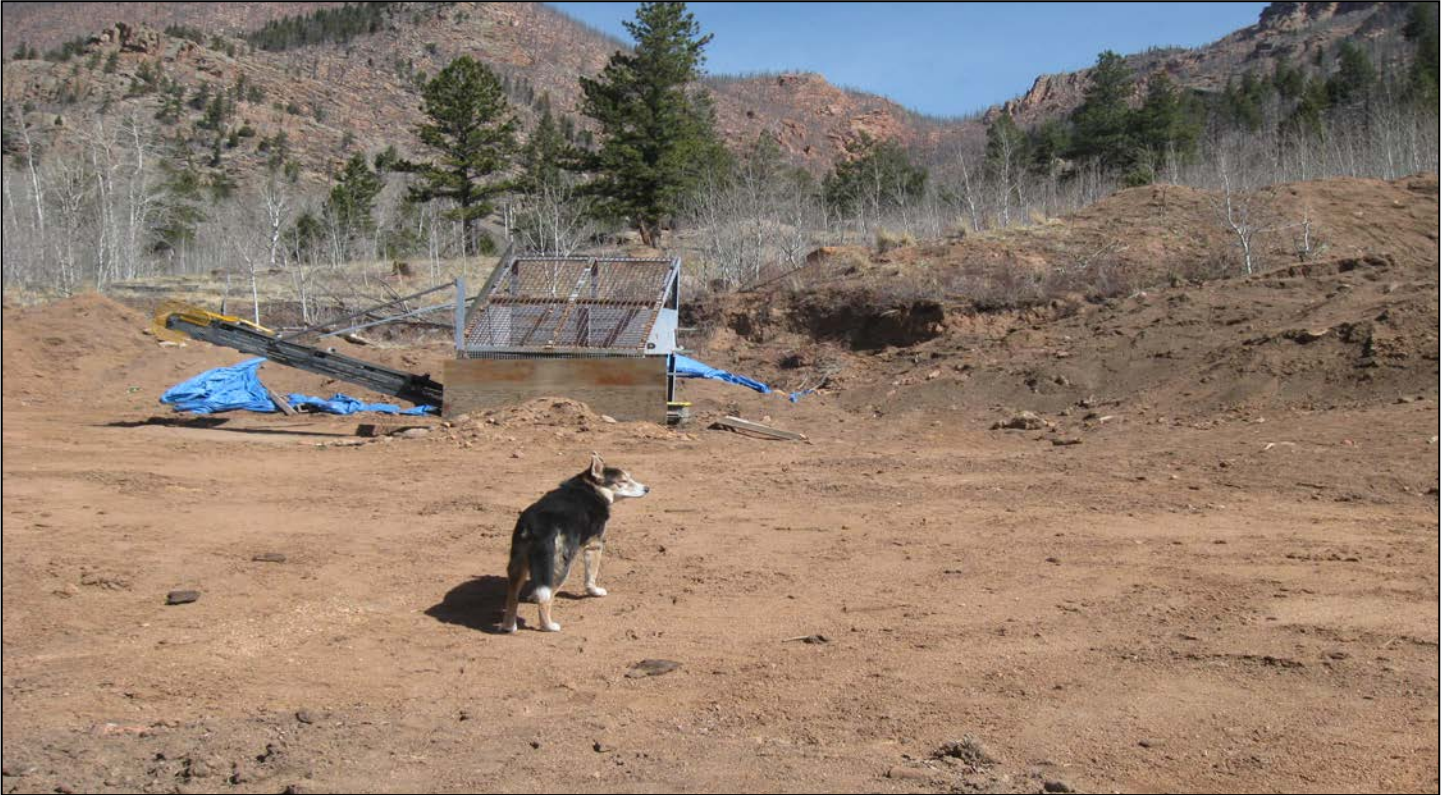
3. Processing area.

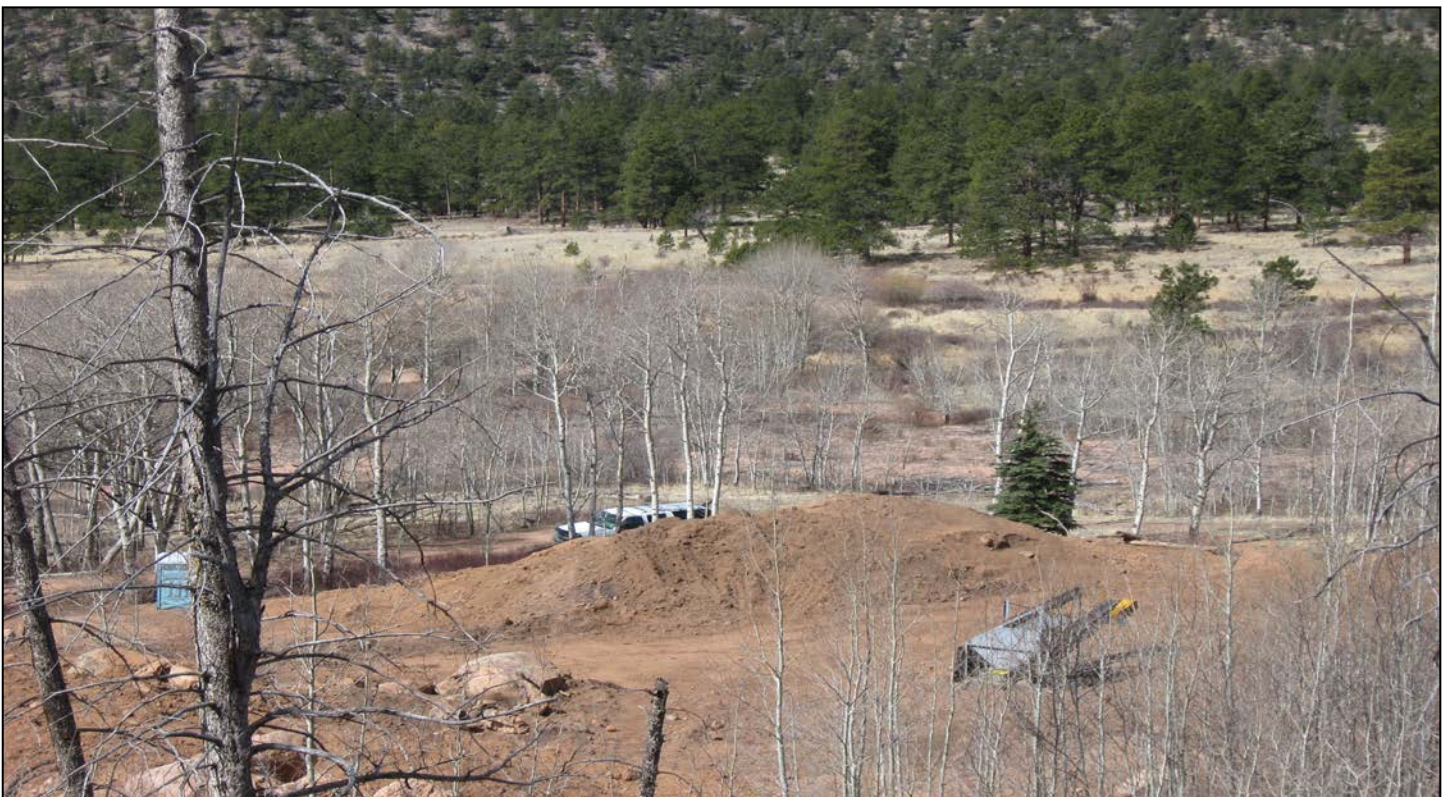
4. Screened material to be used for backfilling.
