# QUARTERLY SEDIMENTATION POND INSPECTION REPORT

Mine: Lorencito  
NPDES ID. No.: Pond #5  
Inspection Period: First Quarter 2018  
Inspection Date: 3/27/18

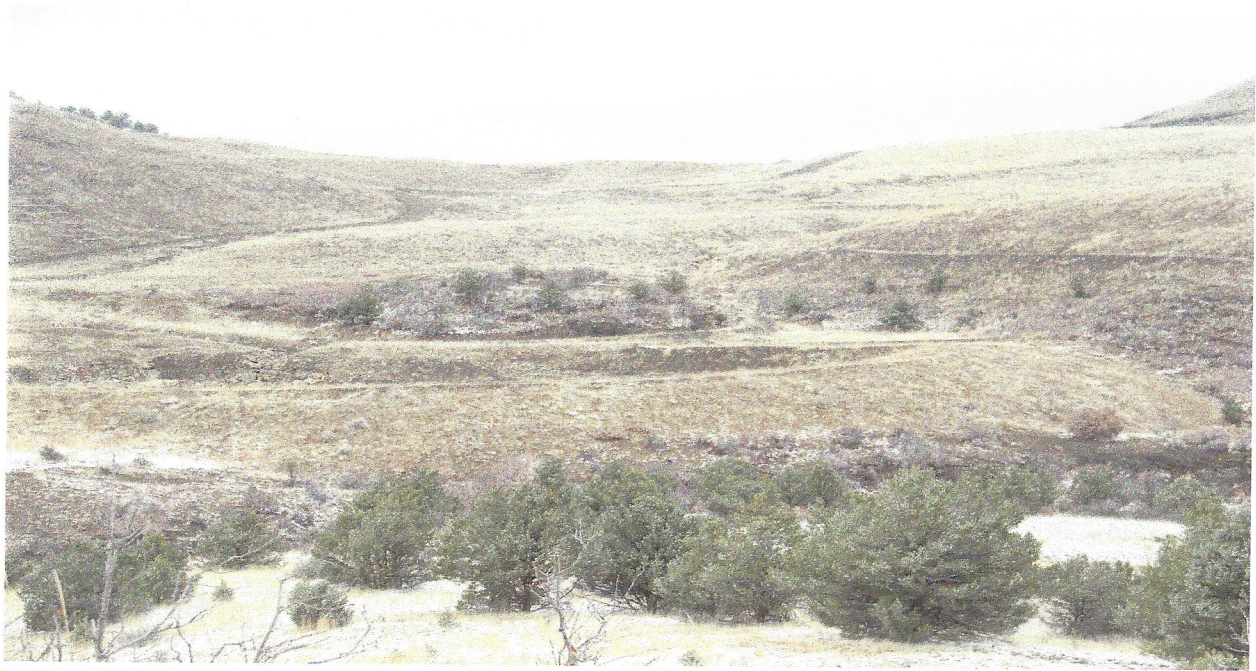
Pond 6 –Lorencito Canyon Mine – March 27, 2018

Minimal water - surface iced over  
\_\_\_\_\_  
\_\_\_\_\_  
\_\_\_\_\_  
\_\_\_\_\_  
\_\_\_\_\_  
\_\_\_\_\_

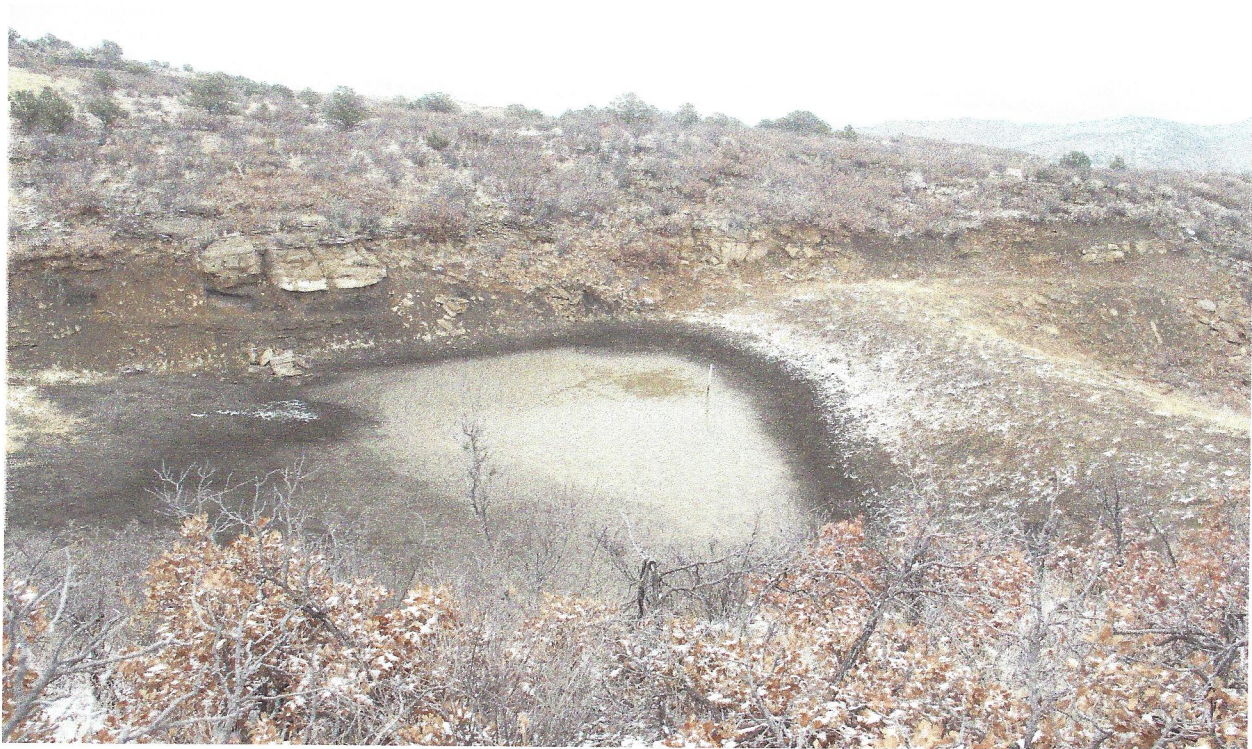
Pond 9A (South) – Lorencito Canyon Mine – March 27, 2018

Pond held minimal water at lowest levels  
of the pond bottom.  
\_\_\_\_\_  
\_\_\_\_\_  
\_\_\_\_\_  
\_\_\_\_\_  
\_\_\_\_\_  
\_\_\_\_\_

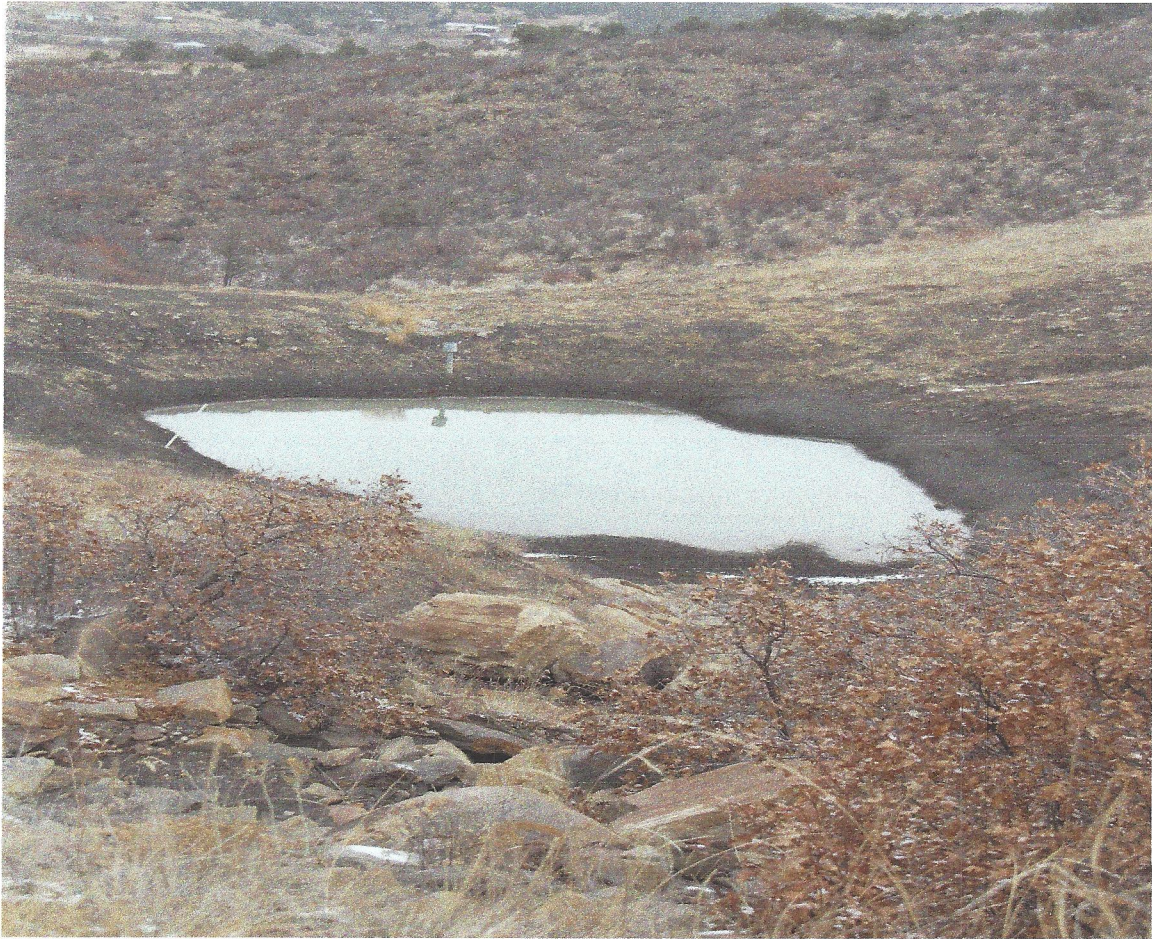
Pond 9B (North) Lorencito Canyon Mine – March 27, 2018

Water level several feet below base of Primary  
discharge riser.  
\_\_\_\_\_  
\_\_\_\_\_  
\_\_\_\_\_  
\_\_\_\_\_  
\_\_\_\_\_  
\_\_\_\_\_
