# LORENCITO CANYON MINE

Permit No. C-1996-084

## INSPECTION OF EXCESS SPOIL-FILLS 7, 8, & 9

March 29-30, 2018

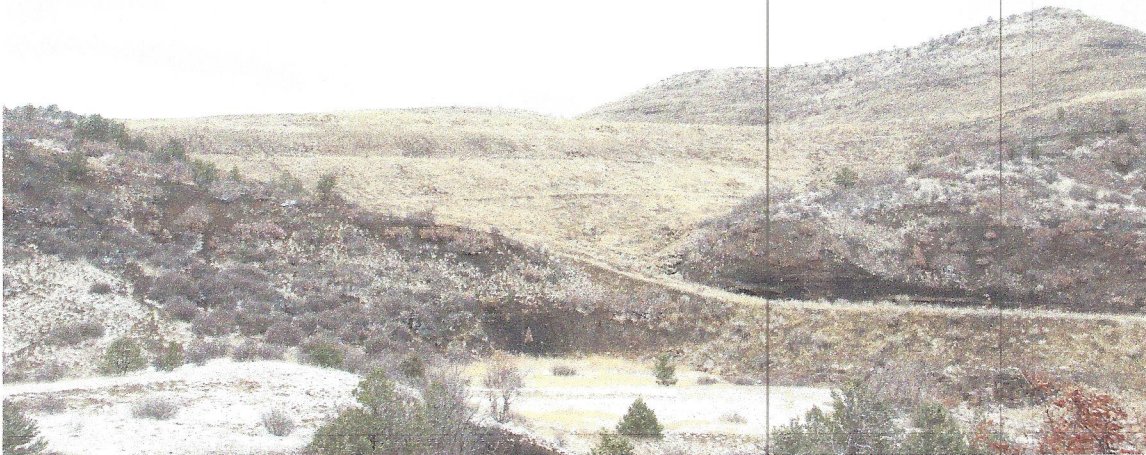
The entire excess spoil fill facility was examined for signs of failure and instability such as tension cracks, ground movement, springs and seeps, and standing water. No indication of potential instability was observed.

Early spring conditions prevail with most areas exhibiting a light-snow cover. Overall the site is in good condition

Above: Fill 7 as viewed from a distance.

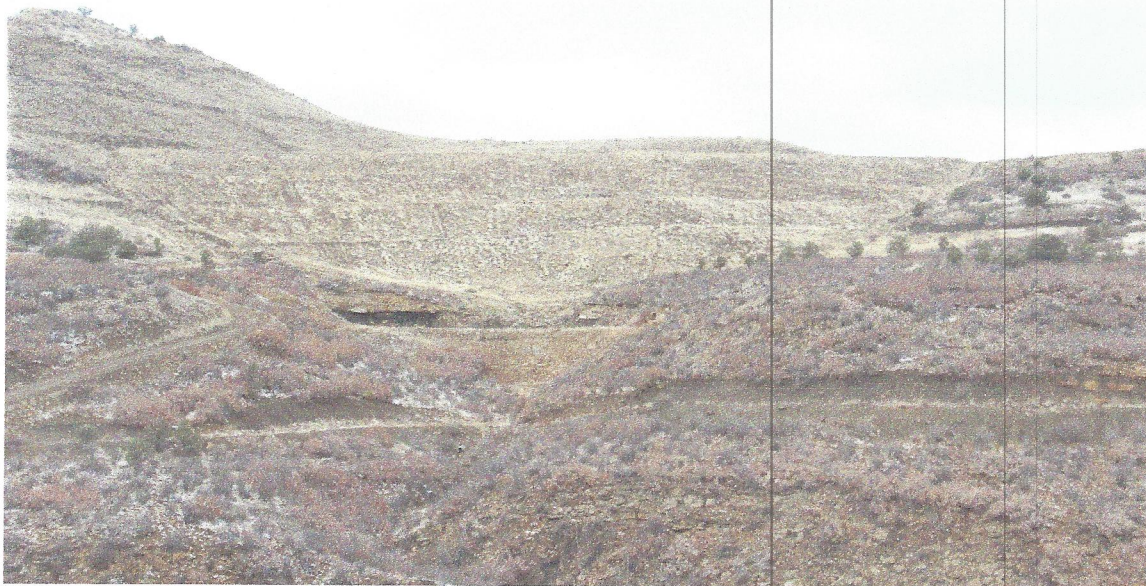
The entire excess spoil fill facility was examined for signs of failure and instability such as tension cracks, ground movement, springs and seeps, and standing water. No indication of potential instability was observed during this inspection.

Early spring conditions prevail with vegetation still dormant. Overall, site is in good condition.

Fill 9 as viewed from a distance
