QUARTERLY SEDIMENTATION POND INSPECTION REPORT

CDMR Rule 4.05.9(17)

Mine: New Elk
NPDES ID. No.: Pond #1
Inspection Period: First Quarter 2018
Inspection Date: 03/27/18

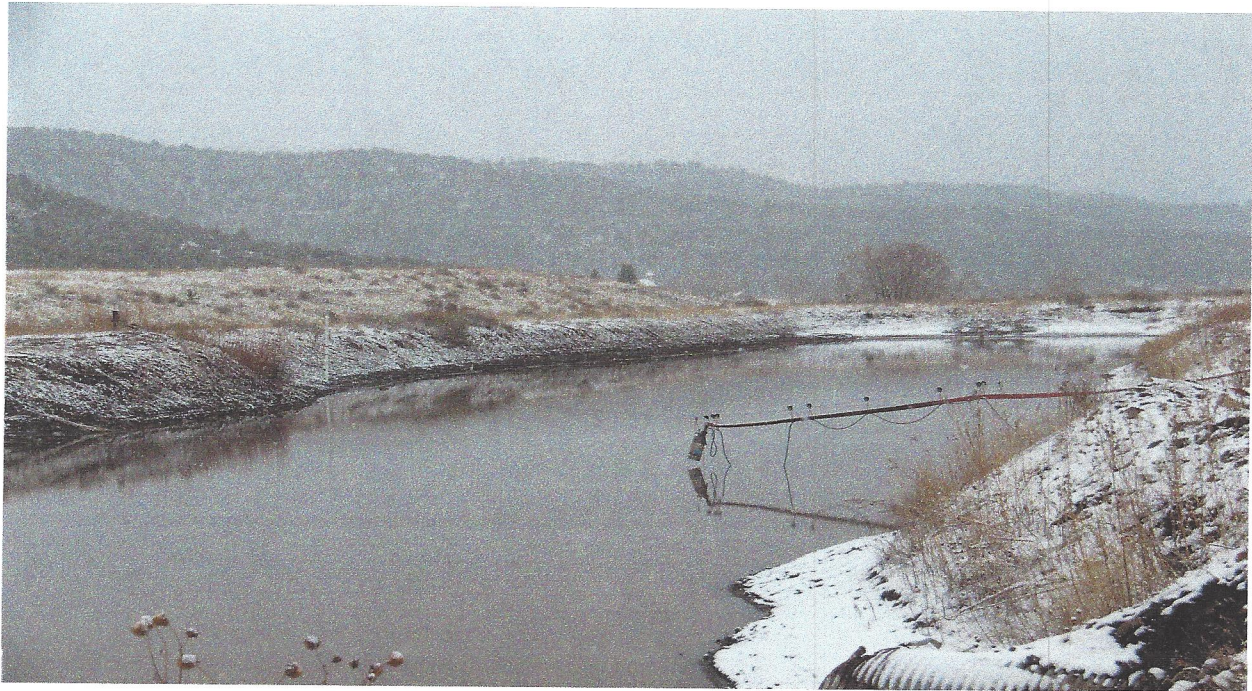
New Elk Pond 7 - March 27, 2018

Pond was cleaned of sediment in 2017.

Water level is about a foot below base of
staff gage and lowest hole of the primary
discharge riser.

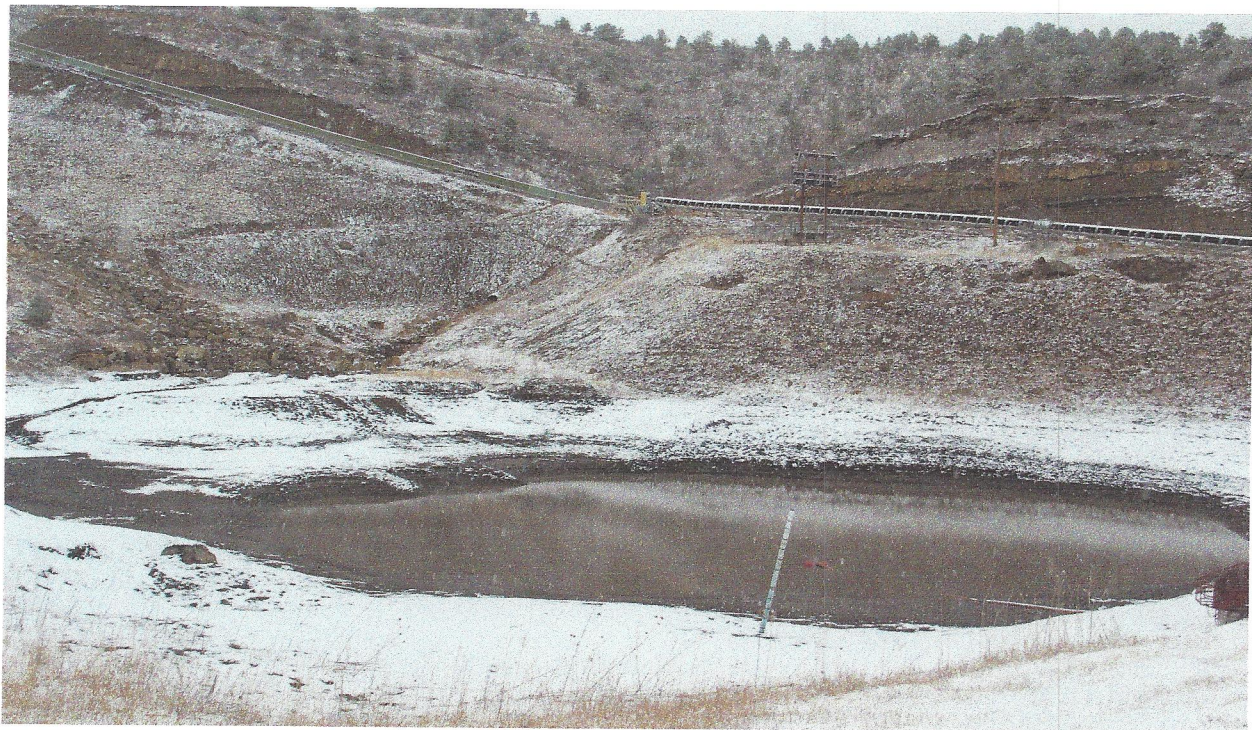
New Elk Pond 8 – March 27, 2018

Visual observation - pond water is being
pumped to pond 6/Pond 4 for scheduled April Cleanout**OTHER OBSERVATIONS**Minor snow cover. Pond water level is
several feet below staff gage based.
