Re: Project, Permit No. M-1980-244;
Technical Revision (TR-100) Second Adequacy Review

NewFields		CLIENT	CRIPPLE CREEK & VICTOR GOLD MINING COMPANY	
PROJECT		VLF2 GEOMEMBRANE RECERTIFICATION		
TITLE		LIMITS OF RE-CERTIFICATION		FILENAME 106.023.004F FIGURE NO. 3 REVISION B

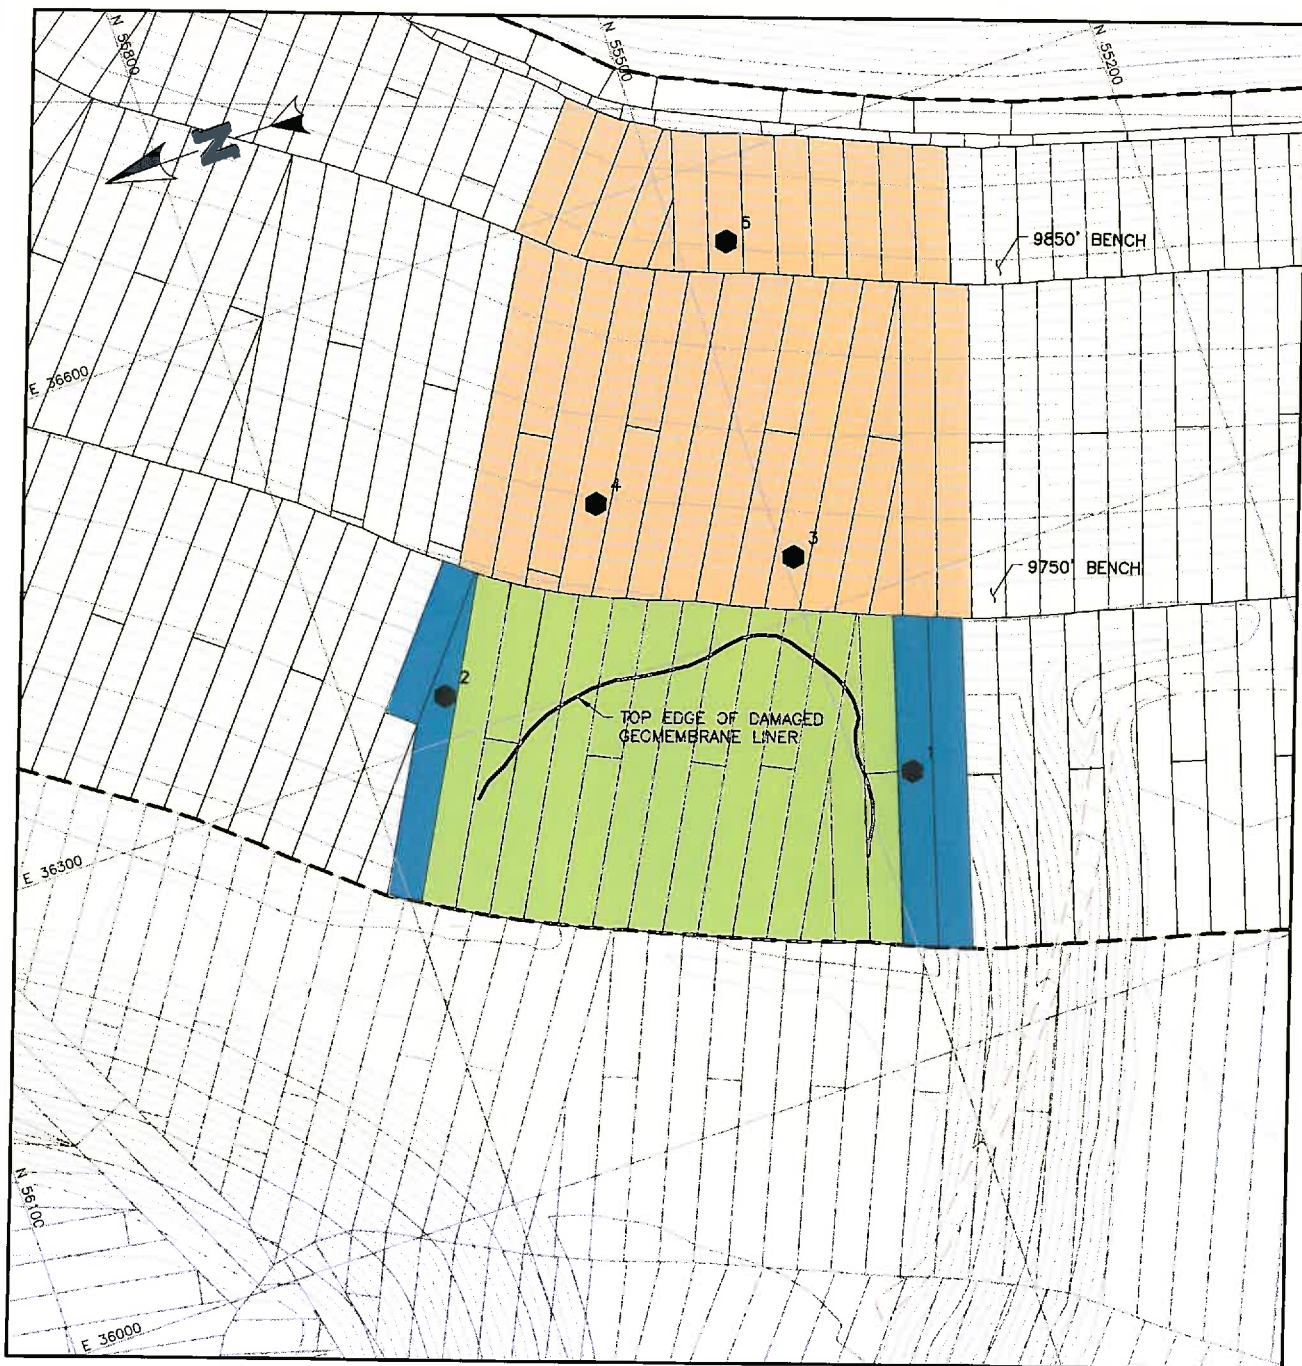
Figure 1

The single panel exposure is horizontal (along contour), as shown in Figure 1. Vertically, the liner will be replaced between the 9650 and 9750' bench.

After the limits of damage have been verified and the DCF has been removed, the following are the steps towards recertification:

Between 9650' and 9750' benches:

- 1. The Soil Liner Fill (SLF) depth will be verified in the area where the geomembrane liner was displaced. Approximately 5 locations will be tested, and backfilled with bentonite (per the technical specifications).**

- 2. The SLF will be prepared for deployment of geomembrane liner (moisture conditioned and rolled).**
- 3. Geomembrane will be deployed, QA/QC'd and documented following the technical specifications. An as-built survey of the geomembrane liner surface will be completed.**

- 4. The existing geomembrane panels on the north and south sides of the replacement area will be vacuumed tested to verify no damage happen to the liner during the removal of ore and DCF. Additionally, samples of the liner will be taken and sent to a third party lab to verify the liner still meets the project technical specifications. These holes will be patched per the technical specifications.**

- 5. Drain Cover Fill (DCF) will be deployed, and documented per the technical specifications. An as-built survey of the top of DCF will be completed.**

Between 9750' and the 9900 benches:

- 1. This area will be visually inspected for damage on the geomembrane liner. If any damage is found, it will be repaired and documented. Additionally, samples of the liner will be taken and sent to a third party lab to verify the liner still meets the project technical specifications. These holes will be patched per the technical specifications.**

- 2. As as-buit survey of the exposed liner will be completed.**
- 3. A sacrificial strip of geomembrane will be welded along the 9750' bench. This strip will be used in isolating the perimeter of the geomembrane being tested using resistivity testing (leak location survey) to look for damage in the geomembrane liner between the 9750 and 9900' benches.**
