MINERALS PROGRAM INSPECTION REPORT
PHONE: (303) 866-3567

MINE NAME: Henderson Mine	MINE/PROSPECTING ID#: M-1977-342	MINERAL: Molybdenum	COUNTY: Clear Creek, Grand
INSPECTION TYPE: Monitoring	INSPECTOR(S): Michael A. Cunningham	INSP. DATE: May 24, 2018	INSP. TIME: 09:00
OPERATOR: Climax Molybdenum Company	OPERATOR REPRESENTATIVE: Amber Parmet	TYPE OF OPERATION: 112d-3 - Designated Mining Operation	
REASON FOR INSPECTION: Normal I&E Program	BOND CALCULATION TYPE: None	BOND AMOUNT: \$37,993,785.00	
DATE OF COMPLAINT: NA	POST INSP. CONTACTS: None	JOINT INSP. AGENCY: None	
WEATHER: Clear	INSPECTOR'S SIGNATURE:

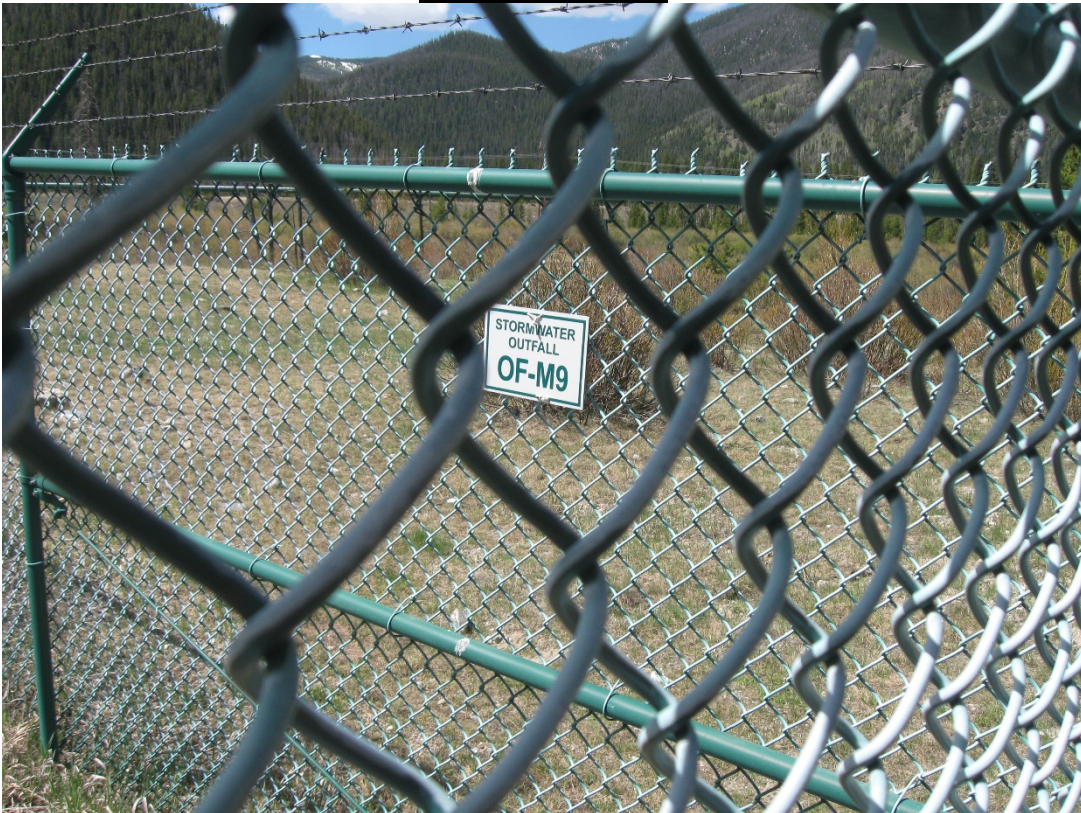
1. Outfall located at northwest corner of Lay-down Yard, no BMPs observed.

Following the inspection of the Ultimate Canal, the Division proceeded to inspect the outfalls located along the ore haulage system. All of the outfalls associated with the ore haulage system were found to be functioning properly, no repairs to existing BMPs were required. However, OF-M14 did not contain any BMPs. The Division also inspected the Portal Lay-down Yard and found OF-M9 and OF-M16 did not contain any BMPs. The outfalls are situated at the northwest and northeast corners of the Lay-down Yard, respectively, and discharge stormwater into wetland areas adjacent to the Williams Fork River. The outfalls were dry at the time of the inspection and the Division did not observe any signs of sediment deposition below the outfalls. The lack of BMPs at outfalls OF-M14, OF-M9 and OF-M16 will not be cited as a problem since they were not discharging water at the time of the inspection and there were no signs sediment was being transported from affected areas. The Operator shall install straw wattles or similar BMPs at the above identified outfalls.

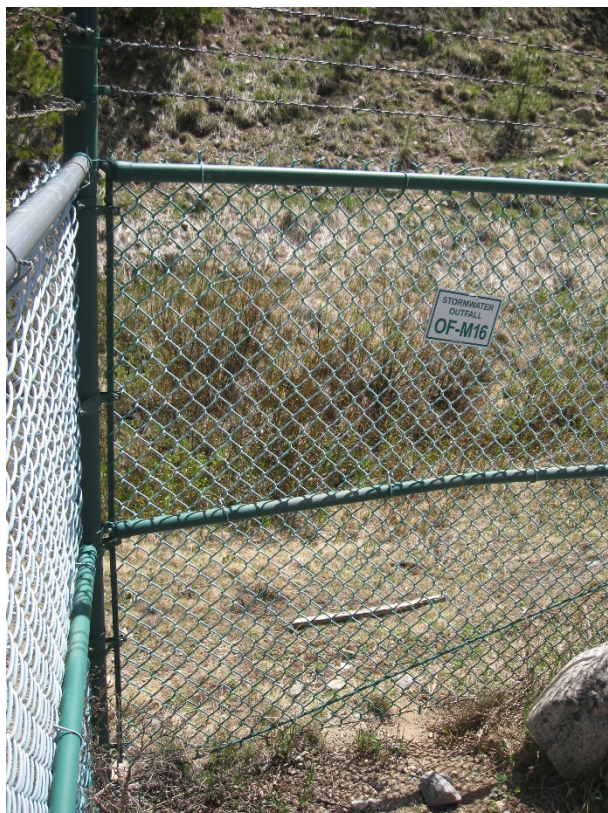
2. Outfall located at northeast corner of Lay-down Yard, no BMPs observed

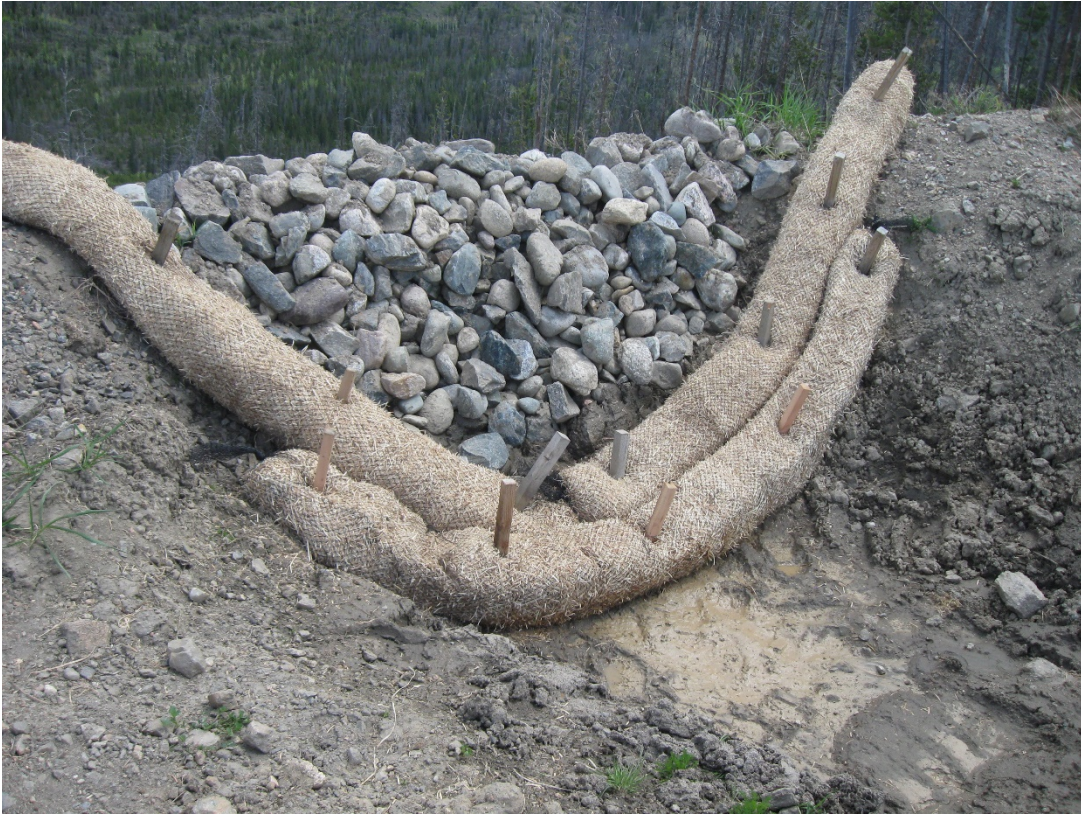
The Division observed two unidentified outfalls along the road leading to the Mill Process Water Tanks. The area is identified on Figure 3, Mill Stormwater Management Map as 'M-5: Steep Bank at the Switchback Along Road to Process/Potable Water Tanks'. The outfalls are not identified on the Mill Stormwater Management Map. The Operator was uncertain as to where the outfalls reported to, but believed they discharged to Bear Paw Gulch which reports to the Tailings Impoundment. No changes to the stormwater management plan are required if the outfalls report to Bear Paw Gulch. However, a Technical Revision may be required to incorporate the outfalls into the stormwater management plan if they directly discharge to the Williams Fork River.

3. Unidentified outfall, located on access road to Mill Process Water Tanks.

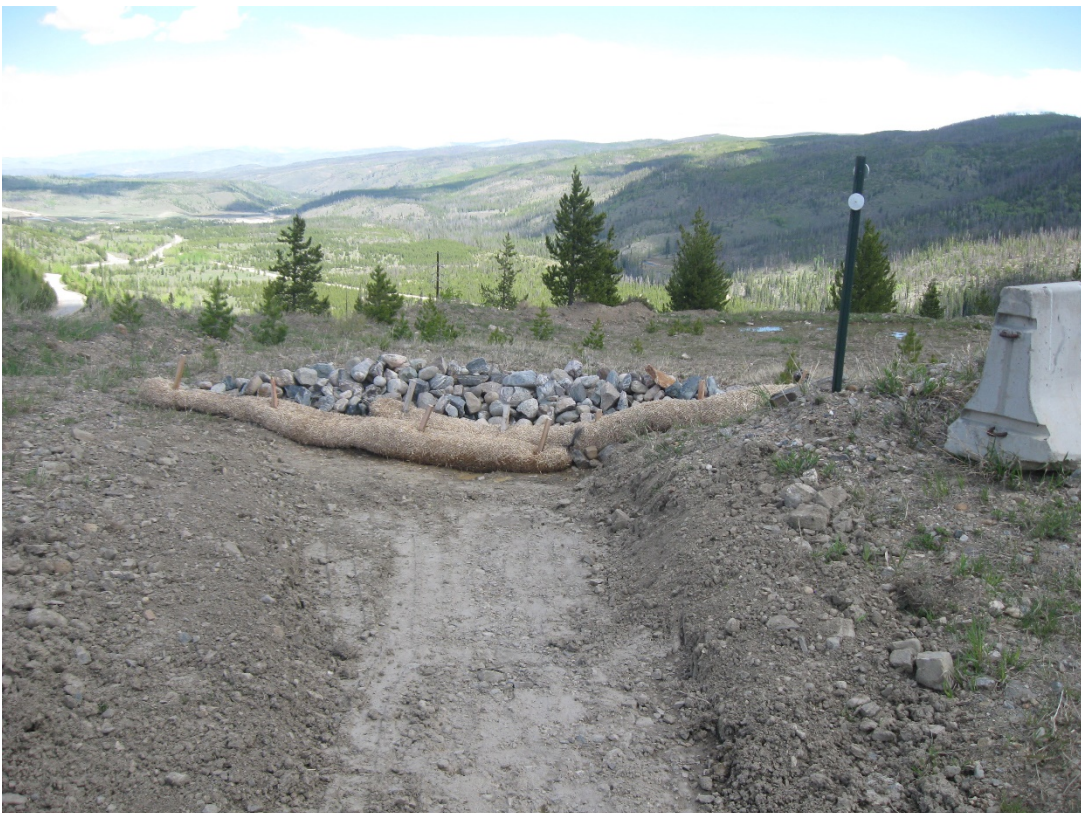
4. Unidentified outfall, located on access road to Mill Process Water Tanks.

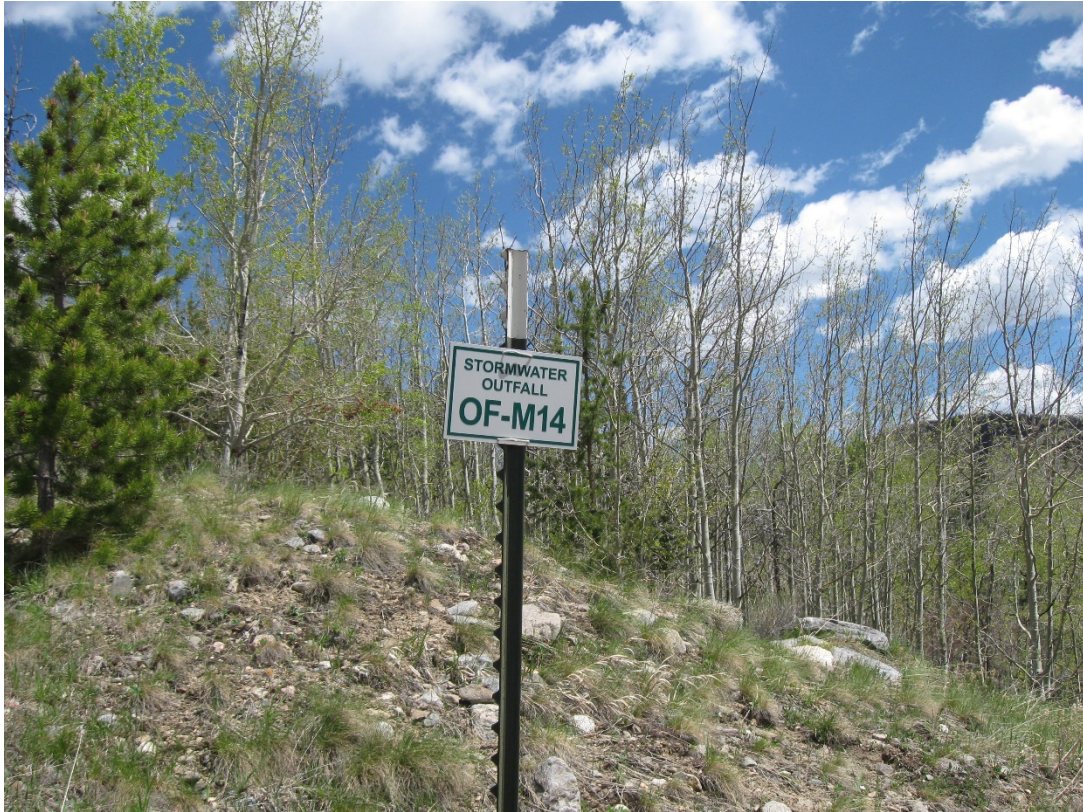
5. Outfall located at north end of storage area, no BMPs observed.
