**MINERALS PROGRAM INSPECTION REPORT**  
**PHONE: (303) 866-3567**

<b>MINE NAME:</b> Purgatoire Valley Construction Borrow Pit	<b>MINE/PROSPECTING ID#:</b> M-2018-025	<b>MINERAL:</b> Borrow	<b>COUNTY:</b> Las Animas
<b>INSPECTION TYPE:</b> Illegal (Unpermitted Operation)	<b>INSPECTOR(S):</b> Elliott R. Russell	<b>INSP. DATE:</b> May 31, 2018	<b>INSP. TIME:</b> 12:30
<b>OPERATOR:</b> Purgatoire Valley Construction, Inc.	<b>OPERATOR REPRESENTATIVE:</b> Glenn Moltrier	<b>TYPE OF OPERATION:</b> ILL - Illegal

# Inspection Map M-2018-025

Purgatoire Valley Construction Borrow Pit

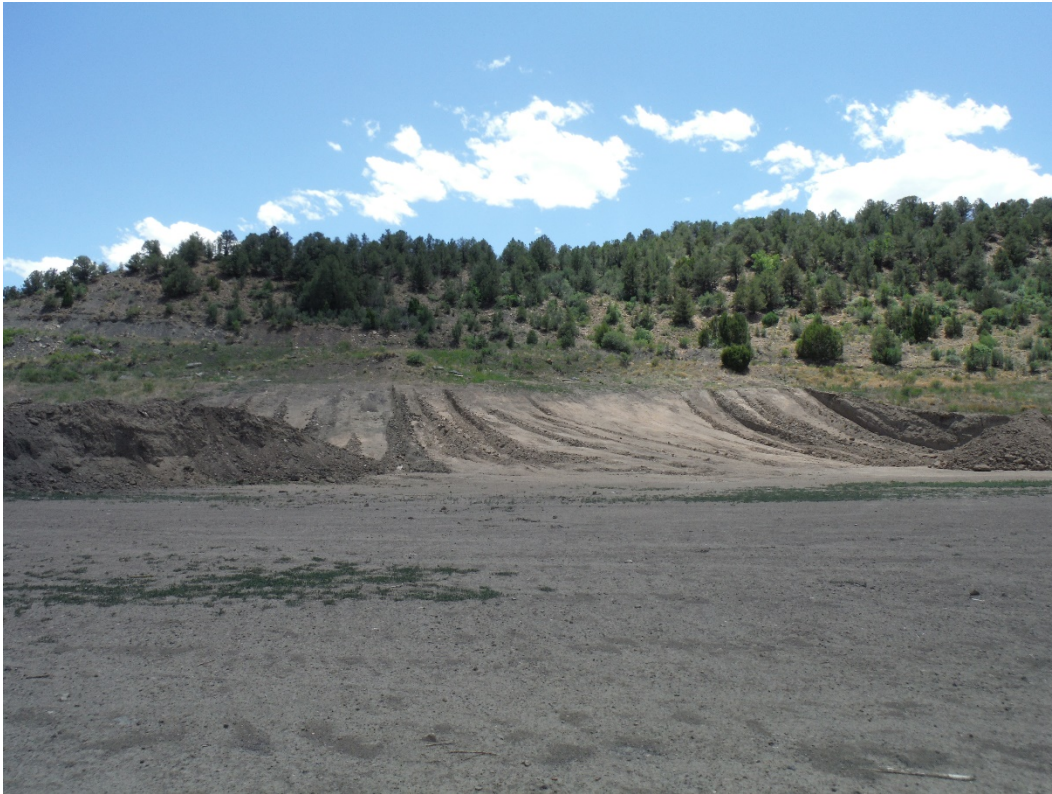
**Photo 1.** Excavation area; looking south.

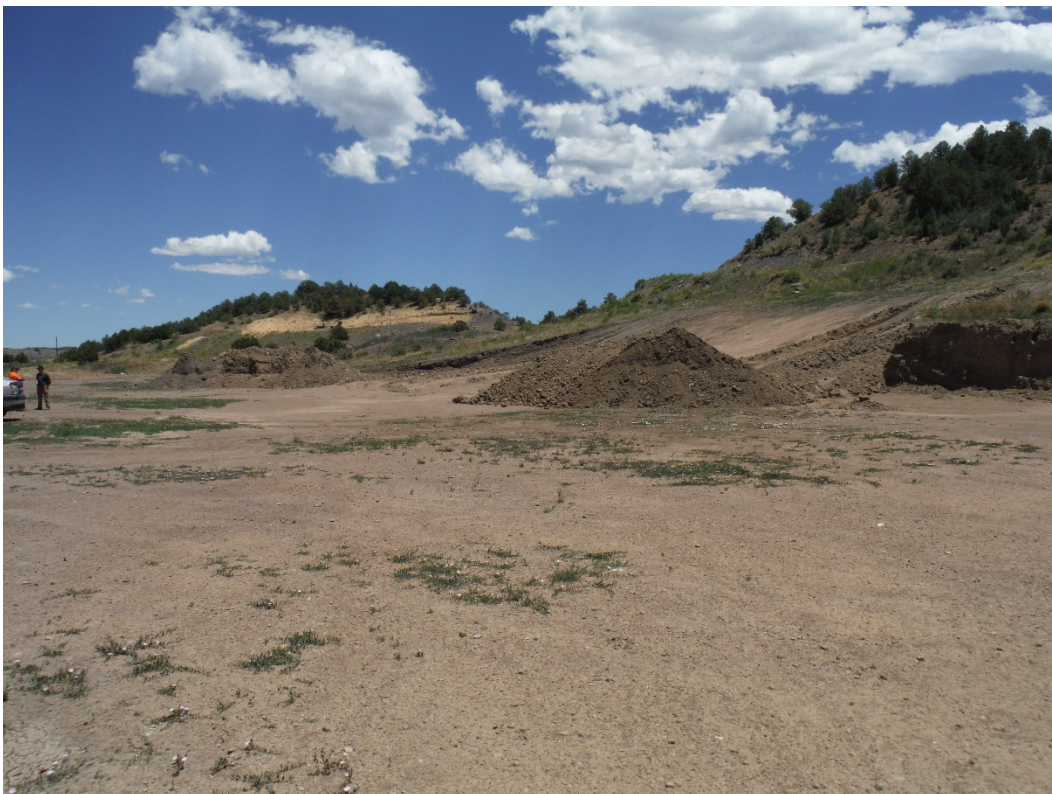
The site consisted of two stockpiles of material on either side of the excavation area. The Moltriers stated the eastern stockpile of material contained too much rock and didn't meet the compaction specification while the western stockpile was the ideal material for the school project. The Division acquired GPS data with a Trimble Juno 3B and used Google Earth to determine the disturbance was approximately 0.64 acres in size. The Division has attached *DRMS 5-31-2018 Inspection Map M2018025* to this report which depicts the size of the extraction area. Glenn Moltrier estimated 1,000 cubic yards of material had already been hauled during the first few weeks of May and another 500 cubic yards of material was still needed at the school. The Moltriers stated they wanted to expand the area of the excavation to the south, up to an old abandoned road and to the west to the previous dig area. The Moltriers also stated that Las Animas County was interested in using material from the site to increase the road grade of the nearby County Road 18.2.

**Photo 2.** Excavation area and western stockpile; looking southeast.

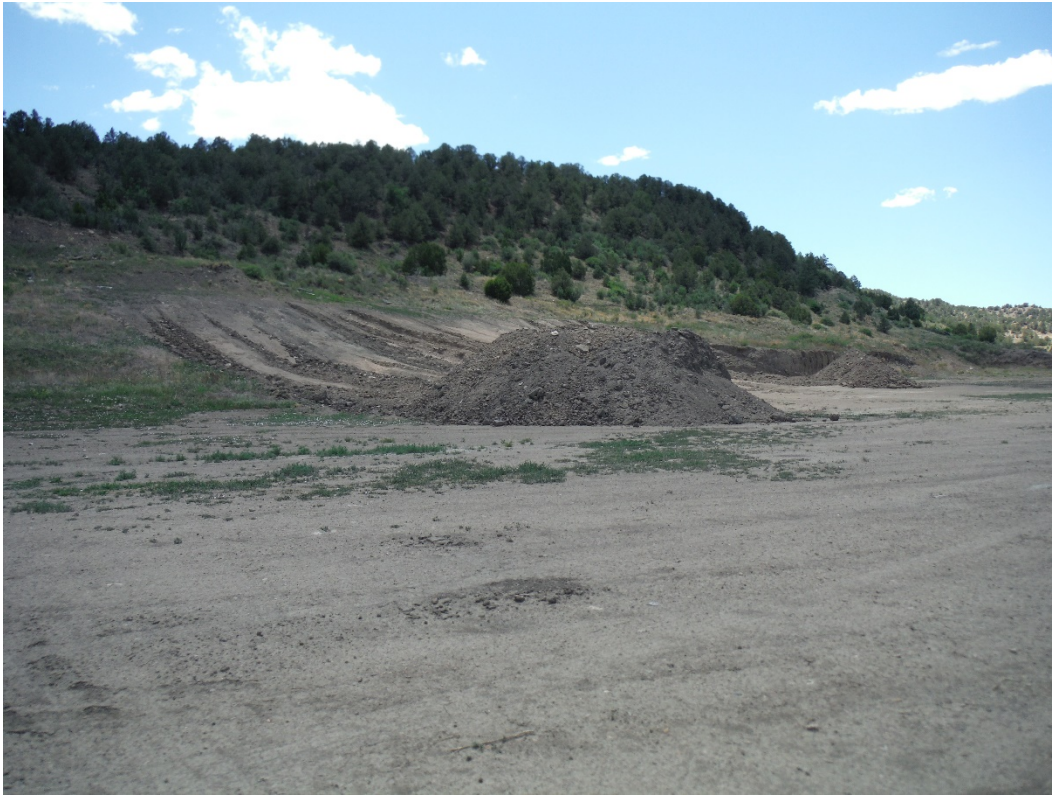
**Photo 3.** Excavation area and eastern stockpile; looking southwest.

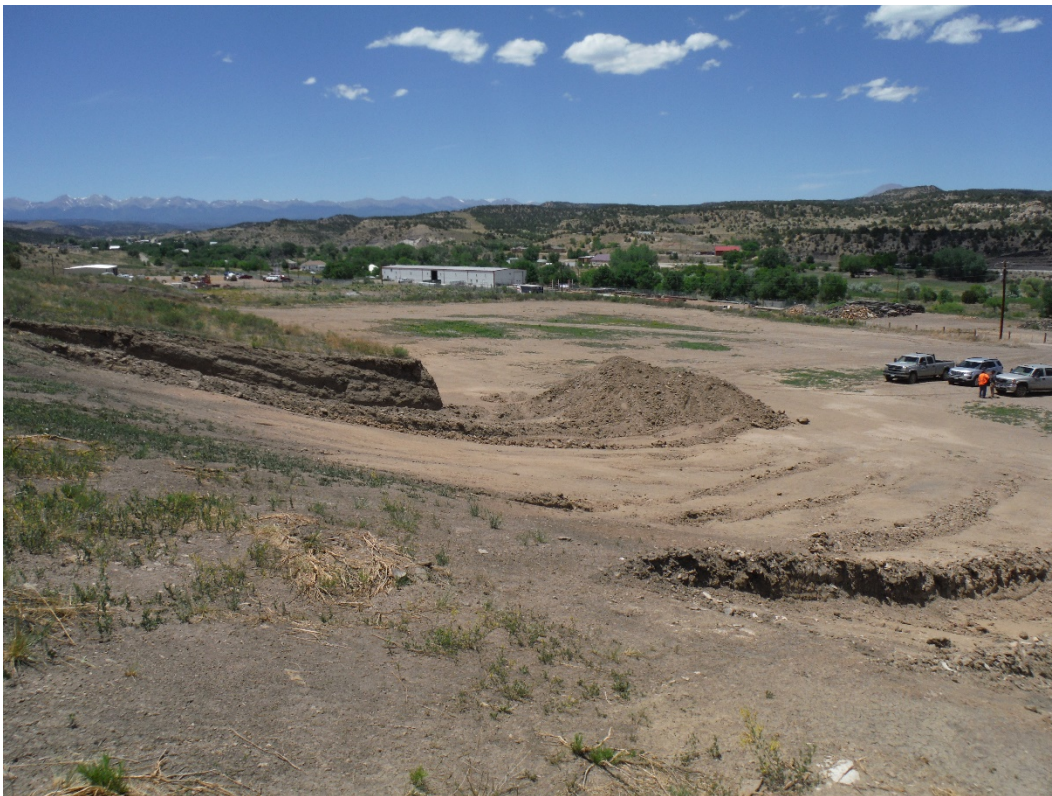
**Photo 4.** Excavation area and western stockpile; looking northwest.

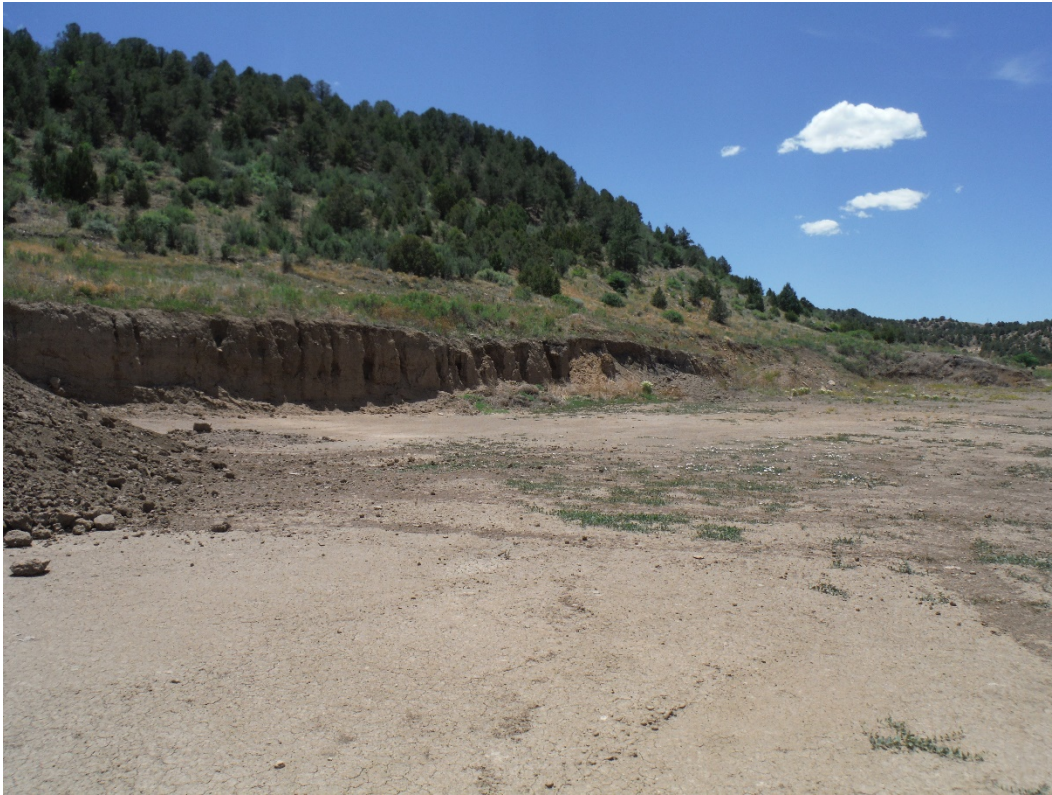
Glenn and Ray Moltrier indicated they owned the property of the excavation under the company Moltrier Bros. LLC and it was zoned industrial. The Moltriers stated they were removing material from the north-facing hillside to create a larger pad for a future building site and donating the material to the Primero Junior-Senior High School for an on-going gym construction project. The Moltriers stated the area was originally padded out roughly 15 years ago and now they were increasing the size of the building pad. East of the excavation was a small highwall in the hillside where a previous excavation occurred. Glenn Moltrier stated this previous dig area was created when he needed fill dirt for areas on his property.

**Photo 5.** Older dig area located west of the excavation; looking southwest.

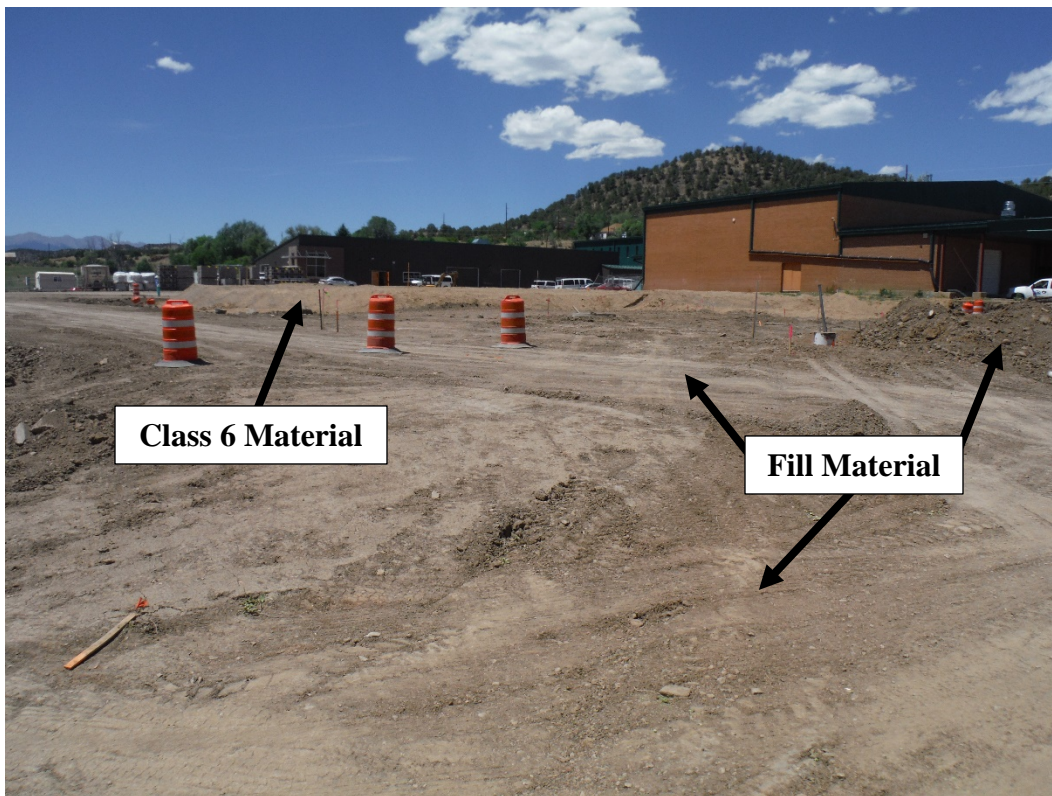
they had used material on-site, as well as the hauled in material from his property, to bring the location of the new gym, parking lot, and school access road up to grade. Mr. Moltrier also stated they had purchased Class 6 Aggregate Base Course from a local permitted mine site to achieve enough weight for the wick drain system being used to dewater the location of the new gym.

**Photo 6.** School construction site; looking northwest.
