MINERALS PROGRAM INSPECTION REPORT
PHONE: (303) 866-3567

MINE NAME: White Wolf Construction Borrow Pit	MINE/PROSPECTING ID#: M-2018-029	MINERAL: Borrow	COUNTY: Las Animas
INSPECTION TYPE: Illegal (Unpermitted Operation)	INSPECTOR(S): Elliott R. Russell	INSP. DATE: May 31, 2018	INSP. TIME: 14:30
OPERATOR: White Wolf Construction & Landscaping, LLC	OPERATOR REPRESENTATIVE: Joe Montoya	TYPE OF OPERATION: ILL - Illegal

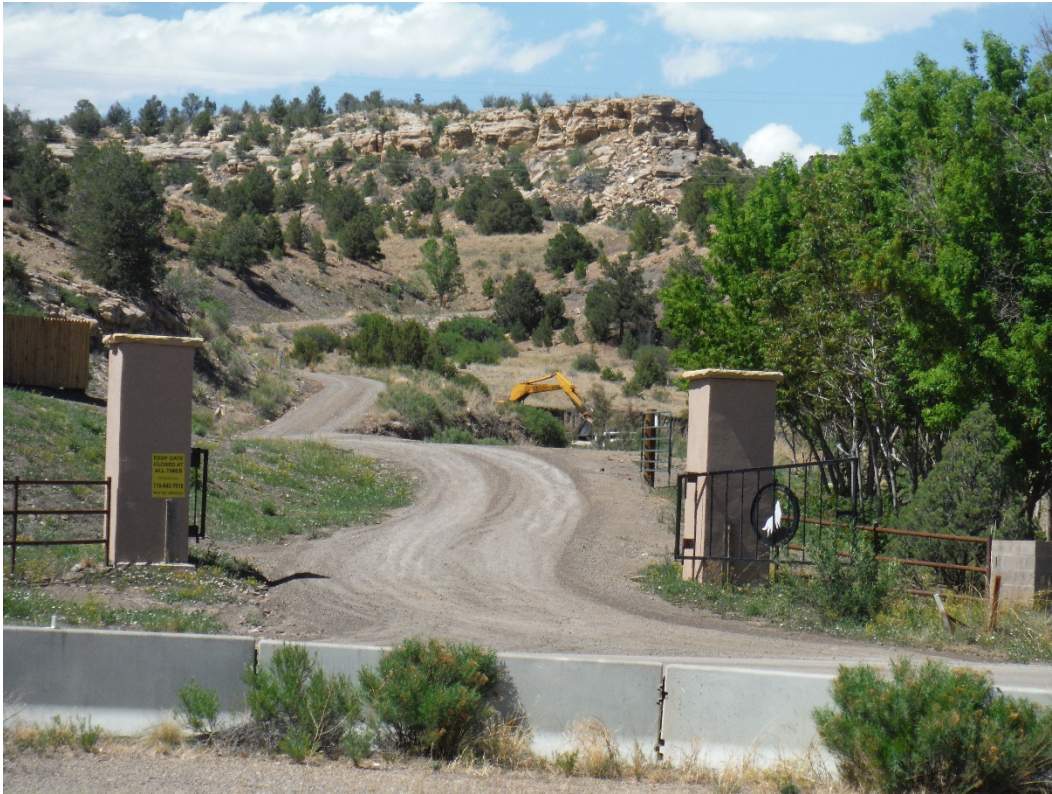
Photo 1. Excavator loading dump truck; looking north from Highway 12 and CR 47.7.

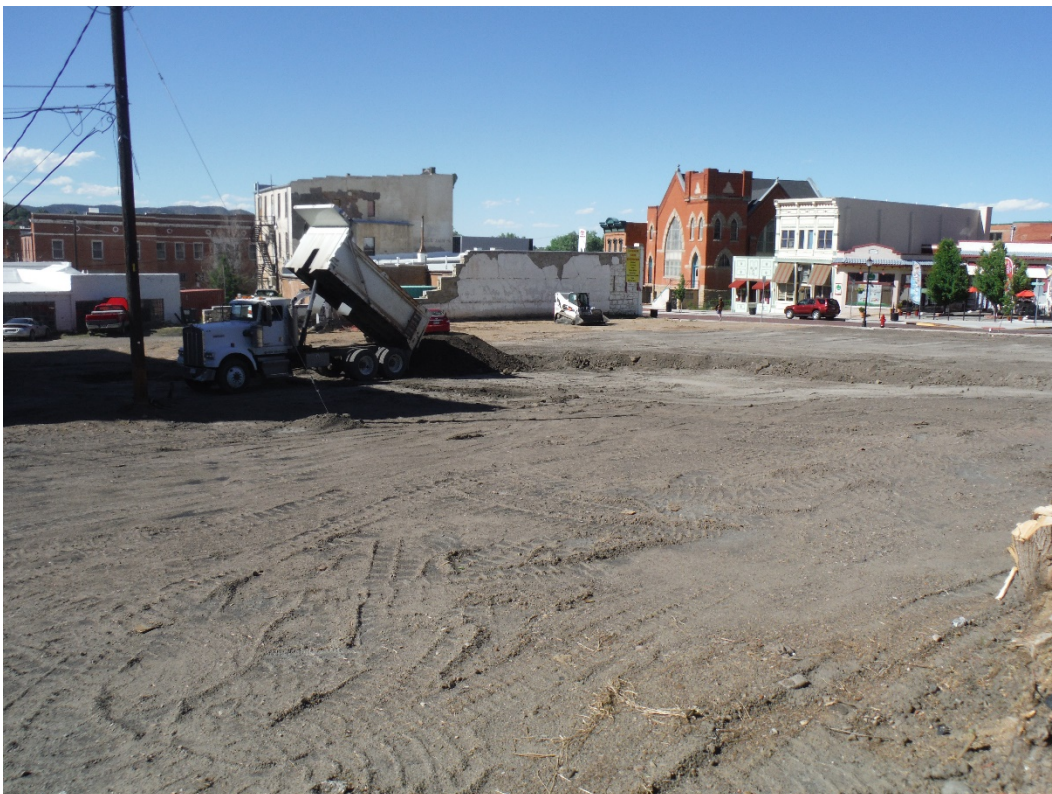
Photo 2. Dump truck at the open lot in Trinidad; looking northeast.

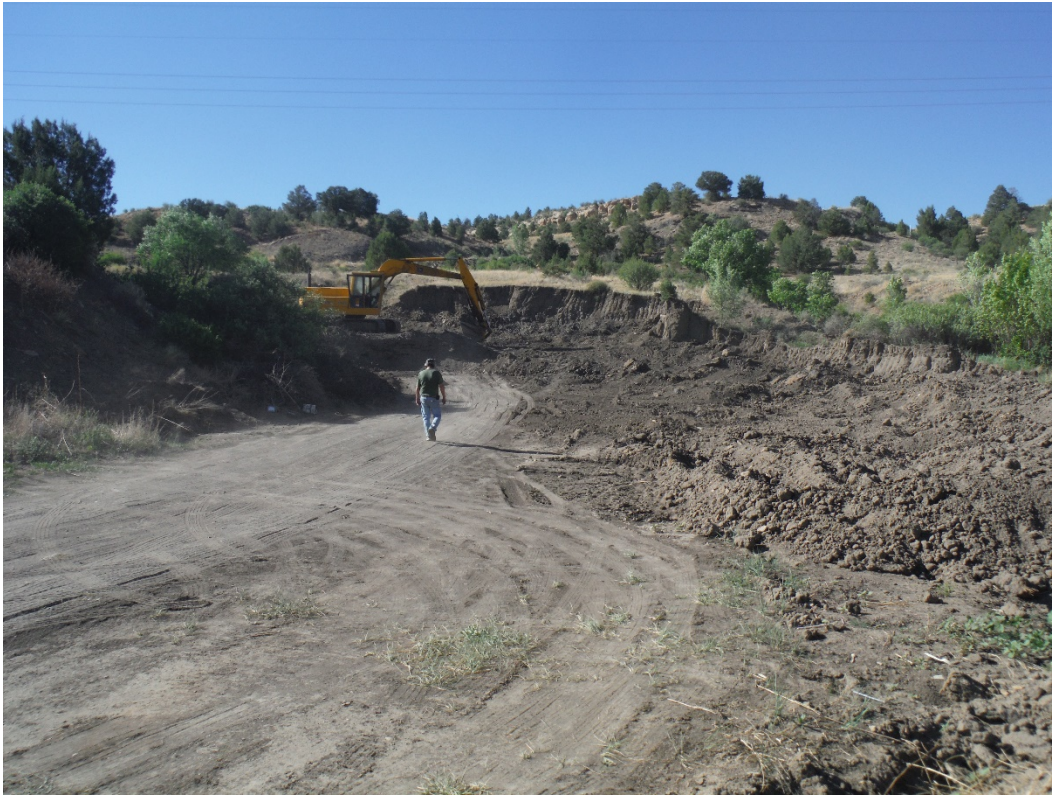
Photo 3. Excavation area and access road; looking north.

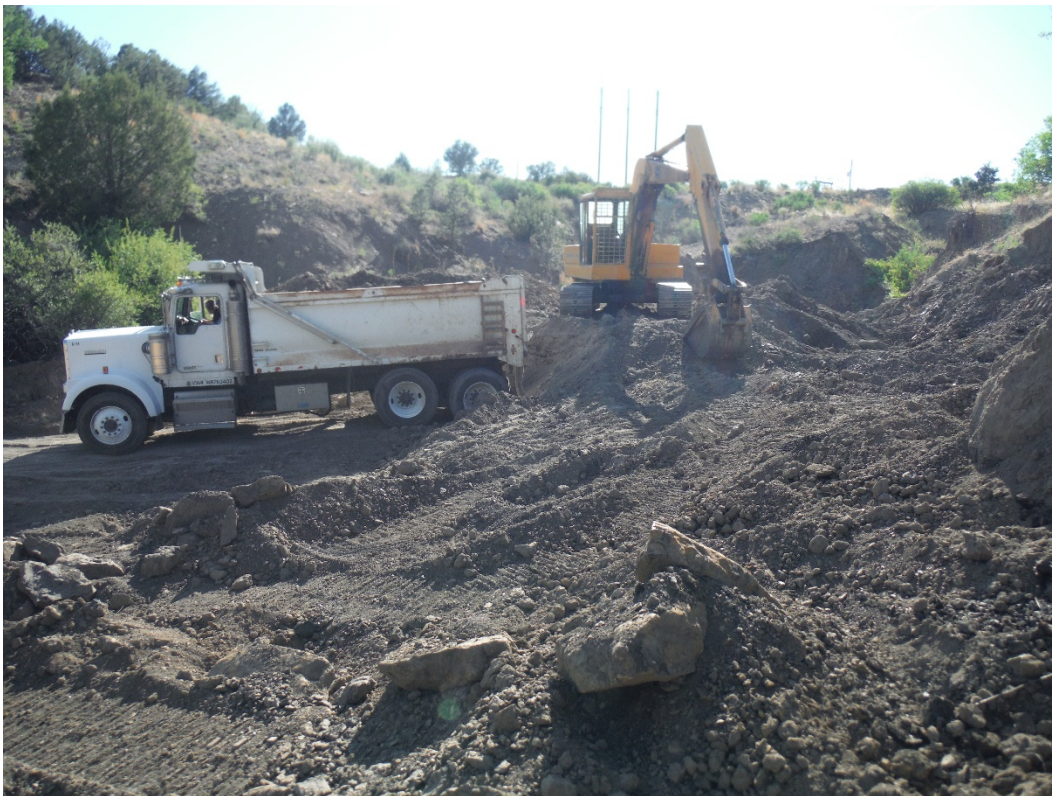
Photo 4. Excavation area; looking west.

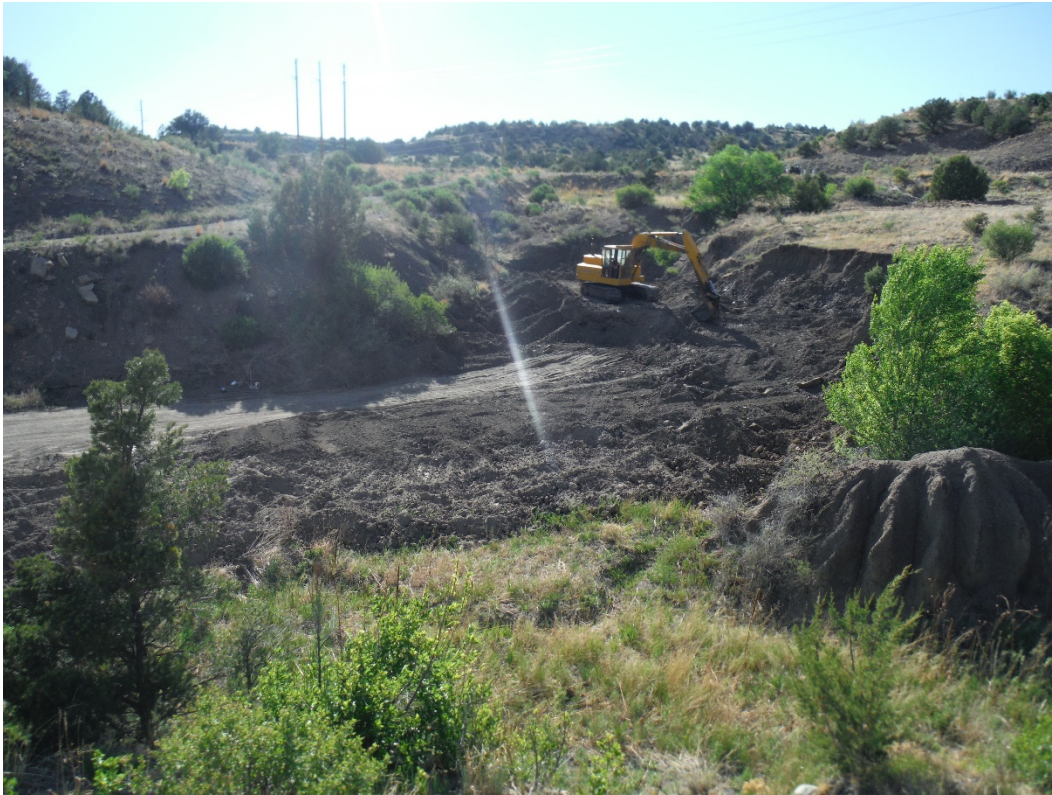
Photo 5. Excavation overview; looking northwest.

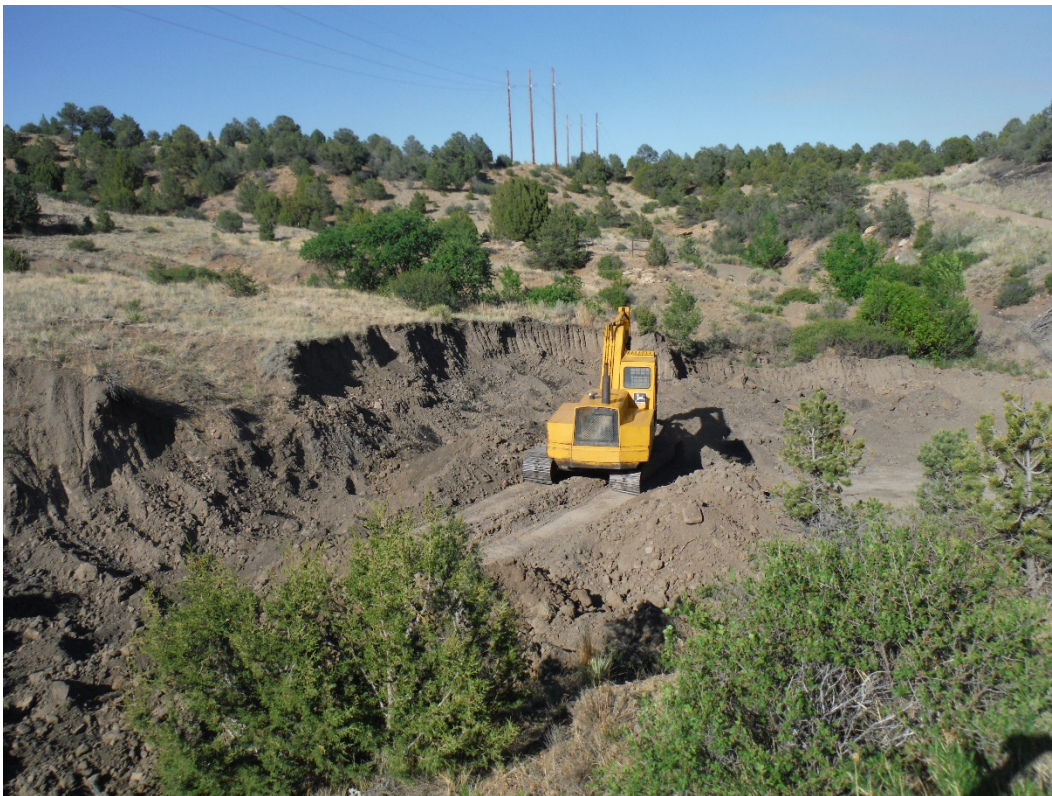
Photo 6. Excavation overview; looking northeast.

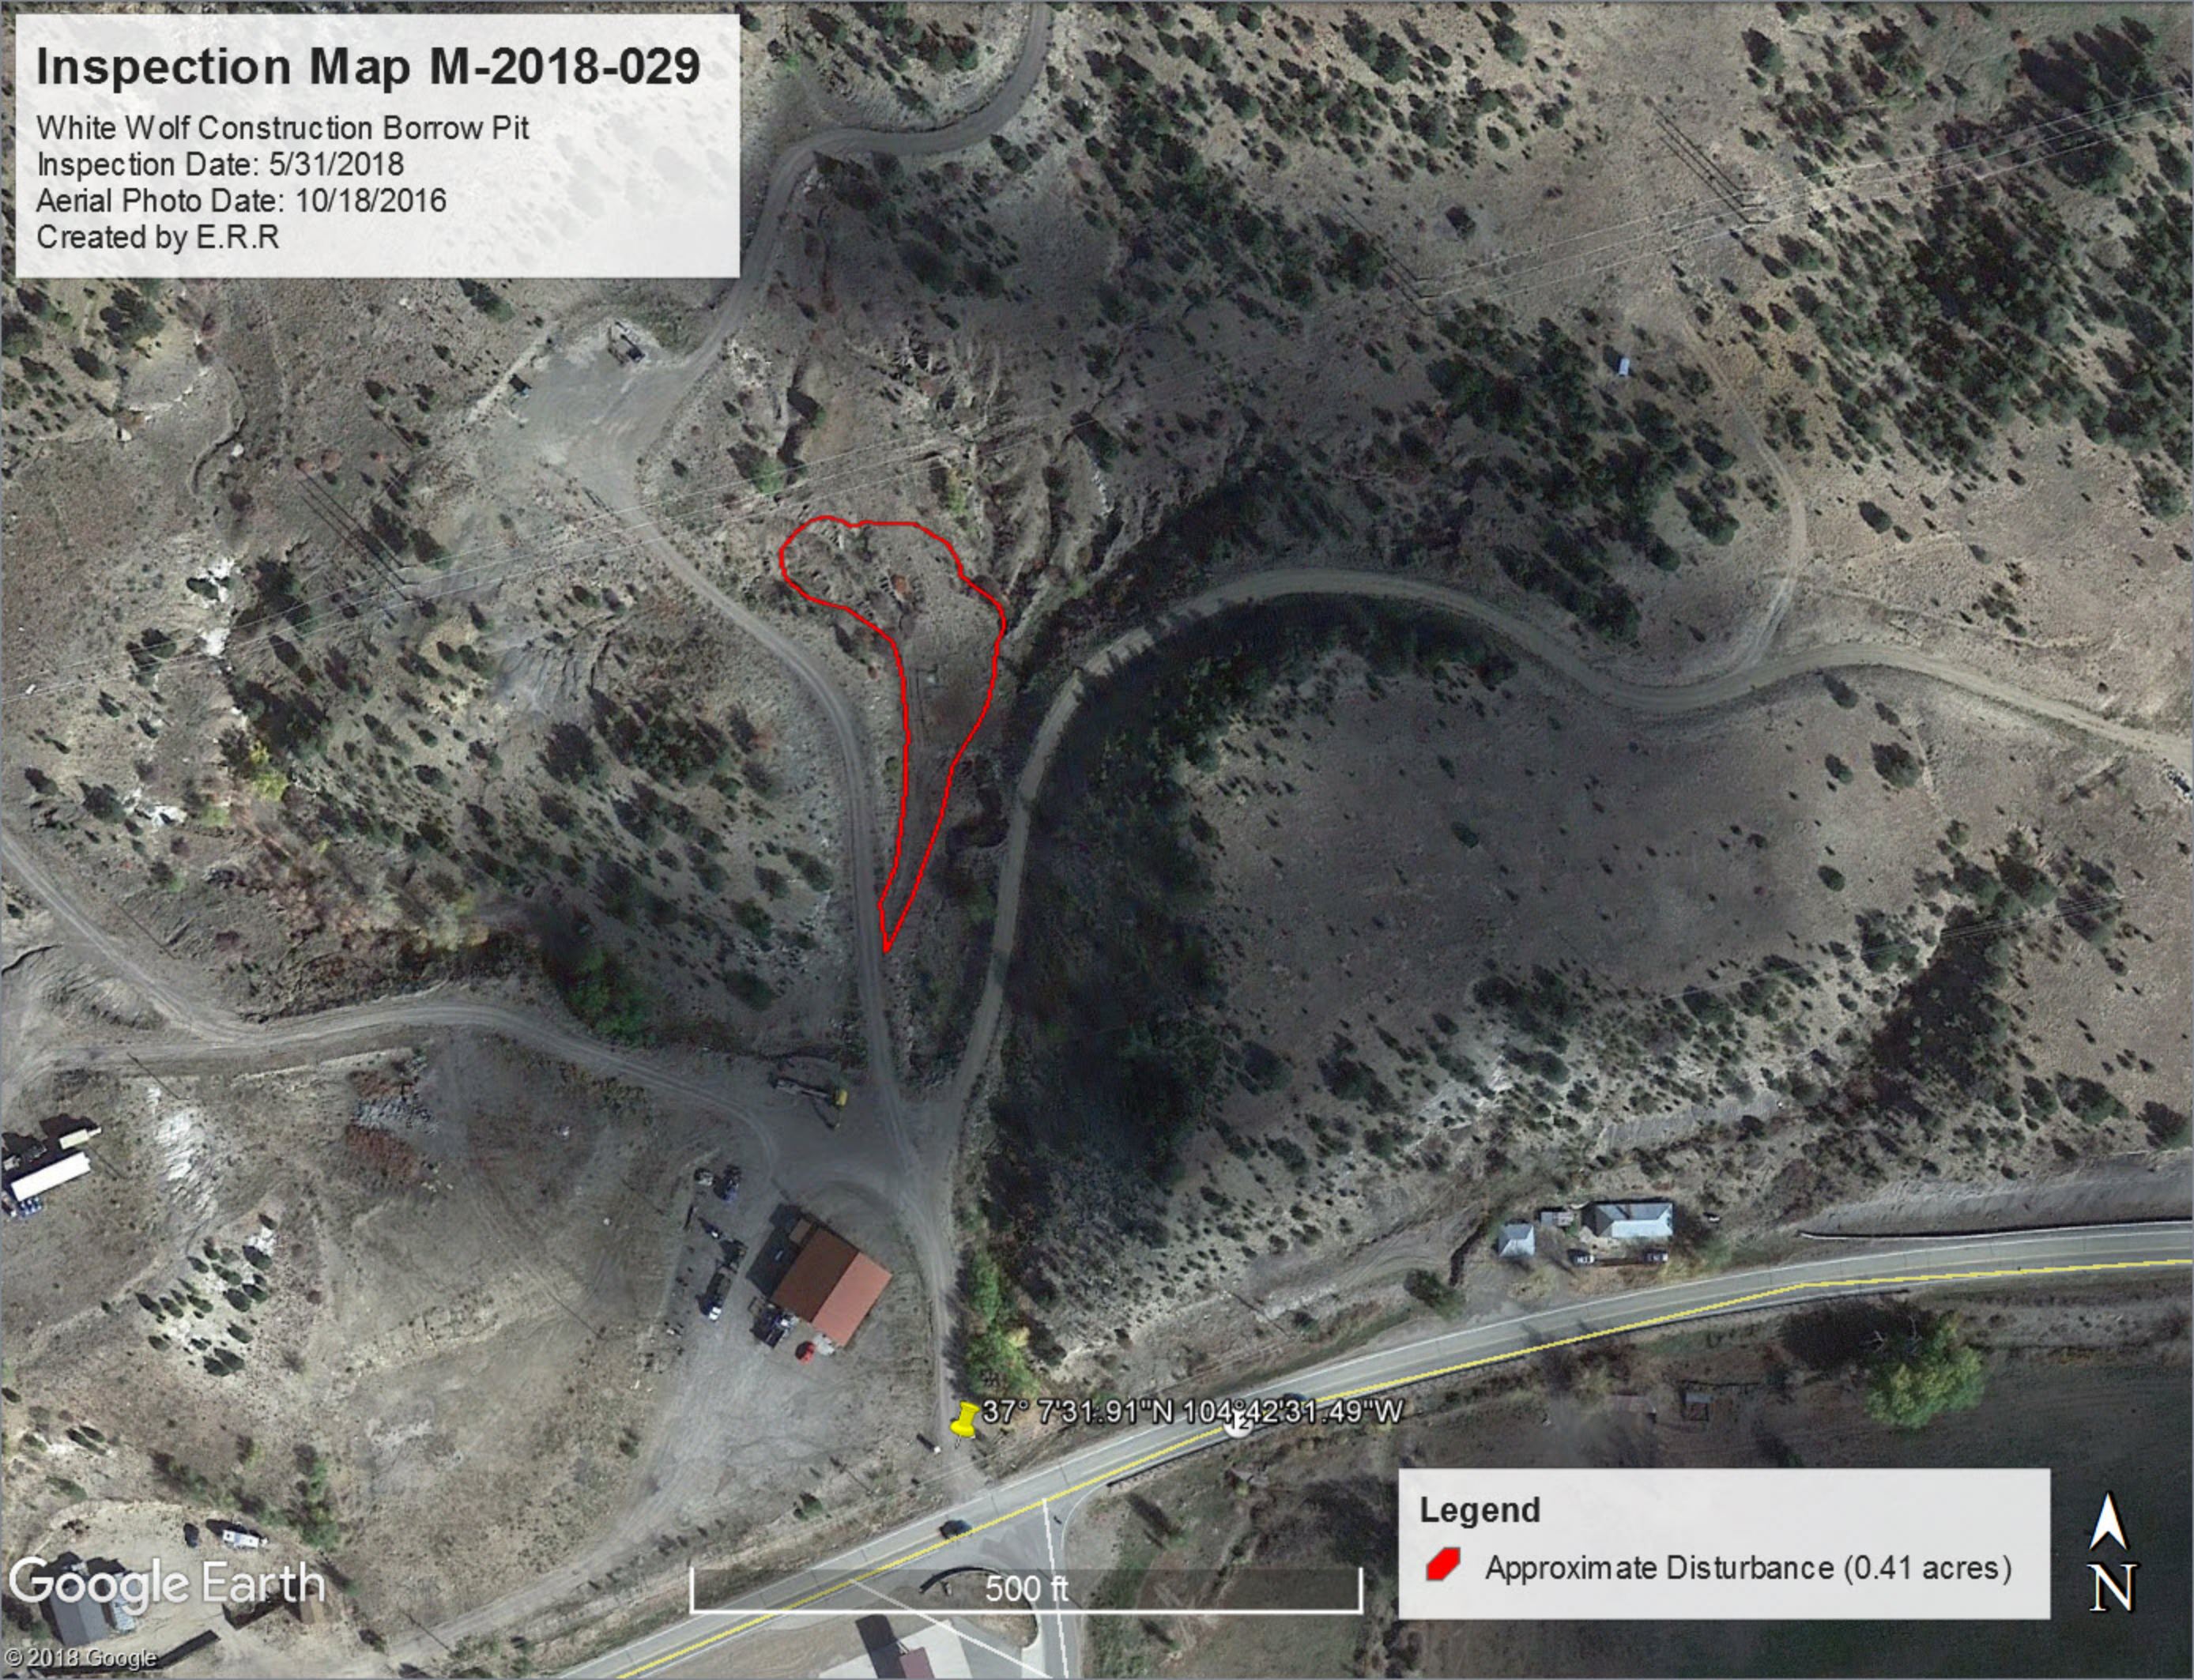
Inspection Map M-2018-029

The site consisted of a short access road and hillside excavation located between two small drainages. The Division acquired GPS data with a Trimble Juno 3B and used Google Earth to determine the disturbance was approximately 0.41 acres in size. The Division has attached *DRMS 5-31-2018 Inspection Map M2018029* to this report which depicts the size of the extraction area. Mr. Montoya said he was trying to develop the area as a future building pad for a shop and once enough material has been delivered to the lot in Trinidad, he would use the cut/fill method for the remaining material. Mr. Montoya anticipated the pad would further extend north approximately 100 feet.

Approximate Disturbance (0.41 acres)
