**COLORADO**Division of Reclamation,
Mining and Safety

MINERALS PROGRAM INSPECTION REPORT**PHONE: (303) 866-3567**

| MINE NAME: Lawrence Pit | MINE/PROSPECTING ID#: M-1974-041 | MINERAL: Sand and gravel | COUNTY: Douglas |
| INSPECTION TYPE: Monitoring | INSPECTOR(S): Peter S. Hays | INSP. DATE: June 14, 2018 | INSP. TIME: 13:00 |

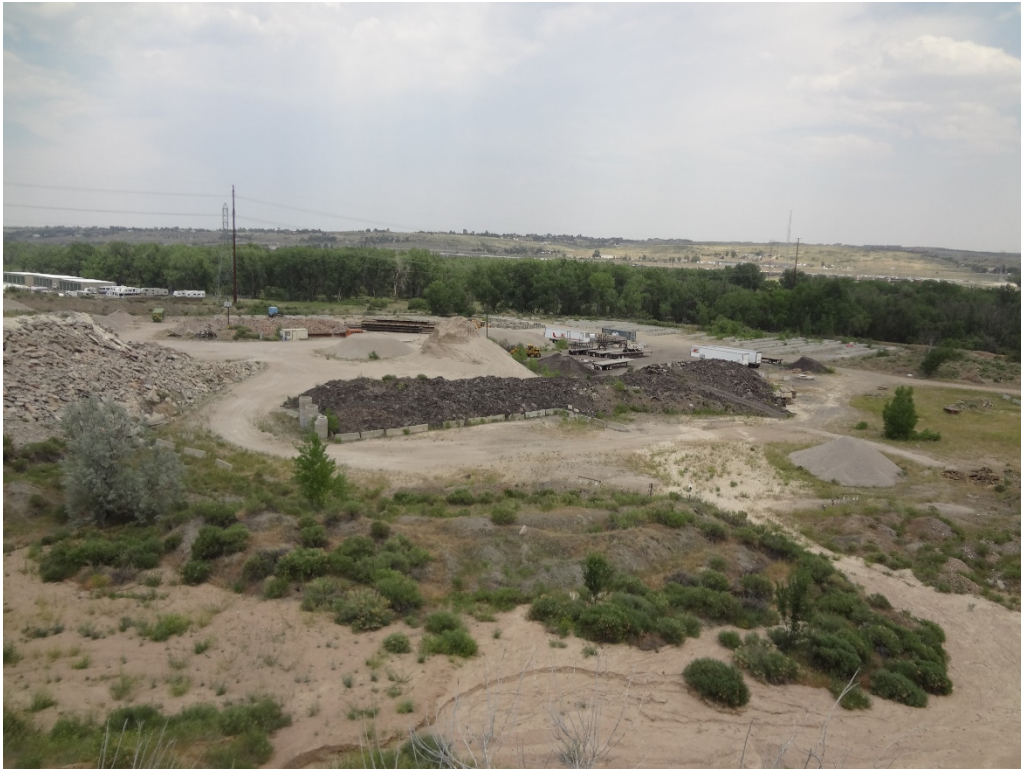
View of site from south highwall looking north

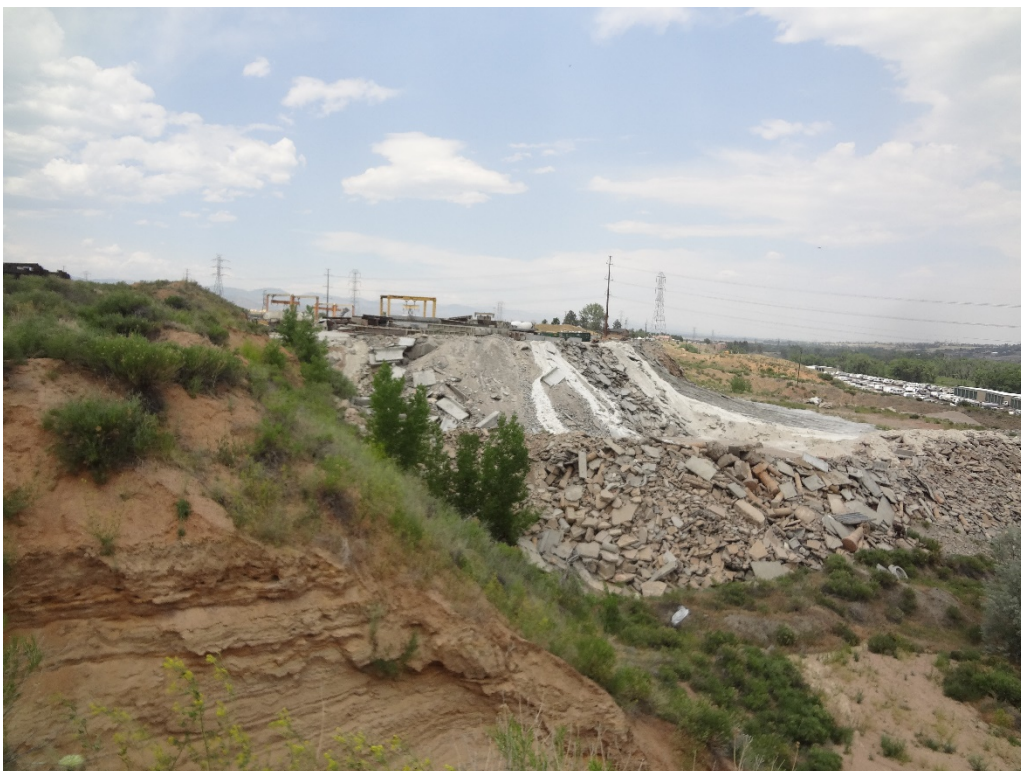
View of the site from the south highwall looking northwest

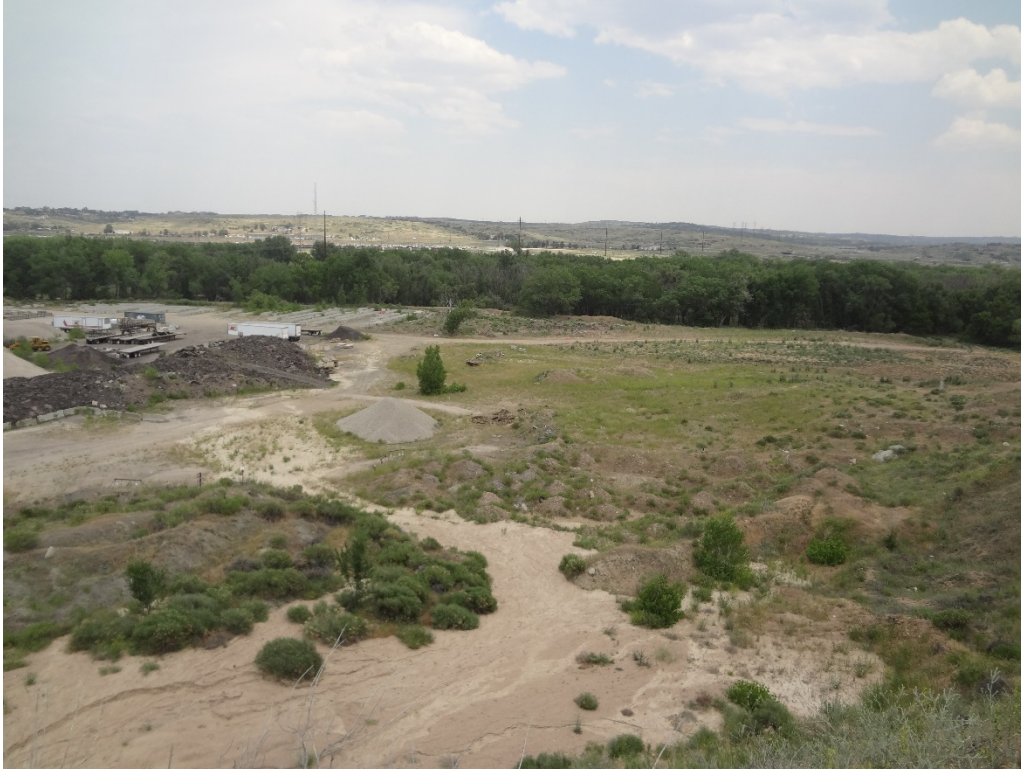
View of site from south highwall looking northeast

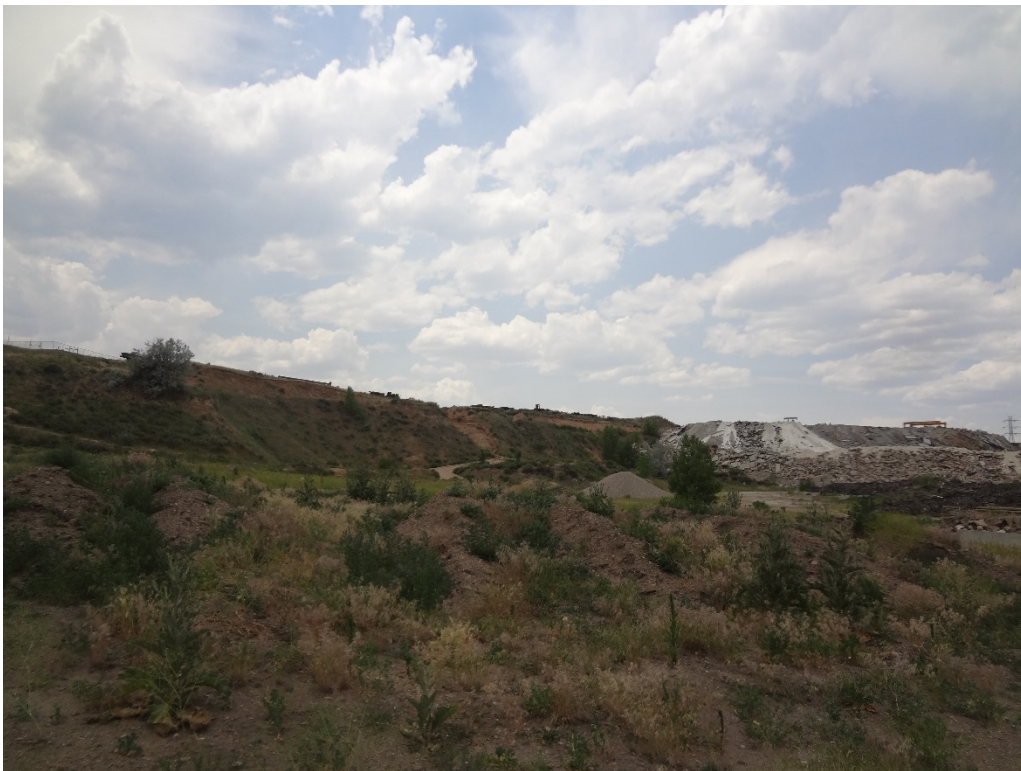
View of south highwall from southeast corner of pit floor looking southwest

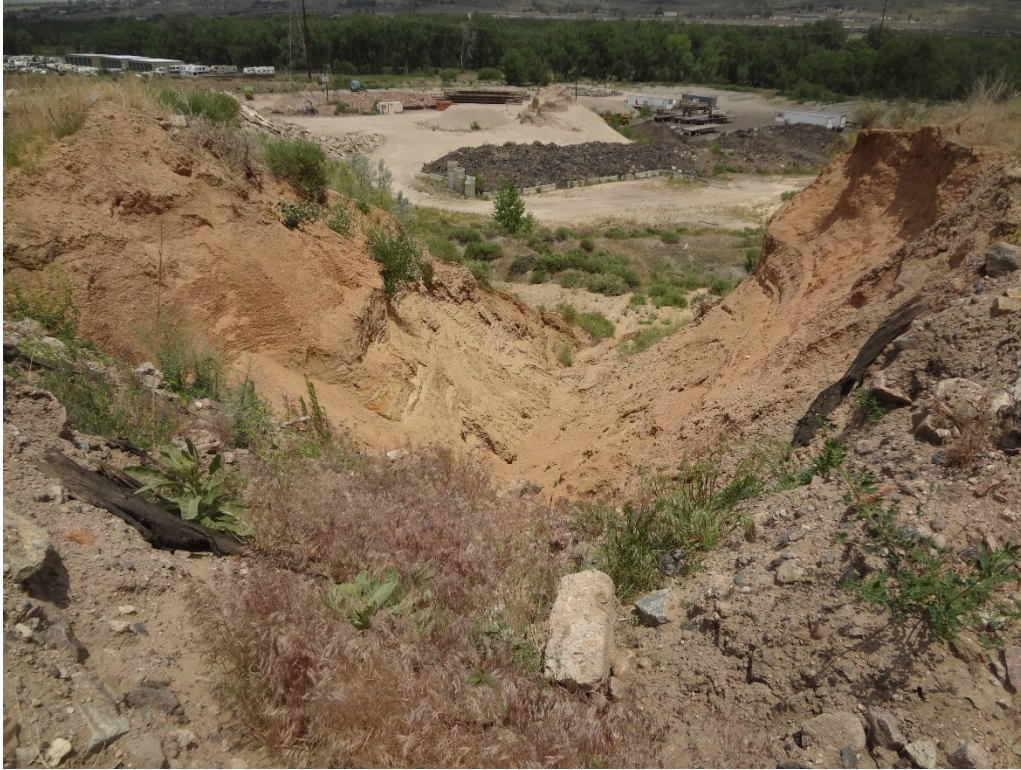
As noted in the previous inspection report, an erosion gully has formed in the middle of the south highwall. The eroded material was contained in the pit floor. The Operator has attempted to stabilize the top of the feature. The feature should be monitored by the Operator, however since the feature is not near the permit boundary and the area adjacent to the feature will be mined in the future, the erosion gully is not cited as a problem by the Division. The pit floor was dry at the time of the inspection.

View of the erosion gully in the south highwall
