## MINERALS PROGRAM INSPECTION REPORT PHONE: (303) 866-3567

MINE NAME:	MINE/PROSPECTING ID#:	MINERAL:	COUNTY:
Lawrence Pit	M-1974-041	Sand and gravel	Douglas
INSPECTION TYPE:	INSPECTOR(S):	INSP. DATE:	INSP. TIME:
Monitoring	Peter S. Hays	June 14, 2018	13:00
OPERATOR:	OPERATOR REPRESENTATIVE:	TYPE OF OPERATION:	
Lawrence Construction Company, Inc.	Brian Benight	112c - Construction Regular Operation	
REASON FOR INSPECTION:	BOND CALCULATION TYPE:	BOND AMOUNT:	
Normal I&E Program	Partial Bond	\$294,000.00	
DATE OF COMPLAINT:	POST INSP. CONTACTS:	JOINT INSP. AGE	ENCY:

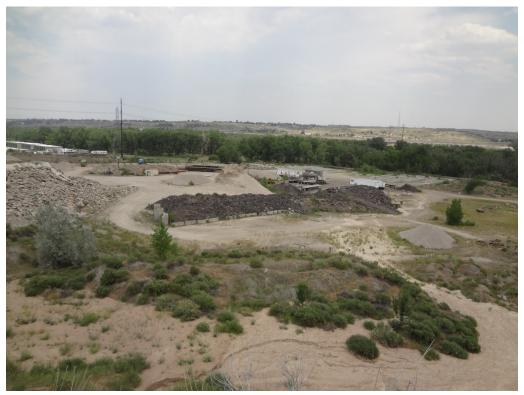
View of site from south highwall looking north

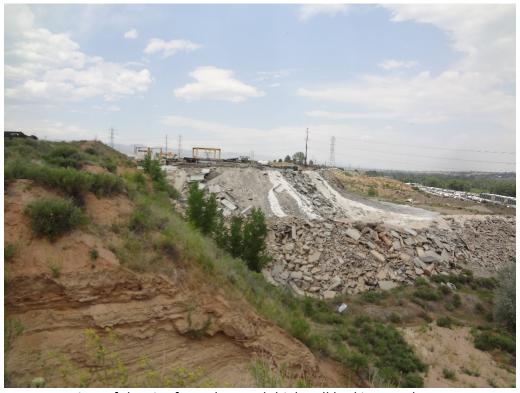
View of the site from the south highwall looking northwest

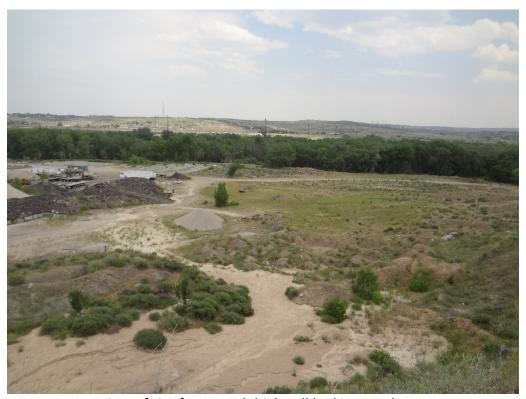
View of site from south highwall looking northeast

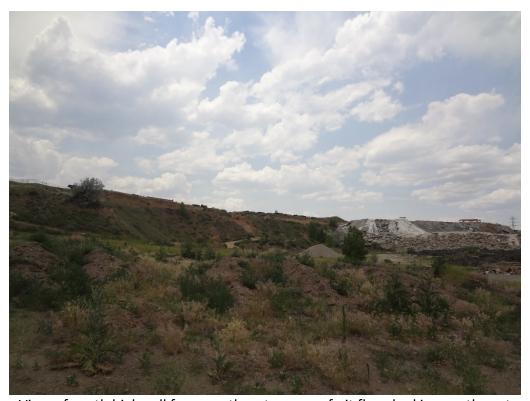
View of south highwall from southeast corner of pit floor looking southwest

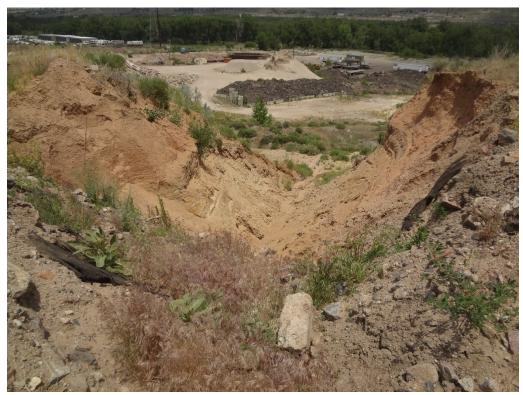
As noted in the previous inspection report, an erosion gully has formed in the middle of the south highwall. The eroded material was contained in the pit floor. The Operator has attempted to stabilize the top of the feature. The feature should be monitored by the Operator, however since the feature is not near the permit boundary and the area adjacent to the feature will be mined in the future, the erosion gully is not cited as a problem by the Division. The pit floor was dry at the time of the inspection.

View of the erosion gully in the south highwall
