**COLORADO**Division of Reclamation,
Mining and Safety

MINERALS PROGRAM INSPECTION REPORT**PHONE: (303) 866-3567**

MINE NAME: ARS Sand and Gravel	MINE/PROSPECTING ID#: M-1980-020	MINERAL: Sand and gravel	COUNTY: Douglas
INSPECTION TYPE: Monitoring	INSPECTOR(S): Peter S. Hays	INSP. DATE: June 14, 2018	INSP. TIME: 11:00
OPERATOR: ARS Sand & Gravel Co, LLC	OPERATOR REPRESENTATIVE: Roy Mayfield	TYPE OF OPERATION: 112c - Construction Regular Operation

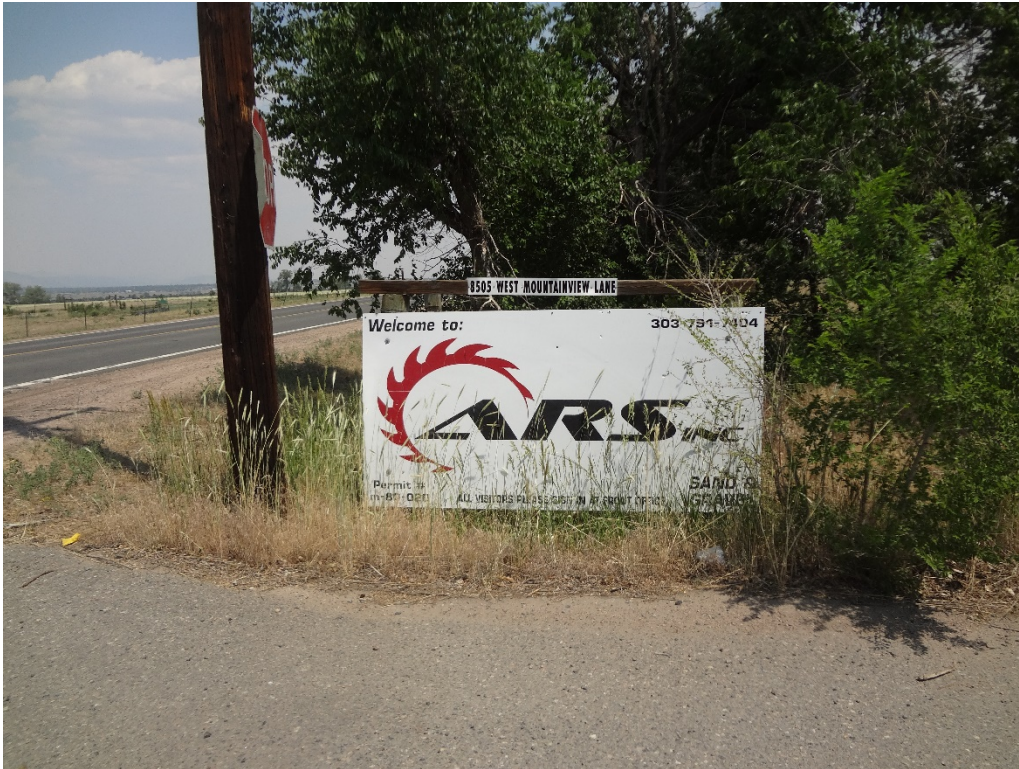
ARS Sand and Gravel mine sign at north entrance

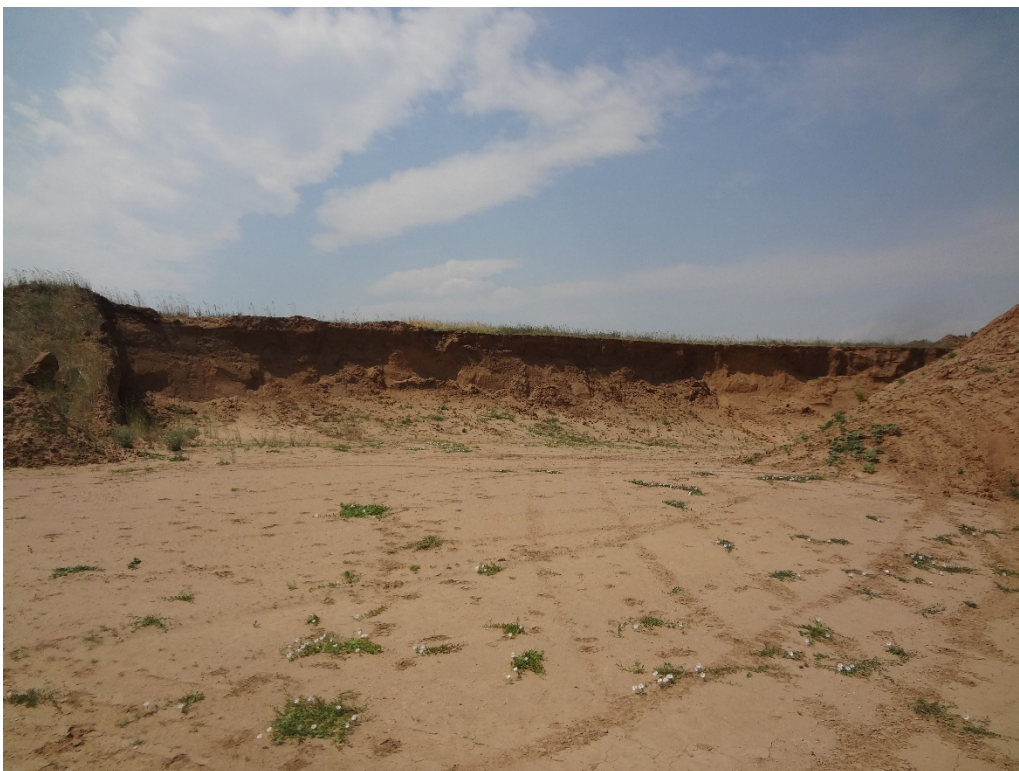
Mining disturbance west of AM-05 area

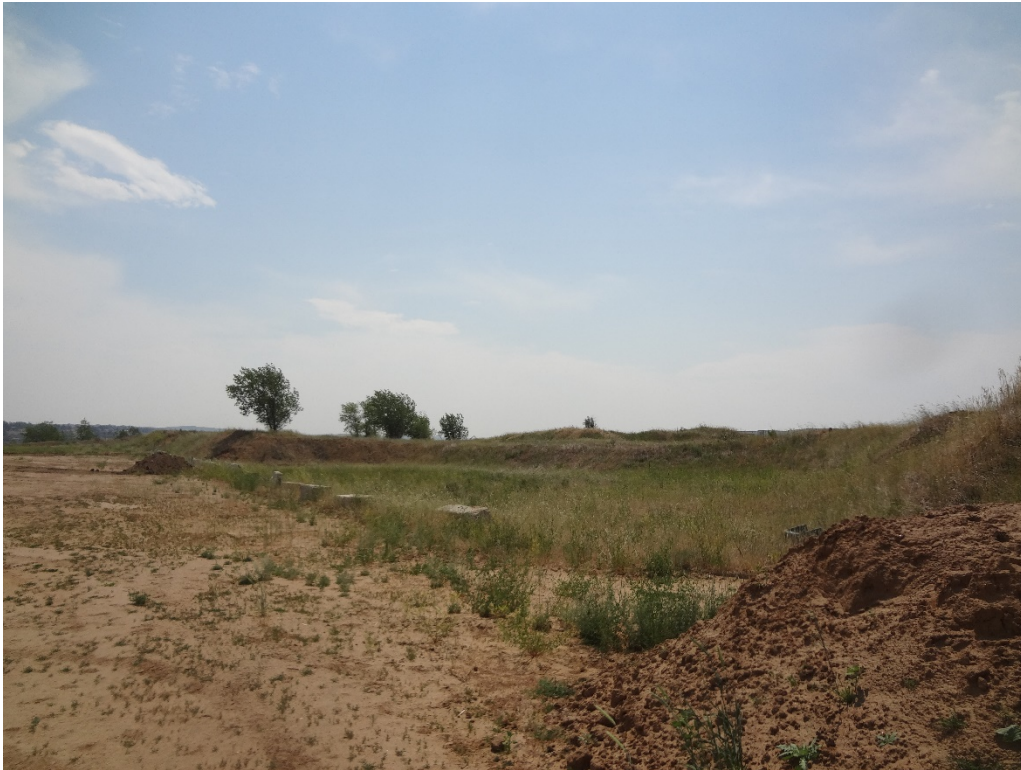
The approved post-mining land use for the site is rangeland. The area mined by the Operator resulting in the submittal of AM-05 has revegetated with volunteer species. The area appeared stable and no erosion features were observed. The Operator will be required to revegetate the area with the approved reclamation seed mixture during the final reclamation of the site. Two stockpiles of topsoil are located at the site; between the current access road and the west highwall and in the southeast corner of the site. The stockpiles were well-vegetated and stable. The Operator stated the site is being evaluated as a reservoir for the Sterling Ranch development to the south of the site. The eastern boundary would be raised in elevation and a clay liner would be constructed around the perimeter of the pit if the Operator decides to construct a reservoir. The Division will require the Operator to submit an amendment application, pursuant to Rule 1.10.1, to change the post-mining land use to developed water resource prior to constructing the reservoir.

AM-05 disturbance area, self-revegetated

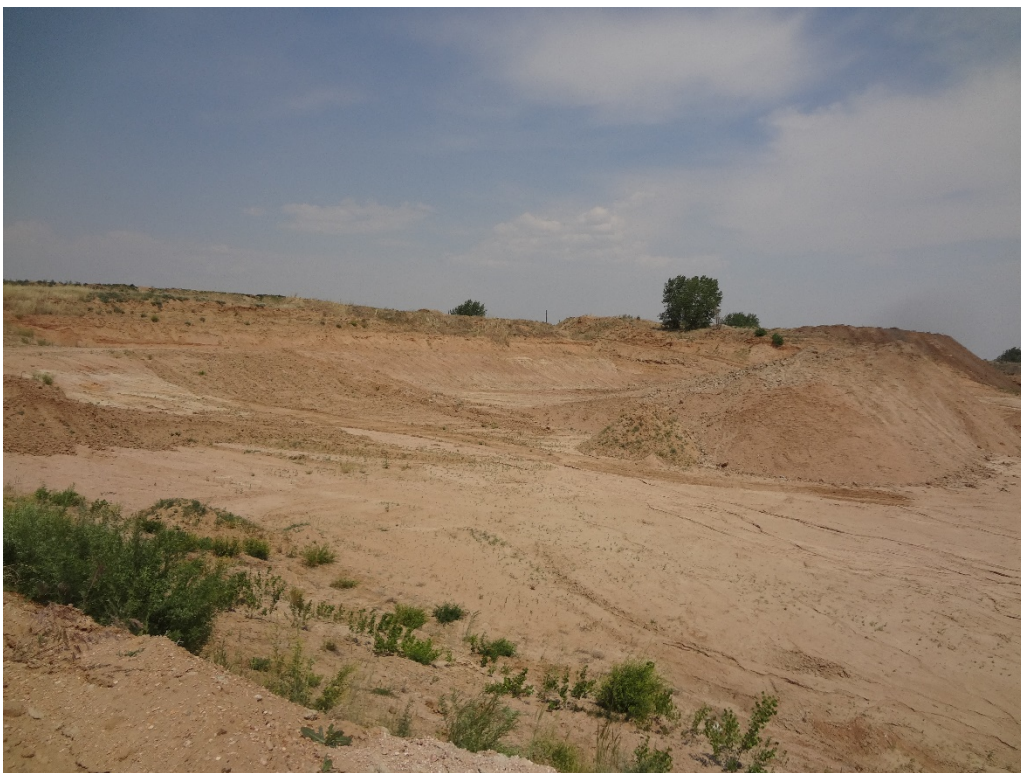
Mining area in west highwall and stockpile looking northeast

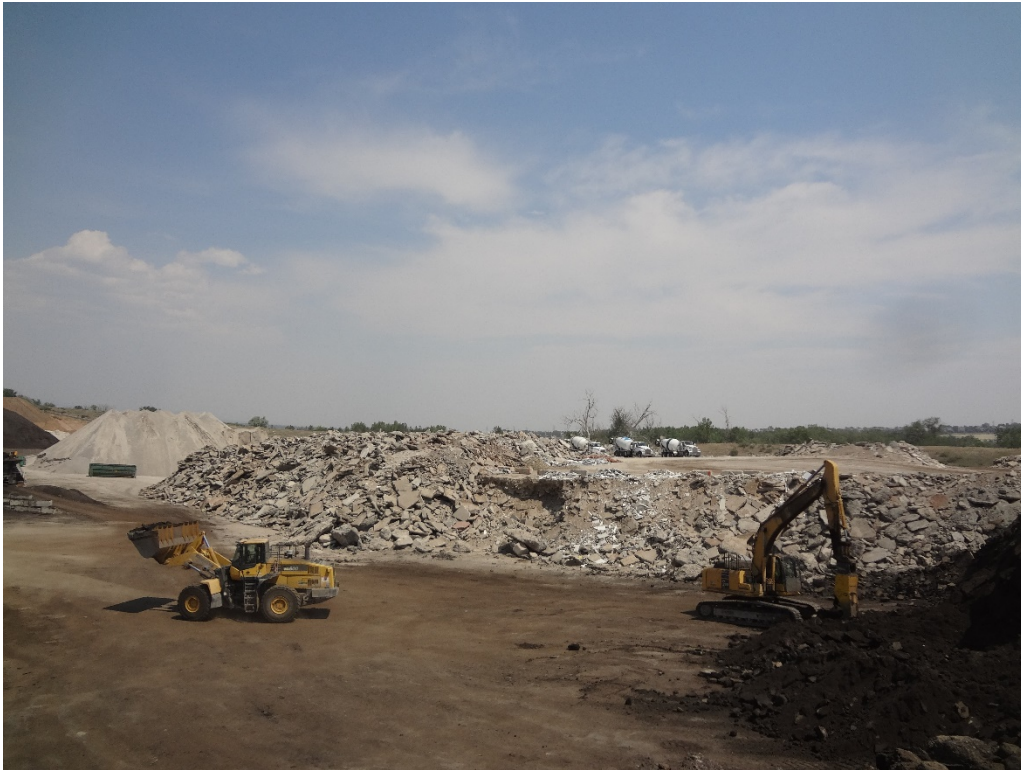
View of concrete and asphalt recycling activities looking northeast

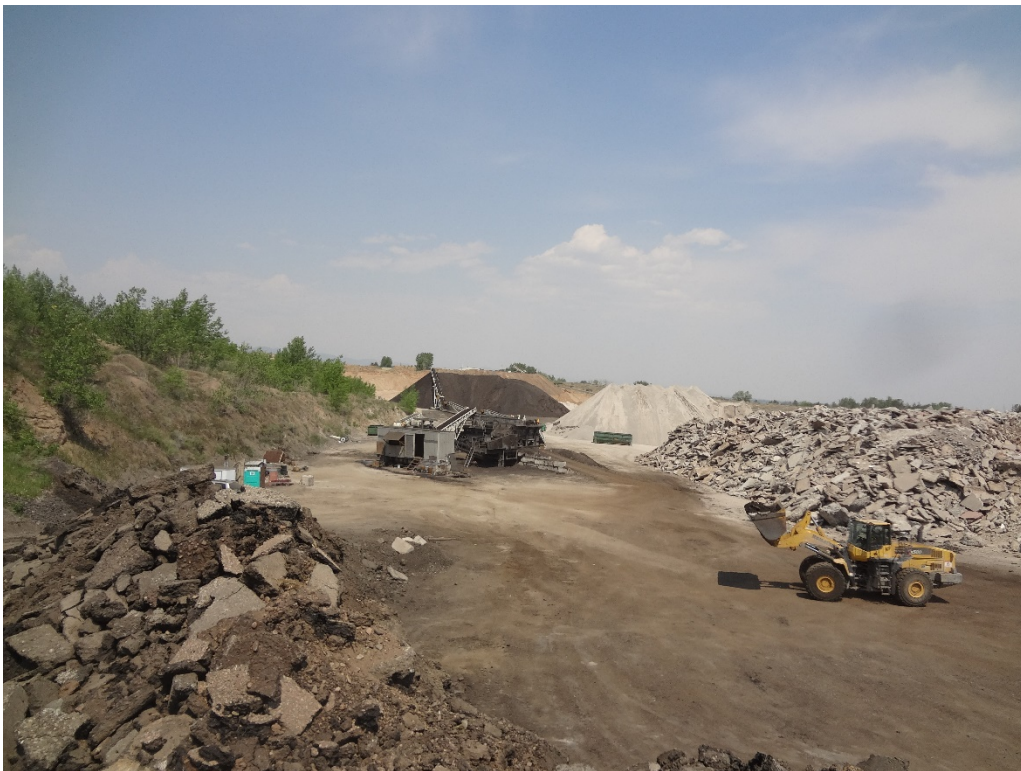
View of concrete and asphalt recycling activities looking north

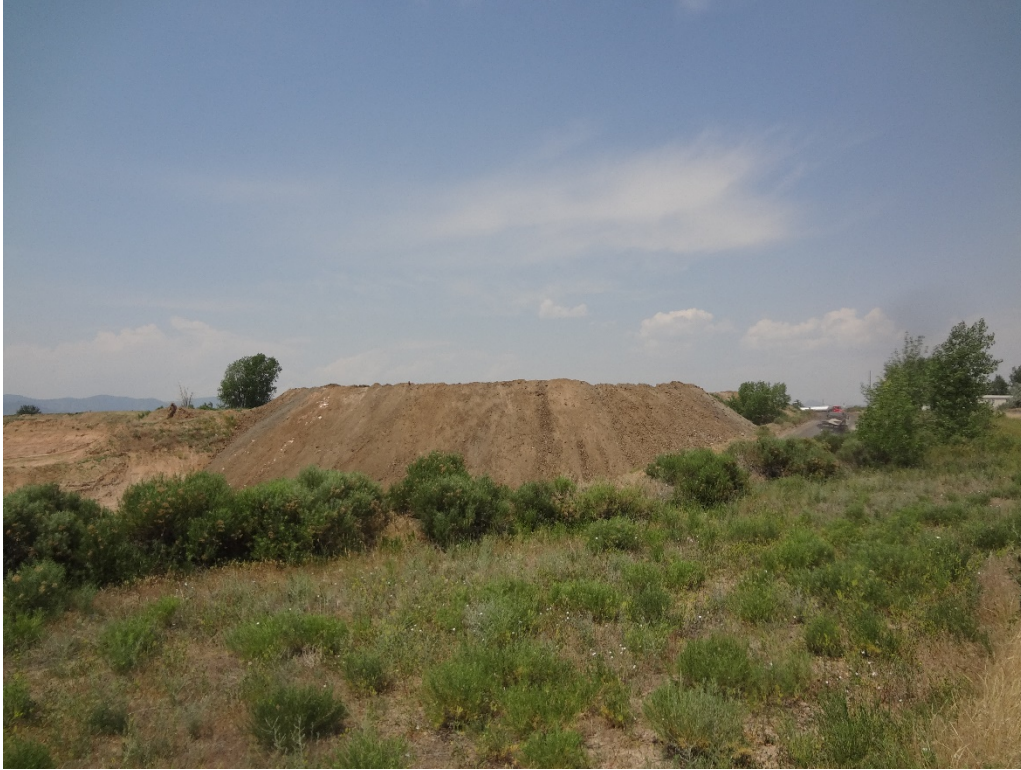
PROBLEM: The Operator is actively backfilling portions of the west highwall and has backfilled an area southwest of the asphalt recycling area with imported fill material. The activity is not permitted under the approved Mine Plan. The current Mine Plan needs to be updated and clarified pursuant to C.R.S. 34-32.5-112 (1)(c)(VI). The Operator must provide sufficient information to describe or identify how the Operator intends to conduct the operation.

View of backfill area located south of scale house looking west

CORRECTIVE ACTIONS: The Operator shall submit a Technical Revision, with the required \$216 revision fee, to update and clarify the current approved mine plan to reflect existing and proposed activities by the corrective action date. The technical revision submittal must comply with the requirements of Rule 3.1.5(9) for the fill material generated outside of the approved permit area to backfill the west highwall and for all future imported material at the site.

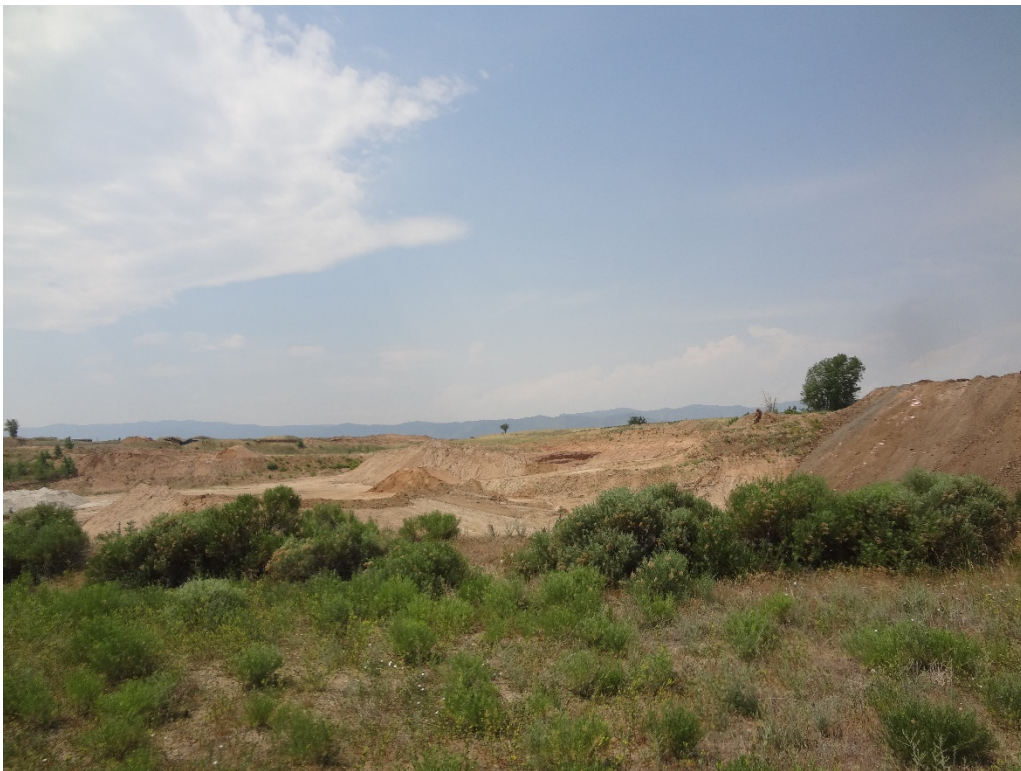
View of the backfill area and mining excavation in the west highwall looking southwest
