**MINERALS PROGRAM INSPECTION REPORT**  
**PHONE: (303) 866-3567**

<b>MINE NAME:</b> Tepee Park Ranch Shale Borrow Pit	<b>MINE/PROSPECTING ID#:</b> M-2008-027	<b>MINERAL:</b> Shale	<b>COUNTY:</b> Garfield
<b>INSPECTION TYPE:</b> Monitoring	<b>INSPECTOR(S):</b> Amy C. Yeldell	<b>INSP. DATE:</b> June 20, 2018	<b>INSP. TIME:</b> 08:30
<b>OPERATOR:</b> CPX Piceance Holdings, LLC	<b>OPERATOR REPRESENTATIVE:</b> Nick Kurtenbach	<b>TYPE OF OPERATION:</b> 110c - Construction Limited Impact	
<b>REASON FOR INSPECTION:</b> Normal I&E Program	<b>BOND CALCULATION TYPE:</b> Complete Bond	<b>BOND AMOUNT:</b> \$23,500.00	
<b>DATE OF COMPLAINT:</b> NA	<b>POST INSP. CONTACTS:</b> None	<b>JOINT INSP. AGENCY:</b> None	
<b>WEATHER:</b> Clear	<b>INSPECTOR'S SIGNATURE:</b>

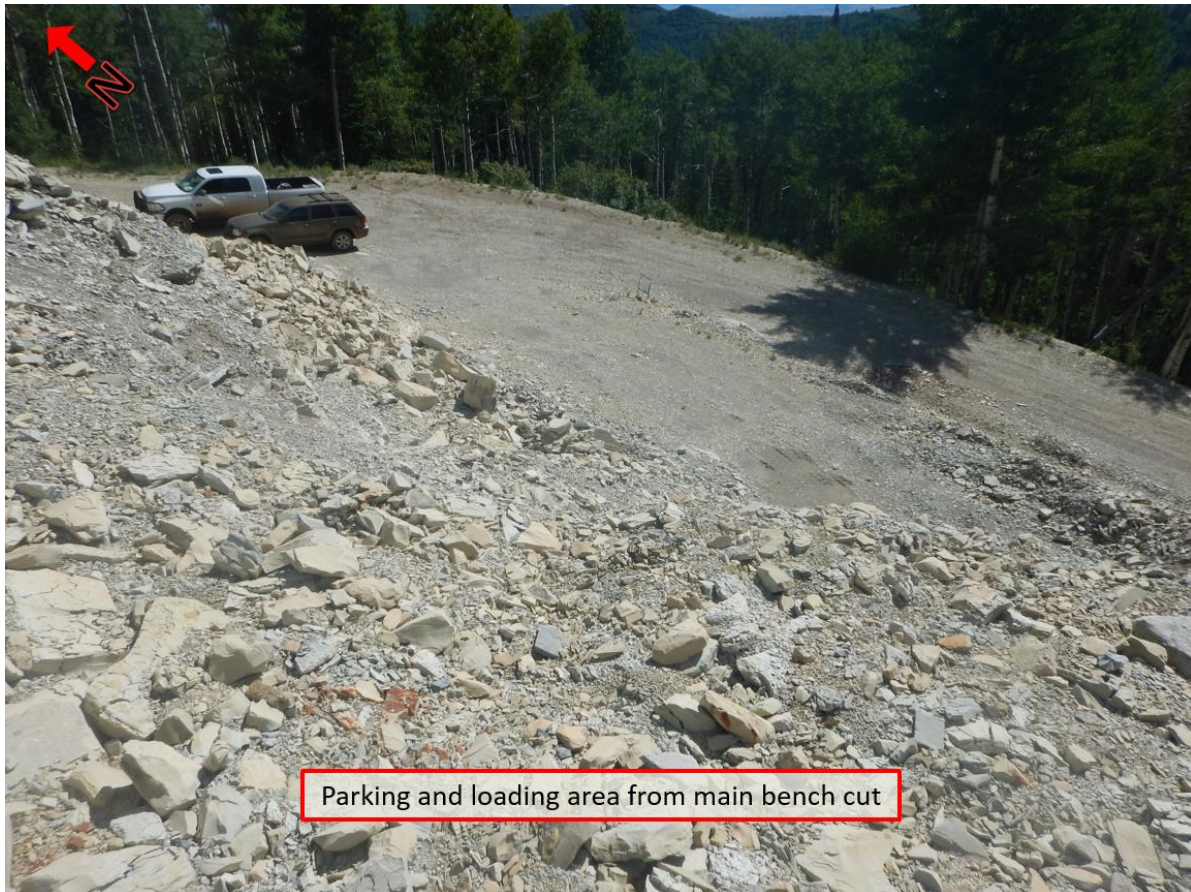
Parking and loading area from main bench cut

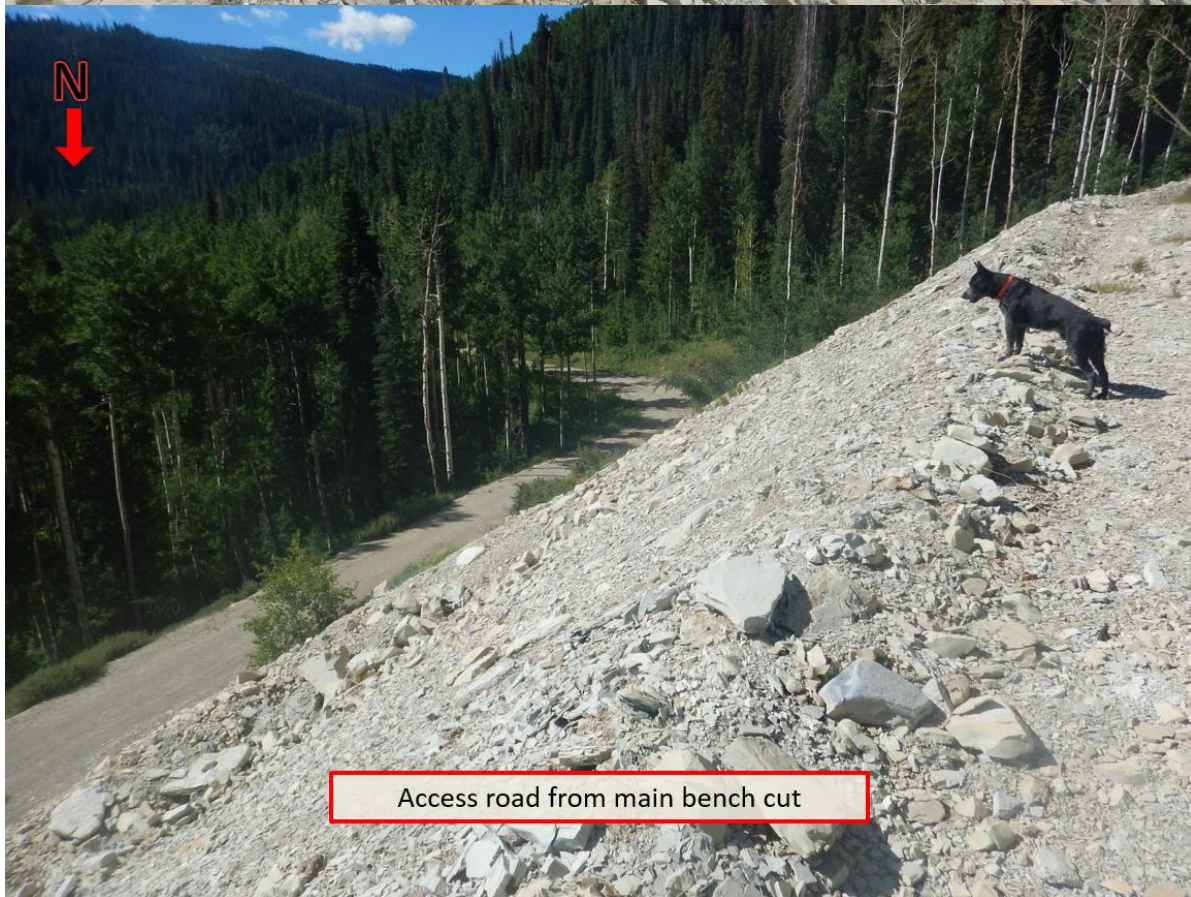
Access road from main bench cut
