**MINERALS PROGRAM INSPECTION REPORT**  
**PHONE: (303) 866-3567**

<b>MINE NAME:</b> Schumacher II	<b>MINE/PROSPECTING ID#:</b> M-2001-018	<b>MINERAL:</b> Gravel	<b>COUNTY:</b> Logan
<b>INSPECTION TYPE:</b> Surety Release Inspection	<b>INSPECTOR(S):</b> Jared L. Ebert	<b>INSP. DATE:</b> June 11, 2018	<b>INSP. TIME:</b> 13:00
<b>OPERATOR:</b> Nienhueser Construction & Excavating Co	<b>OPERATOR REPRESENTATIVE:</b> None	<b>TYPE OF OPERATION:</b> 110c - Construction Limited Impact	
<b>REASON FOR INSPECTION:</b> Surety Release Requested	<b>BOND CALCULATION TYPE:</b> Complete Bond	<b>BOND AMOUNT:</b> \$16,470.90	
<b>DATE OF COMPLAINT:</b> NA	<b>POST INSP. CONTACTS:</b> None	<b>JOINT INSP. AGENCY:</b> None	
<b>WEATHER:</b> Clear	<b>INSPECTOR'S SIGNATURE:</b>

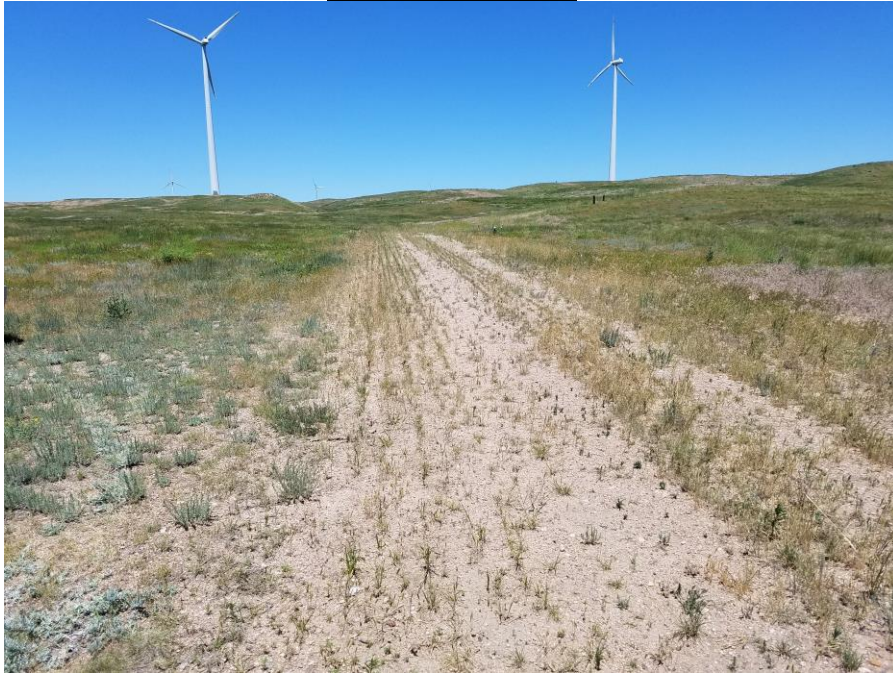
**Figure 1. From the access road into the site looking north.**

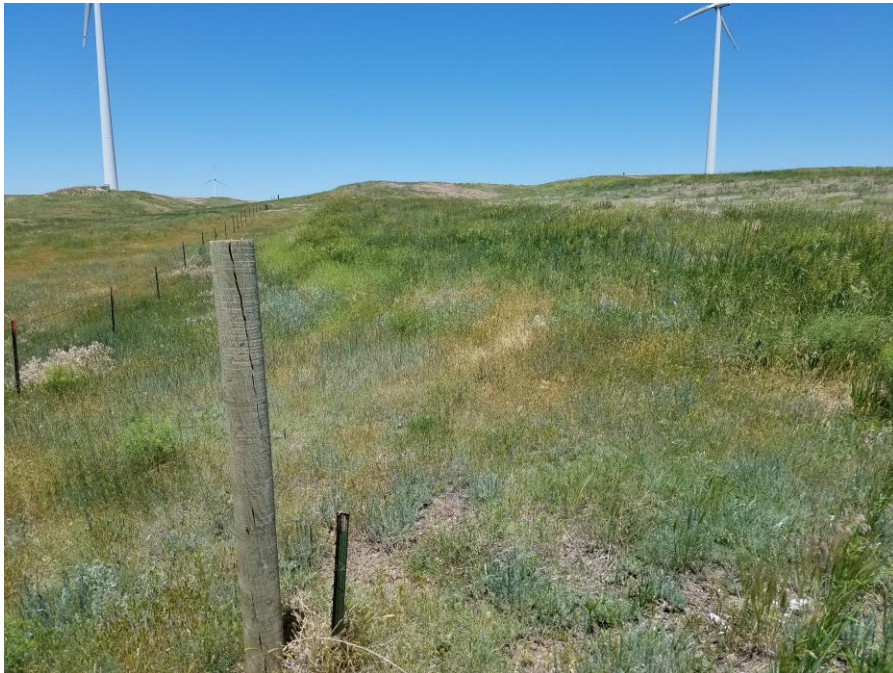
**Figure 2. From the southwest corner looking north.**

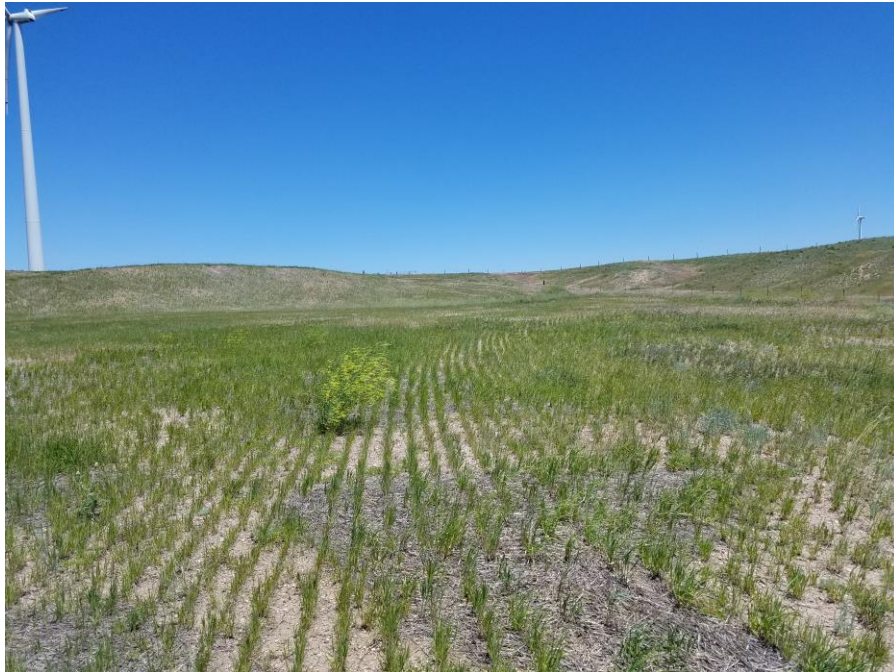
Figure 3. From the southern end of the pit looking north.

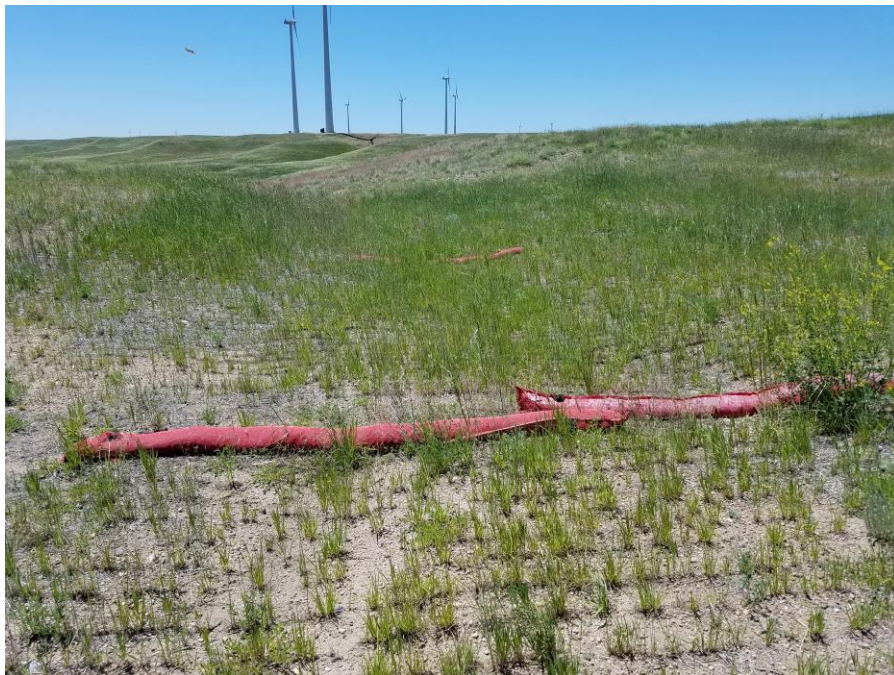
Figure 4. Near the center of the site looking south. Drainage established.

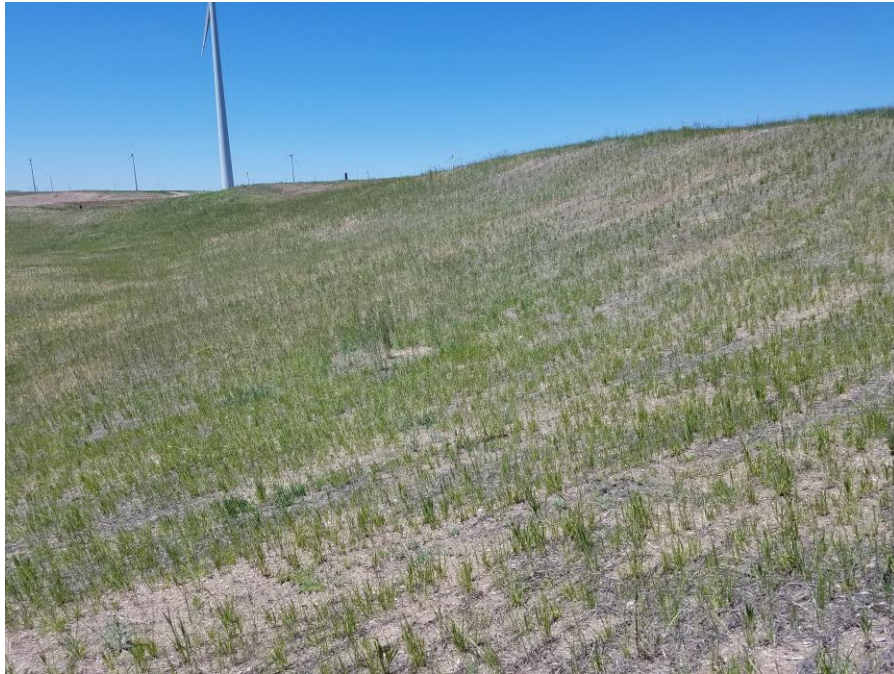
**Figure 5. From the western end of the site looking east.**
