**COLORADO**Division of Reclamation,
Mining and Safety

MINERALS PROGRAM INSPECTION REPORT**PHONE: (303) 866-3567**

MINE NAME: Henderson Mine	MINE/PROSPECTING ID#: M-1977-342	MINERAL: Molybdenum	COUNTY: Clear Creek, Grand
INSPECTION TYPE: Monitoring	INSPECTOR(S): Peter S. Hays	INSP. DATE: June 20, 2018	INSP. TIME: 09:00
OPERATOR: Climax Molybdenum Company	OPERATOR REPRESENTATIVE: Miguel Hamarat, Alex Ungers	TYPE OF OPERATION: 112d-3 - Designated Mining Operation	
REASON FOR INSPECTION: Normal I&E Program	BOND CALCULATION TYPE: None	BOND AMOUNT: \$37,993,785.00	
DATE OF COMPLAINT: NA	POST INSP. CONTACTS: None	JOINT INSP. AGENCY: None	
WEATHER: Clear	INSPECTOR'S SIGNATURE:

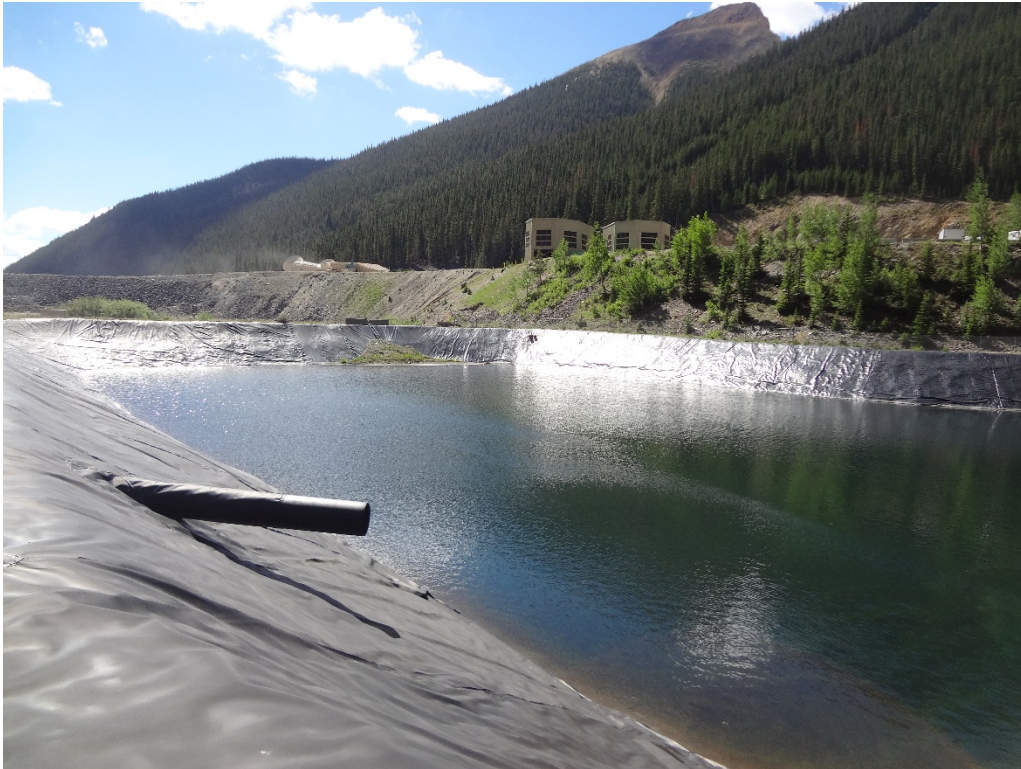
EPF 1.2 Pond from NW corner looking SE

Mine EPF 1.2 is utilized for stormwater control at the site. As reported in last year's inspection of the facility, the fence surrounding the facility needs repair. The Pond 1.2 liner, inlet and outlet appear to be working as designed and in accordance with the approved as-built drawings.

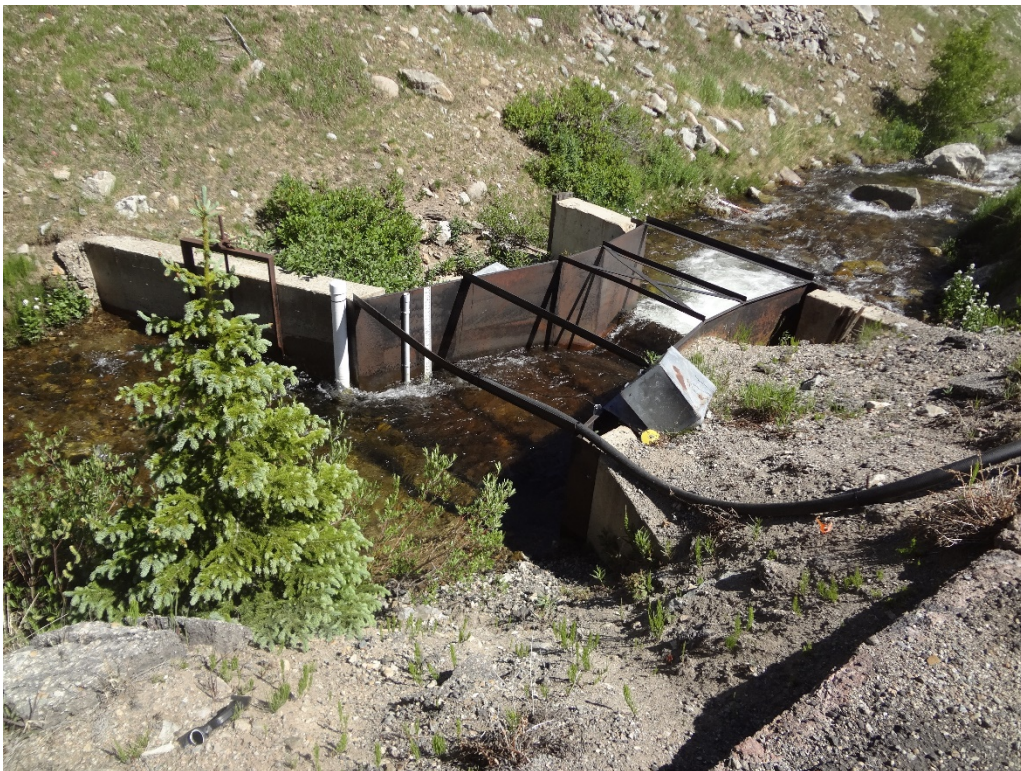
View of BG-20 location

Surface and groundwater compliance points, CC-10, CC-30, BG-20 and MNGW-1 were observed. The surface water locations were not indicated by signage, but were locatable based on the monitoring locations map. The Operator reported no apparent trends or anomalies were observed in 2017 in the Annual Water Monitoring Report dated May 24, 2018. Tabular data for the surface water compliance points was provided in the report.

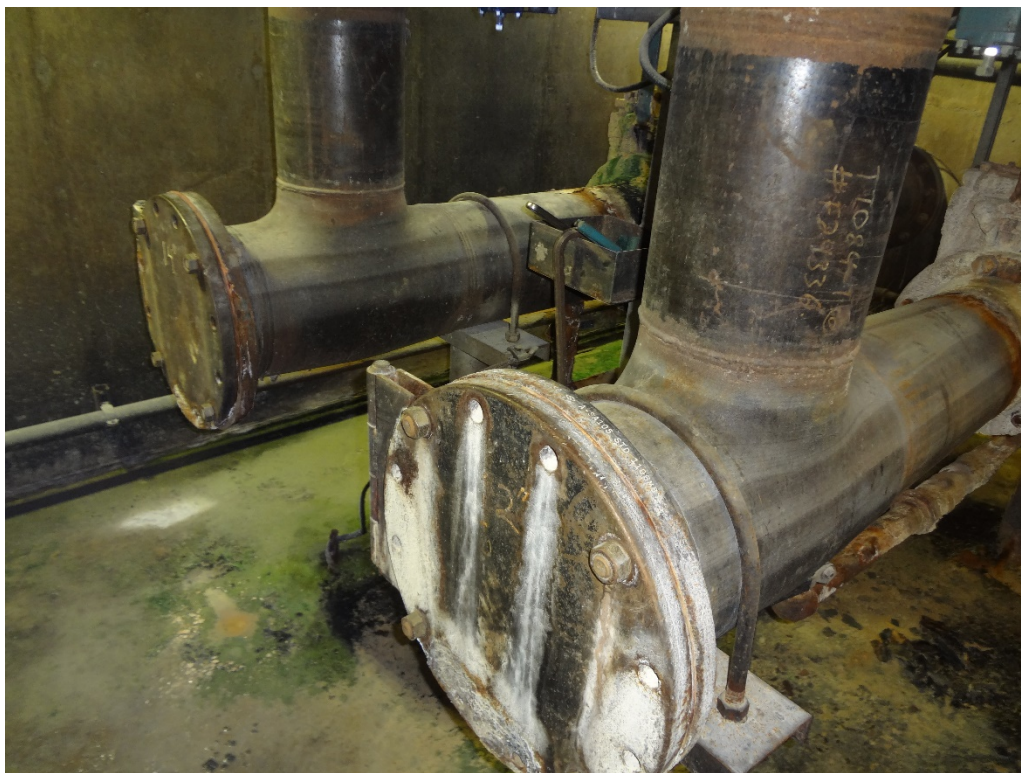
EPF 1.1 pipelines in pig pit

Mine EPF 1.1 – Mine Water System diverts a portion of the mine water from the underground workings to the URAD Mine for treatment via 12" and 14" HDPE pipelines. The pipelines are estimated to be 2.5 miles long and appeared to be working as designed and in accordance with the approved as-built drawings. The lines are cleaned weekly, alternating lines, with "pigs" which are pushed through the lines with pressure from a surge tank to scour and reduce scaling in the pipes. The surge tank and pig house were observed during the inspection. Henderson is preparing an amendment to incorporate the URAD water treatment plant and pipelines into the permit.
