PERMIT INFORMATION

Permit Number: C-1981-028 Mine Name: Keenesburg Strip Mine Operator: Coors Energy Company Operator Address: Mr. Danny Kipp P.O Box 467 Golden , CO 80402	County: Weld Operation Type: Surface Permit Status: Active Ownership: Private
	Operator Representative Present: Danny Kipp
Operator Representative Signature: (Field Issuance Only)

Inspection Start Date: June 27, 2018 Inspection Start Time: 08:40 Inspection End Date: Inspection End Time:		Inspection Type: Coal Partial Inspection Inspection Reason: Normal I&E Program Weather: Clear	
Joint Inspection Agency: None		Joint Inspection Contacts: 	
Post Inspection Agency: None		Post Inspection Contacts: 	
Inspector(s): Robert D. Zuber, P.E.	Inspector's Signature:

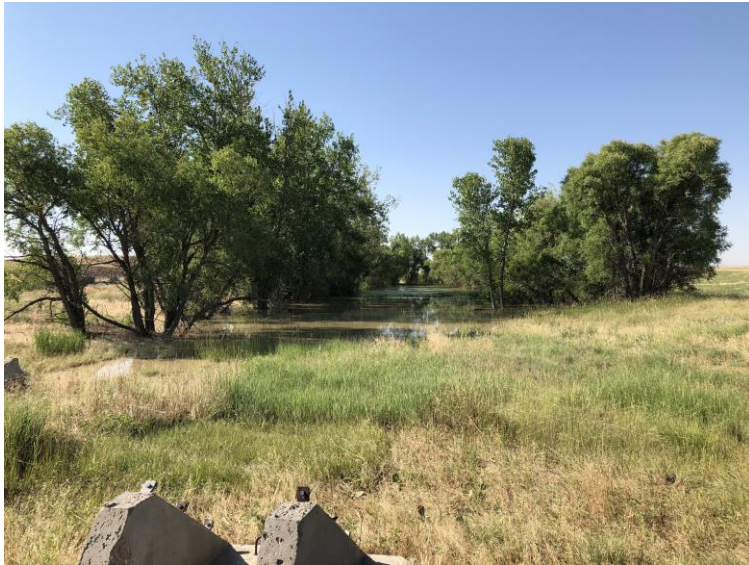
Large quantities of standing water were observed in Sediment Pond 2 and the Dugout Pond. Neither pond was discharging during the inspection, but Mr. Kipp indicated that Sediment Pond 2 did discharge after recent events (and debris such as twigs was observed in the spillway). Very little sediment was seen north of the permit boundary (off site) near this pond. A pump was moving water from the sediment pond to the dugout pond, and Mr. Kipp said that this has been occurring for approximately six days. No problems were observed with the two ponds.

High level of water in Dugout Pond

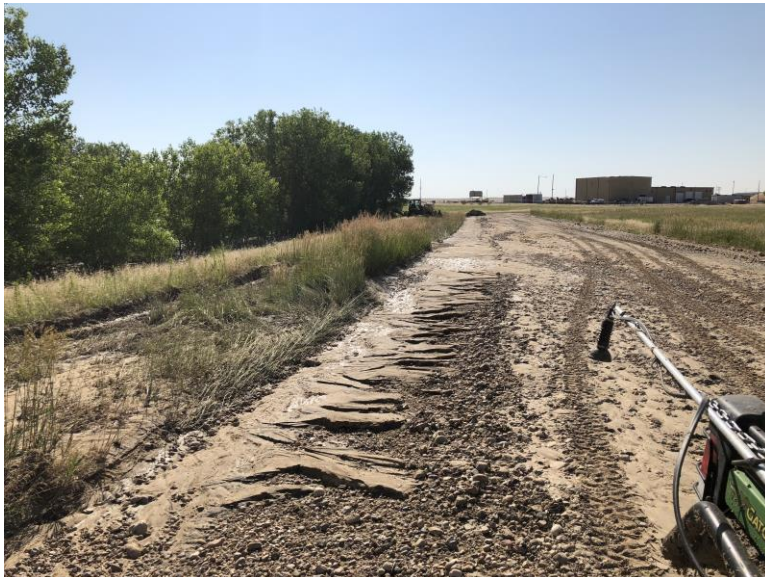
The roads were generally in good shape even though large flows from the recent storms left sand on the road surfaces, especially near Sediment Pond 2.

Sediment on road near Sediment Pond 2

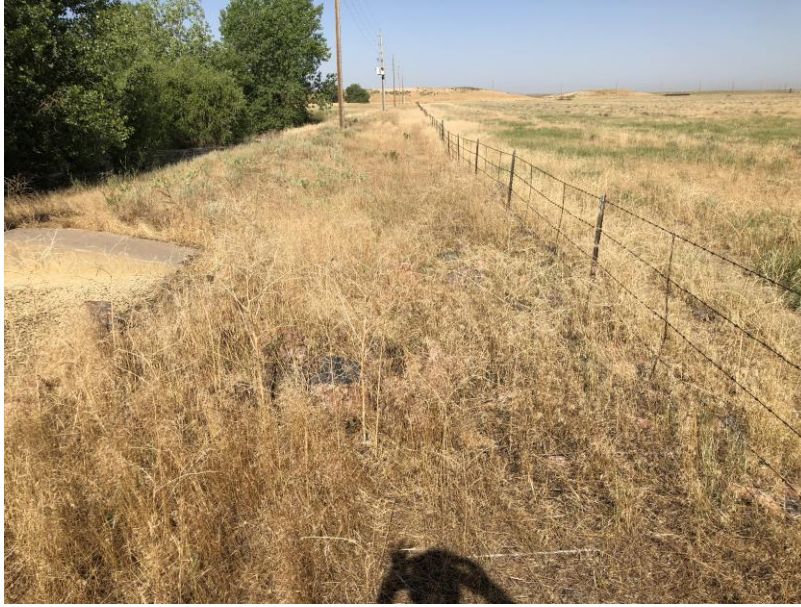
Area below Sediment Pond 2 (no detrimental impacts from discharge)

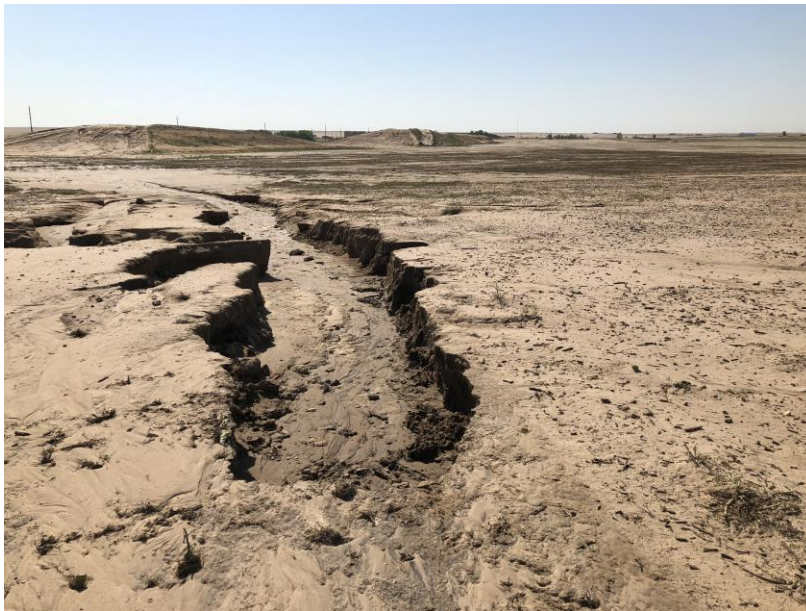
The recent storms caused significant erosion at the northeast corner of the B Pit. CEC staff plan to repair this in near future.

Erosion from recent storms in north part of B Pit

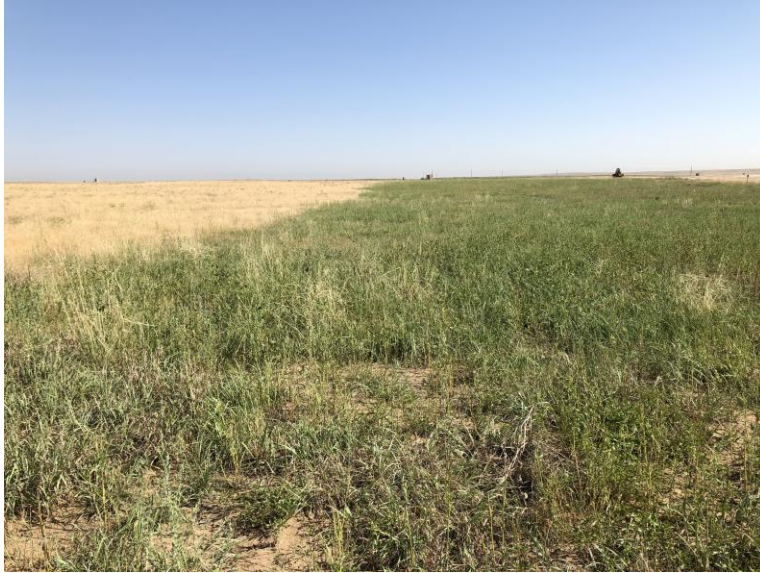
**West of B Pit – cheat grass treatment by CEC has been effective
(yellow grass on left side is off site)**

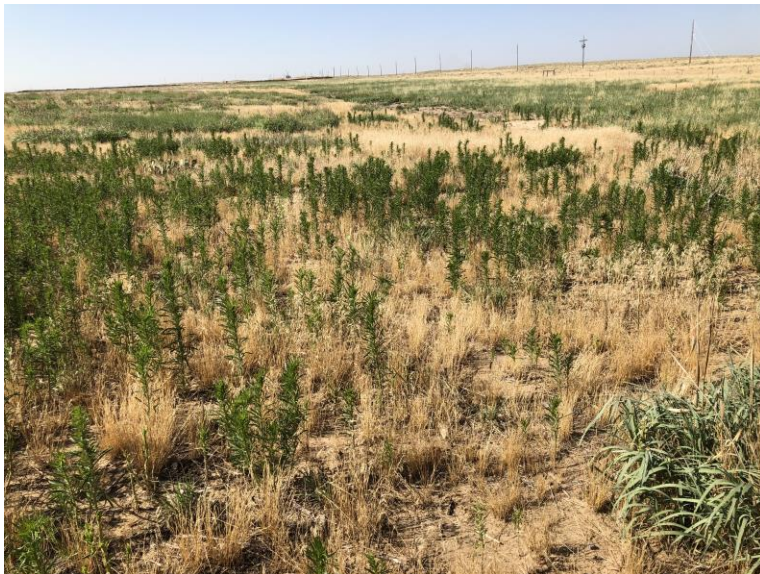
Good vegetation was seen at reclamation parcels around the site. Some less desirable species were seen in Areas 29 and 30 (horseweed, pricklepoppy, and cheat grass). These are nuisance weeds.

Horseweed in Area 30

Danny Kipp indicated that CEC will likely apply pre-emergent herbicide in 2018 around the site.

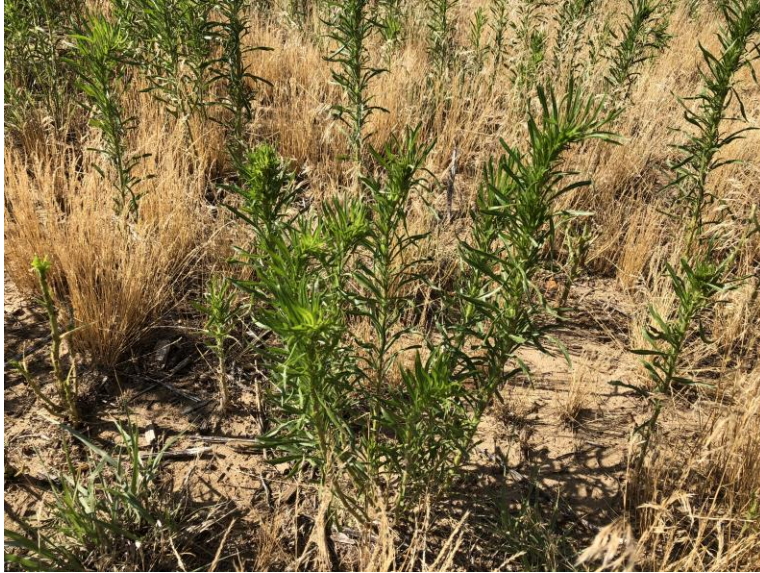
Close up of horseweed

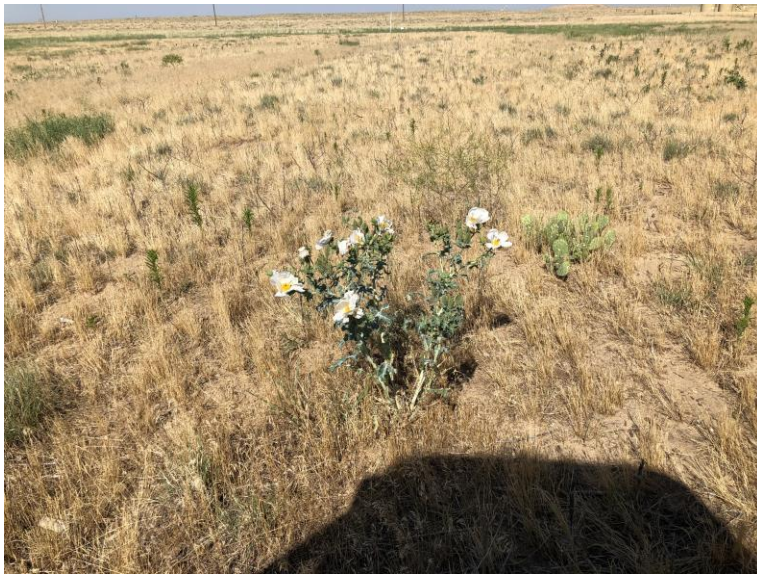
Pricklepoppy in Area 29

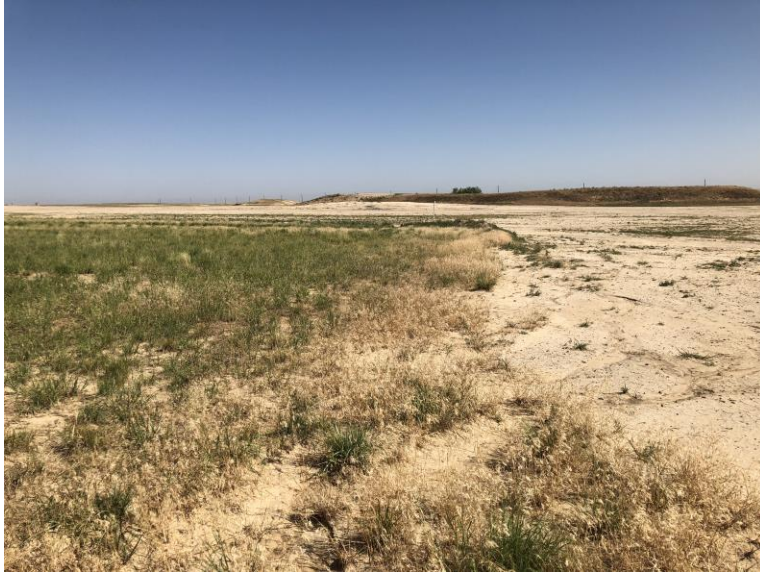
During the inspection, no backfill or grading operations were taking place. The spoil pile continues to shrink.

Looking north toward spoil area

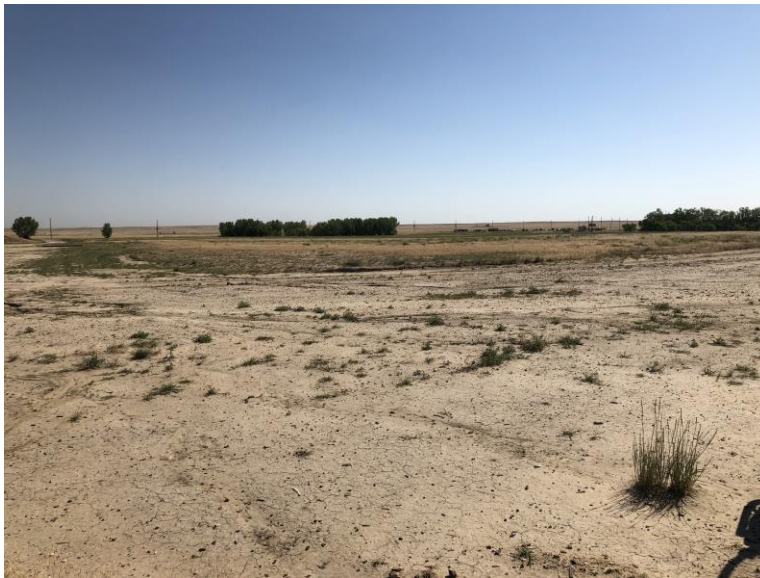
Looking northeast toward Area 25
