**COLORADO**Division of Reclamation,
Mining and Safety

MINERALS PROGRAM INSPECTION REPORT**PHONE: (303) 866-3567**

MINE NAME: Sooner Lucky Strike Mine and Mill	MINE/PROSPECTING ID#: M-1982-020	MINERAL: Gold and silver	COUNTY: Gunnison
INSPECTION TYPE: Monitoring	INSPECTOR(S): Dustin M. Czapla	INSP. DATE: June 19, 2018	INSP. TIME: 11:00
OPERATOR: ALSH, LLC	OPERATOR REPRESENTATIVE: Jake Wilkinson	TYPE OF OPERATION: 110d - Designated Limited Impact	
REASON FOR INSPECTION: Normal I&E Program	BOND CALCULATION TYPE: None	BOND AMOUNT: \$49,992.54	
DATE OF COMPLAINT: NA	POST INSP. CONTACTS: None	JOINT INSP. AGENCY: None	
WEATHER: Clear	INSPECTOR'S SIGNATURE:

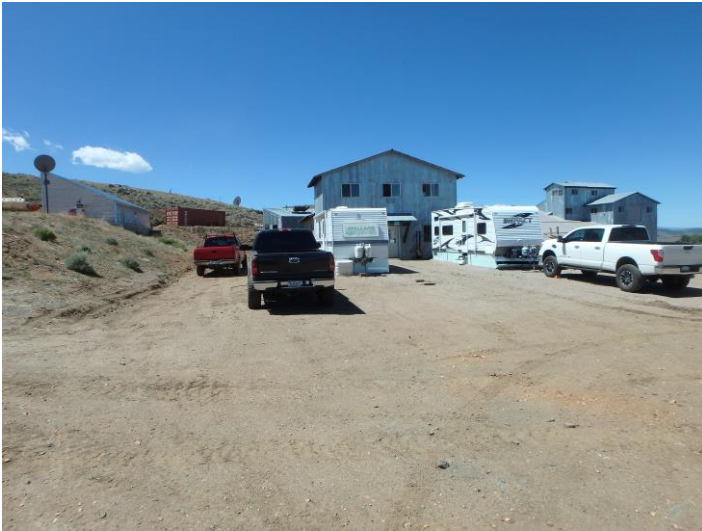
Parking area in front of mill facility

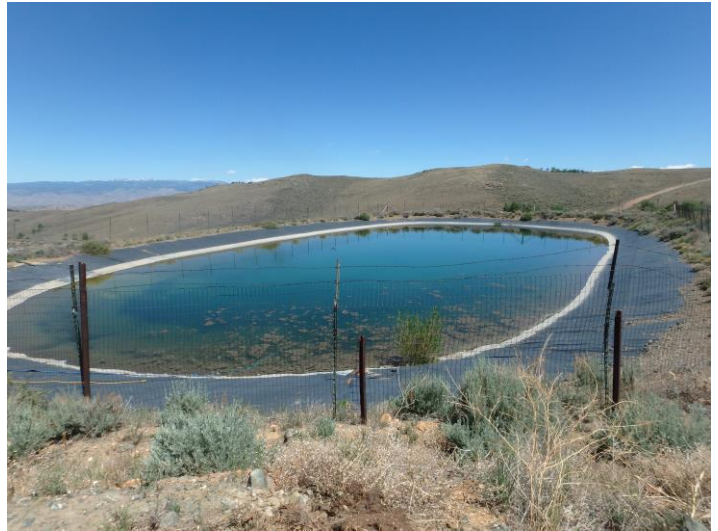
The lined pond was mostly filled with water, but still had several feet of free board. This pond is being utilized for water storage for recirculation through the mill facility. A pump was located in the primary settling pond with a hose routed up to the lined pond. Fresh tails were observed in the primary settling pond with a small amount of water pooled in the west side of the pond. The pond banks appeared stable and no signs of seepage were noted.

Upper "lined" pond

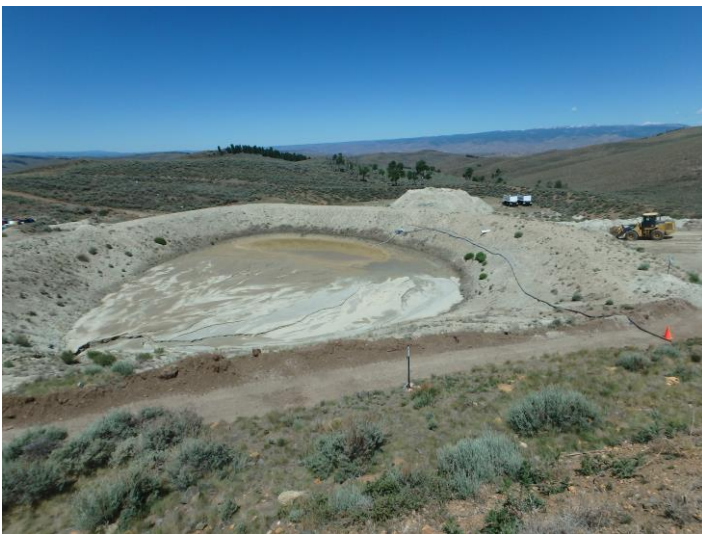
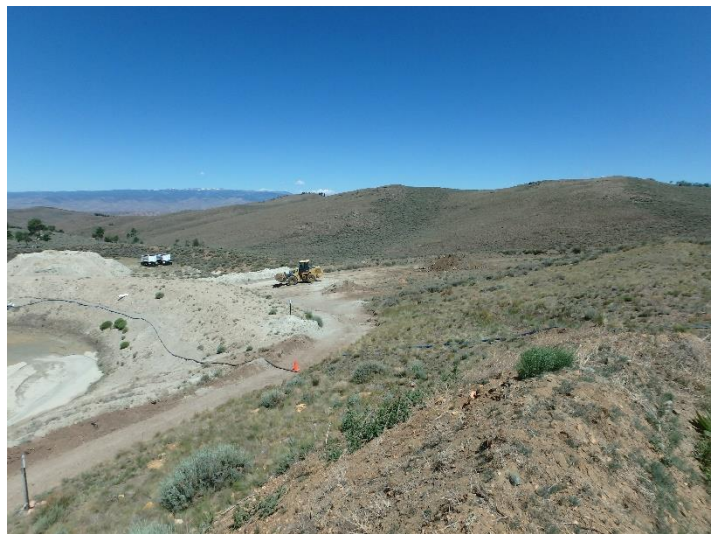
Primary settling pond

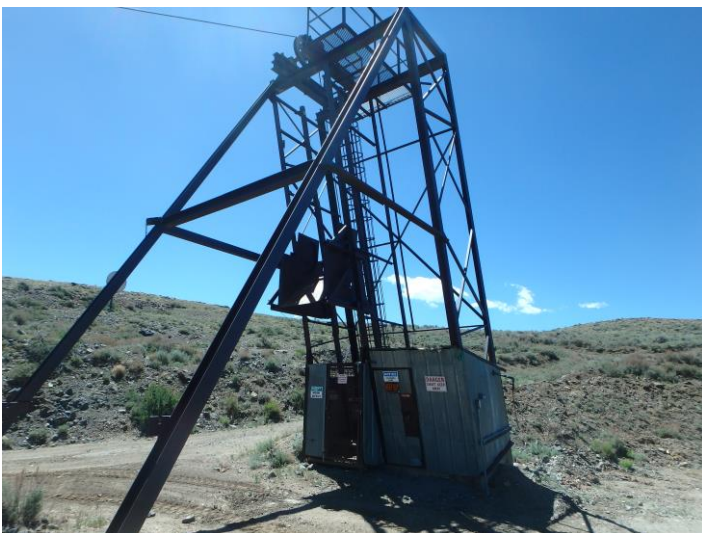
The hoist assembly was adequately secured.

Secured hoist assembly

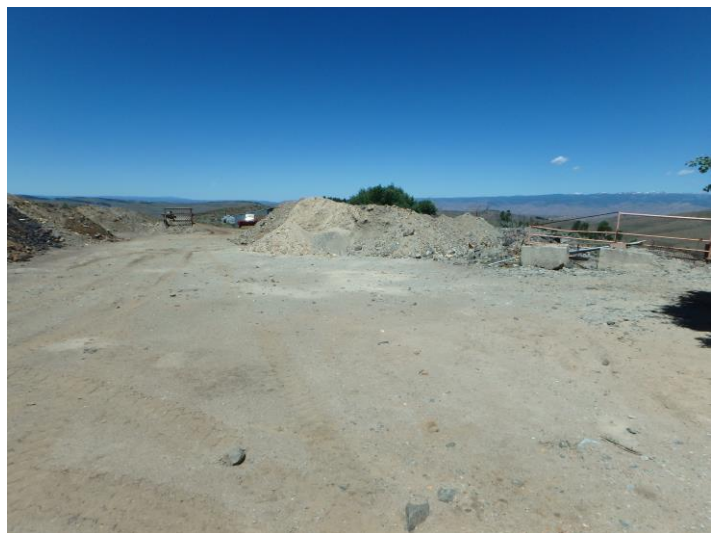
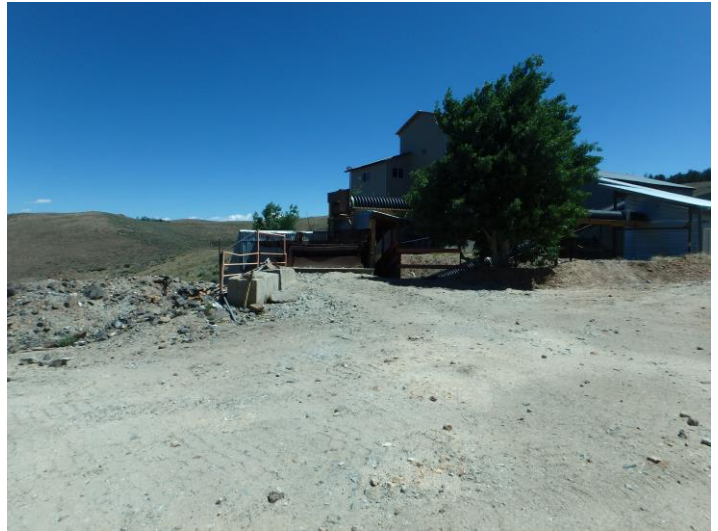
Ore storage pad

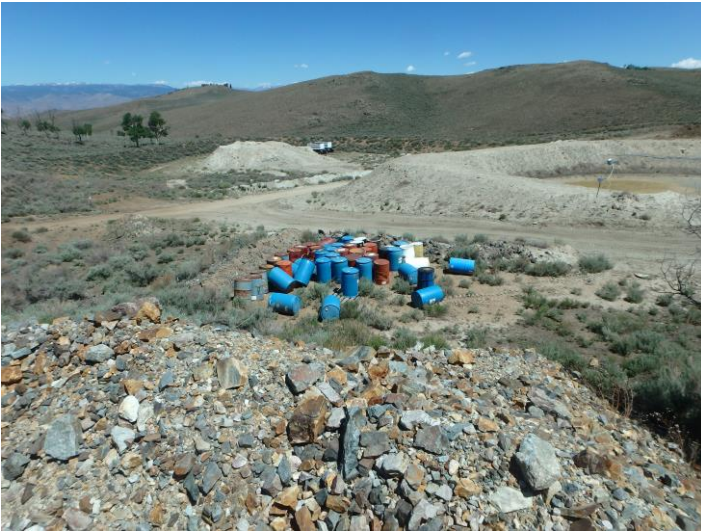
A small amount of ore was stored on the ore storage pad located near the crusher. A stormwater berm is constructed around the storage pad area that appeared in good repair. The empty oil barrels are still located below the pad near the secondary escapeway and should be removed from the site.

Empty barrels stored below ore storage pad

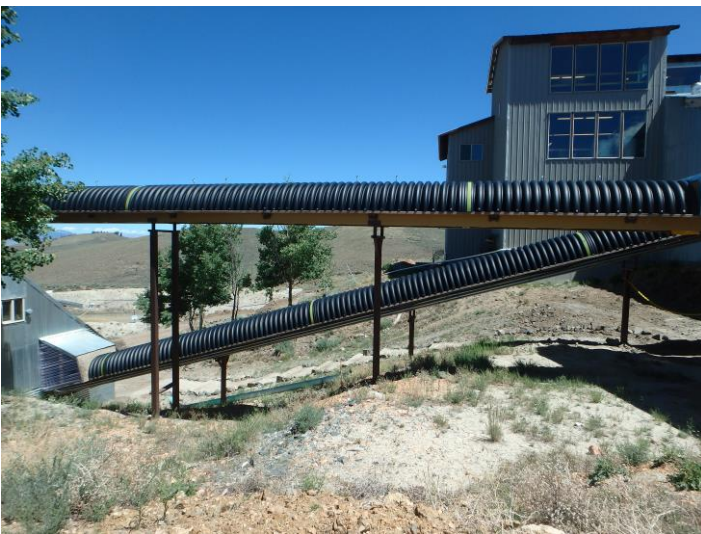
Conveyor system from crusher

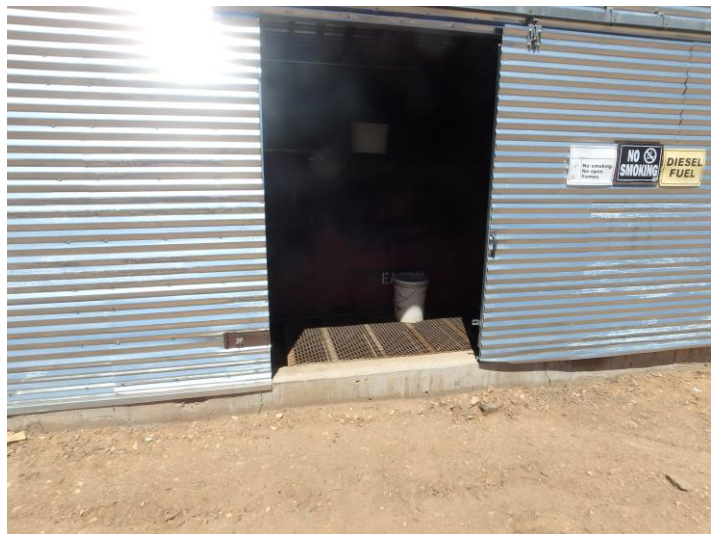
Concrete lined fuel storage shed

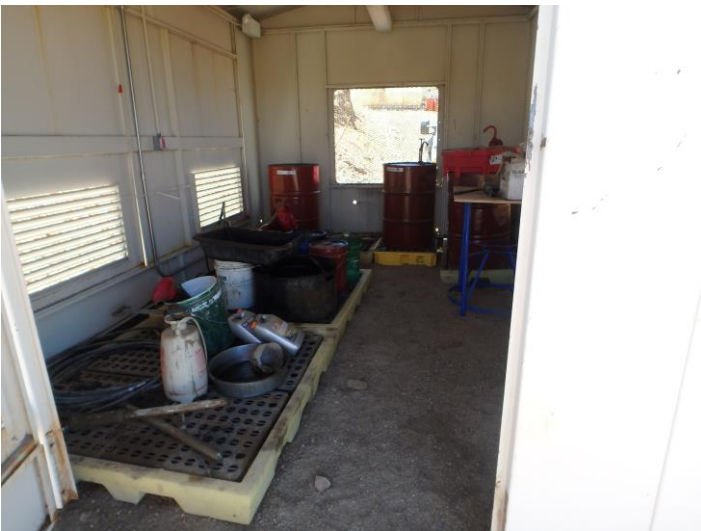
The mill facility appeared well kept and chemicals are stored with proper secondary containment.

Chemical storage shed

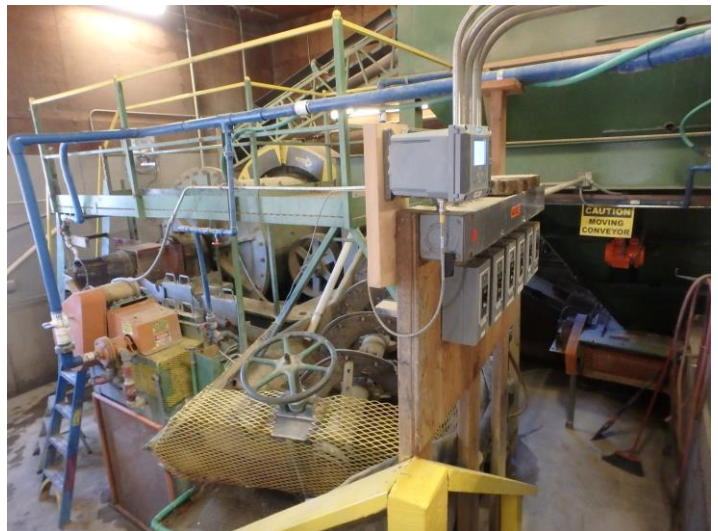
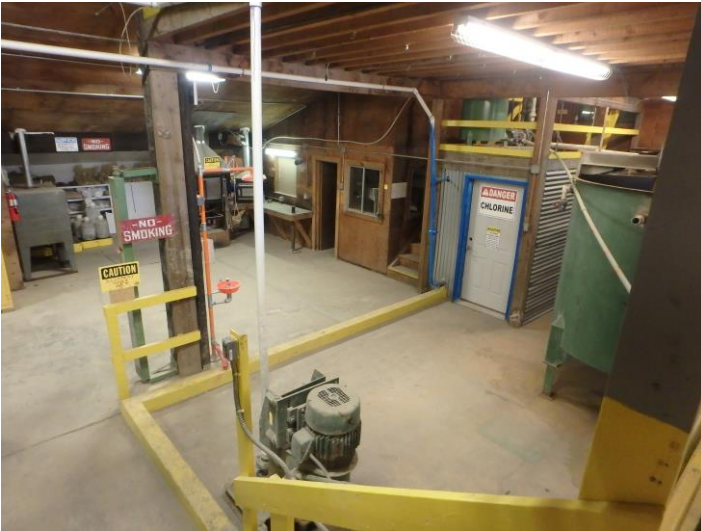
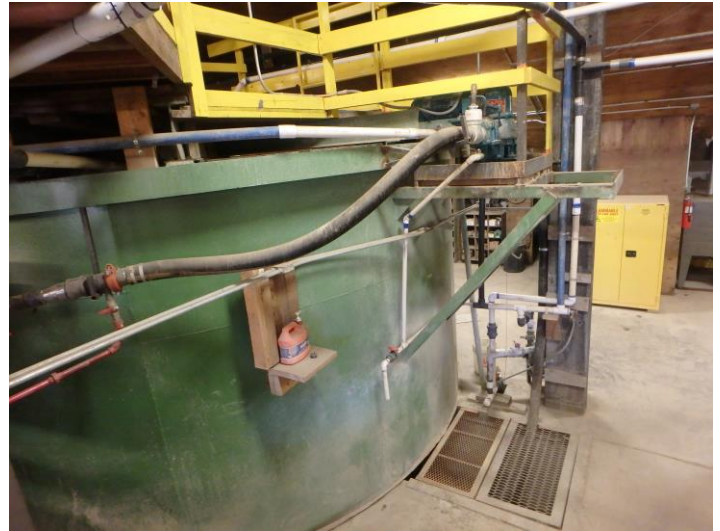
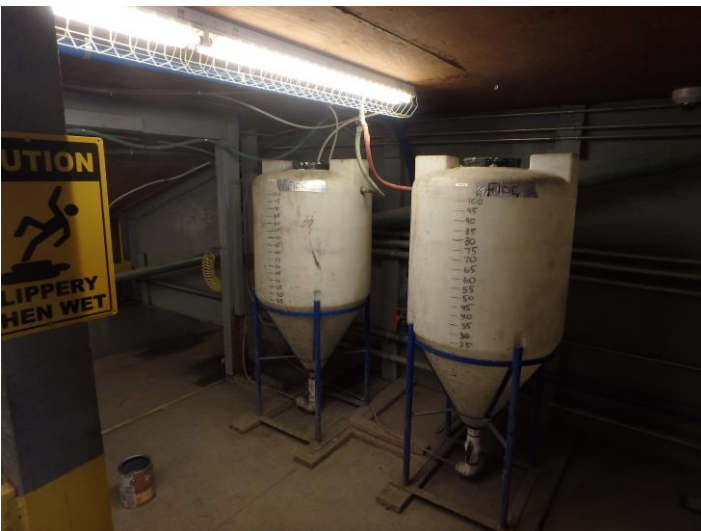
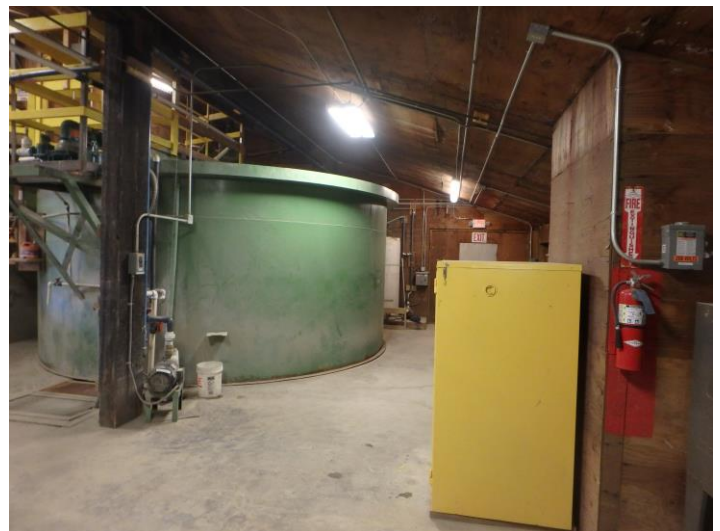
Mill interior
