Weekly Liner Update

Liner replacement has continued without issue in the VLF2 repair area. Liner placement was completed between the 9650' and 9750' elevations on June 23. The anchor trench at the 9850' bench was excavated using a CAT 305.5 E mini excavator. A Cat 336 F excavator was used to remove geomembrane and expose the soil liner fill between the 9750' and 9850' benches. Drain cover fill (DCF) was removed from the 9750' bench to expose existing geomembrane. Four soil liner fill (SLF) depth checks were completed between the 9750' and 9850' benches; all test results indicated >12" of SLF.

Newmont Mining Corporation
Cripple Creek and Victor Gold Mining Co.

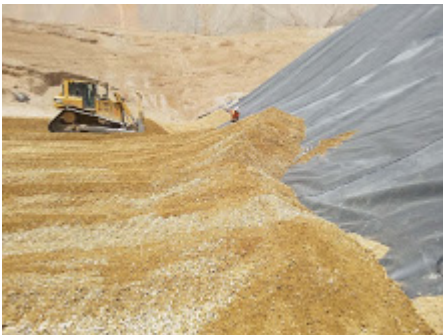
06.27_DCFP_Placement.jpg
268K

DCF was stockpiled at the 9650' bench. Once Newfields inspected and approved the panels between the 9650' and 9750' elevations for DCF placement, Ames began pushing a two-foot lift of DCF from the 9650' stockpile onto the geomembrane using a CAT D6 LGP dozer.

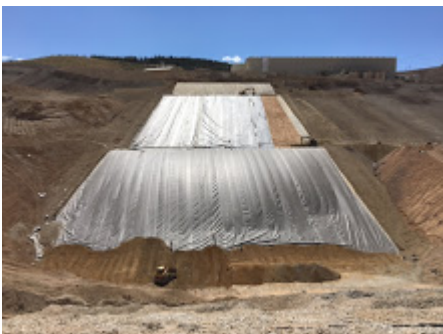
6.28_Liner_overview.JPG
137K

Deployment of 80 Mil LLPDE double sided textured geomembrane began between the 9850' and 9750' elevations began on June 27th. The liner panel seaming was performed using one fusion machine/operator method. Non-destructive testing was performed for fusion welded seams. Repairs were performed using the extrusion welding method for all marked defects.
