**COLORADO**Division of Reclamation,  
Mining and Safety

**MINERALS PROGRAM INSPECTION REPORT****PHONE: (303) 866-3567**

<b>MINE NAME:</b> Riverview Resource	<b>MINE/PROSPECTING ID#:</b> M-1999-098	<b>MINERAL:</b> Sand and gravel	<b>COUNTY:</b> Weld
<b>INSPECTION TYPE:</b> Monitoring	<b>INSPECTOR(S):</b> Peter S. Hays	<b>INSP. DATE:</b> June 28, 2018	<b>INSP. TIME:</b> 10:00
<b>OPERATOR:</b> Aggregate Industries - WCR, Inc.	<b>OPERATOR REPRESENTATIVE:</b> Connie Davis	<b>TYPE OF OPERATION:</b> 112c - Construction Regular Operation

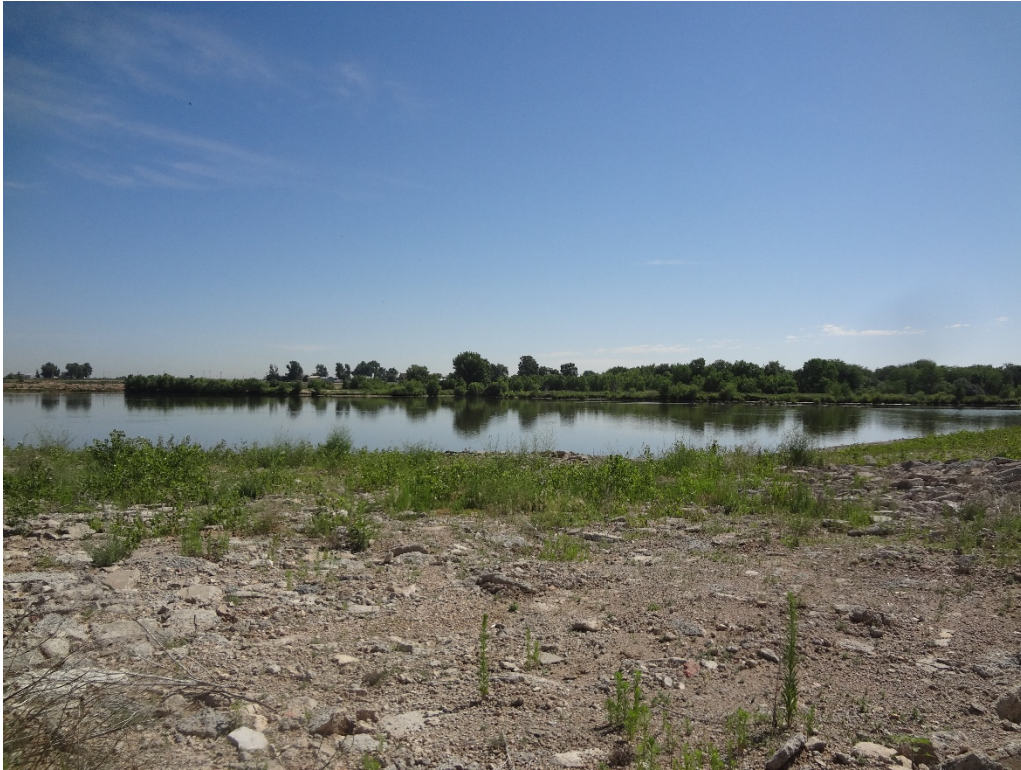
Flood Repair area in SW section of Cell 3 looking NE

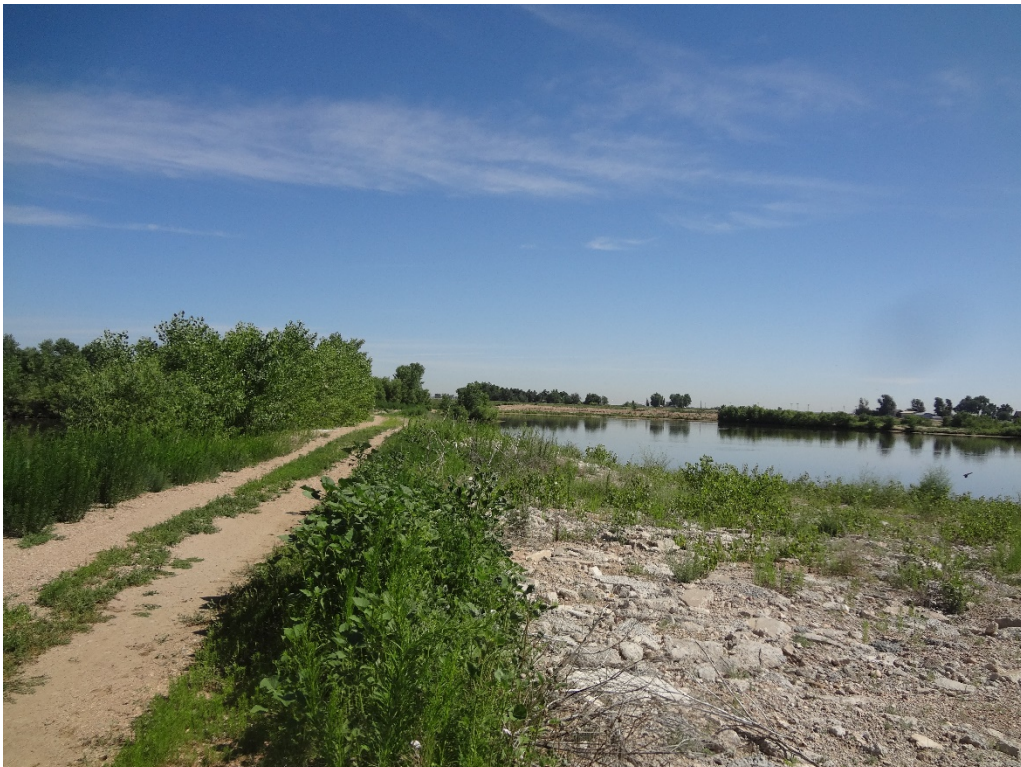
Flood Repair area in SW section of Cell 3 looking north

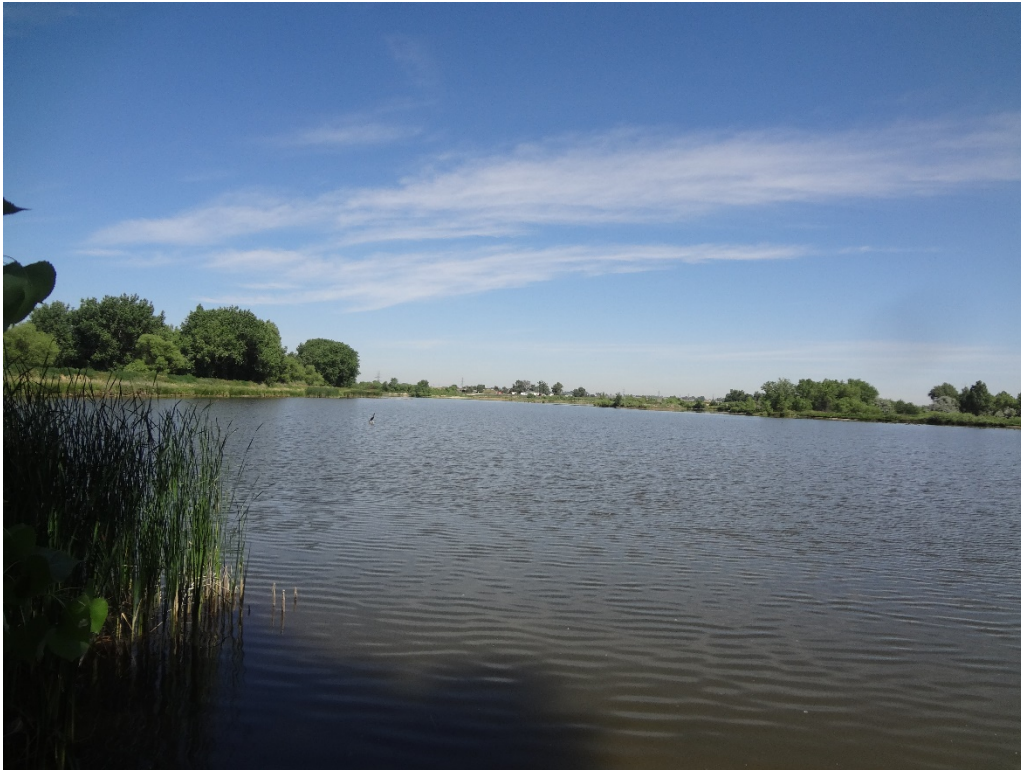
View of southern portion of Cell 3 from SE permit boundary looking NW

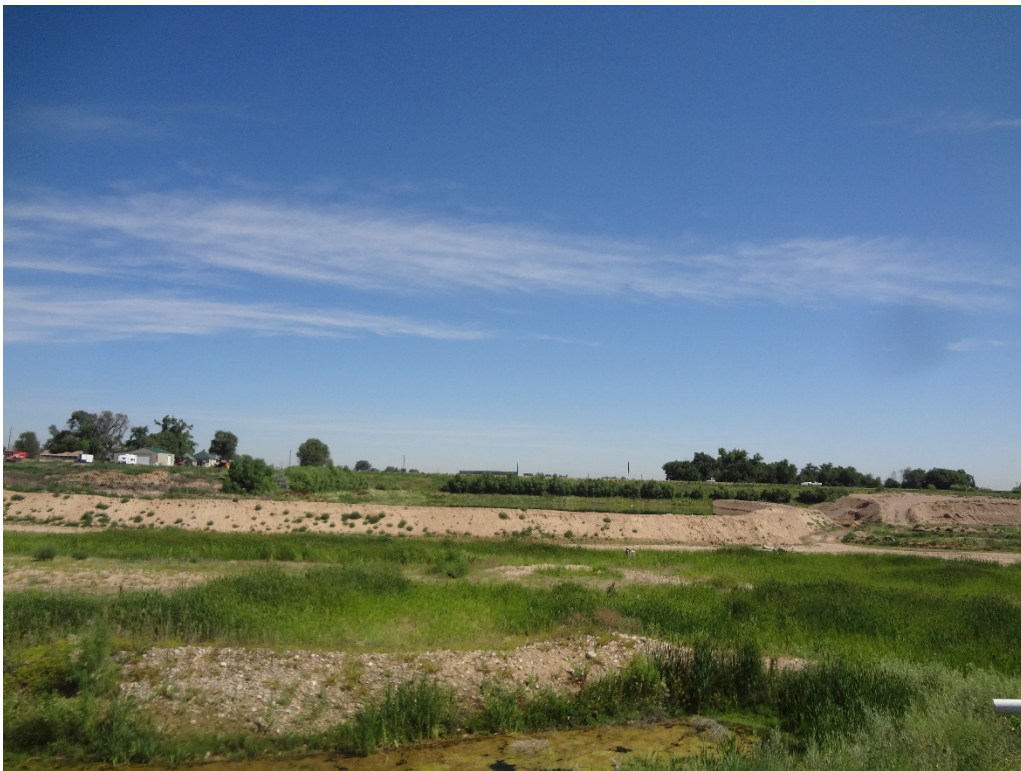
View of the silt pond berm in northern portion of Cell 3

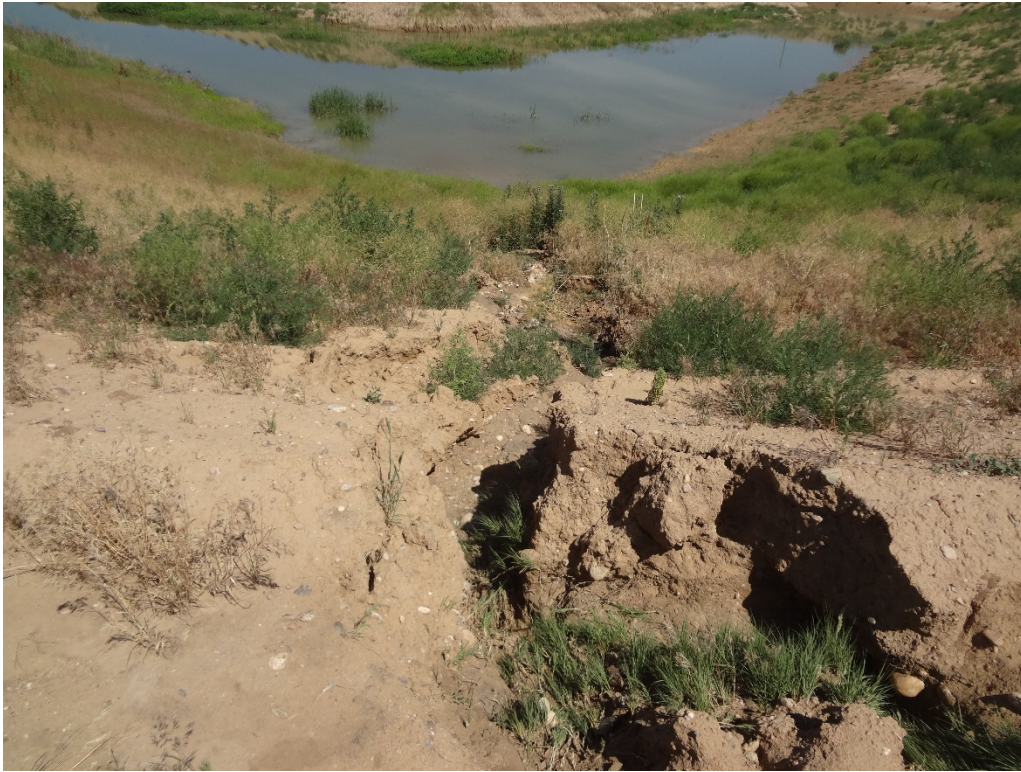
Erosion gulling in SE slope in the northeast portion of Cell 3

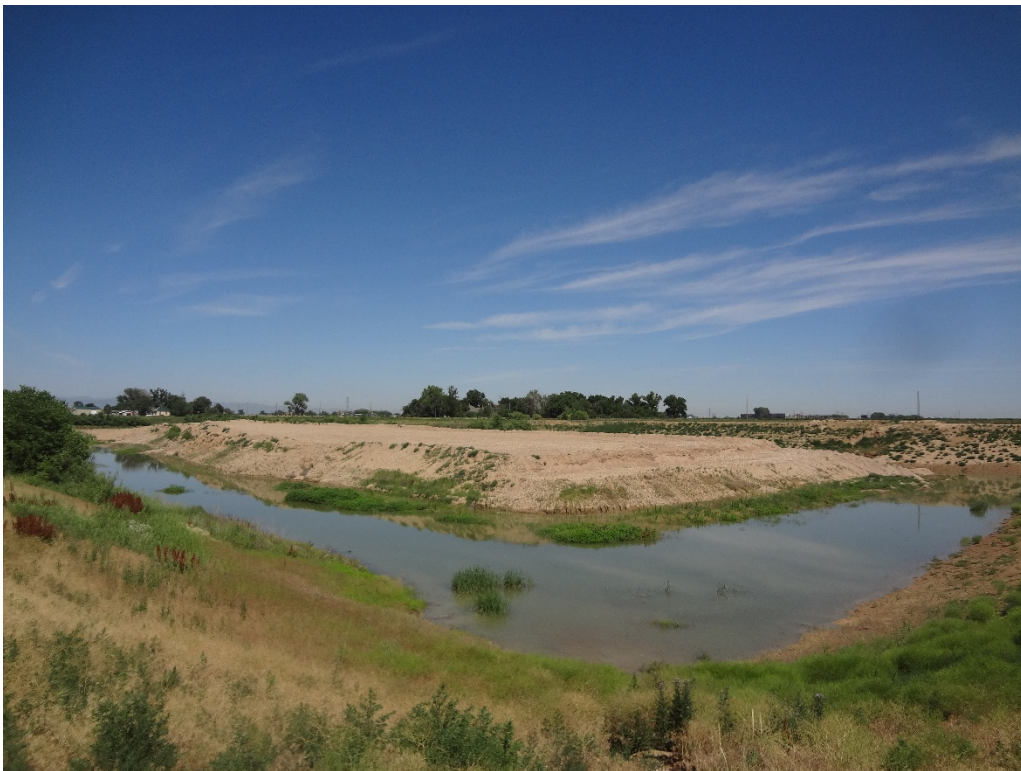
View of northeast portion of Cell 3 from SE corner looking NW

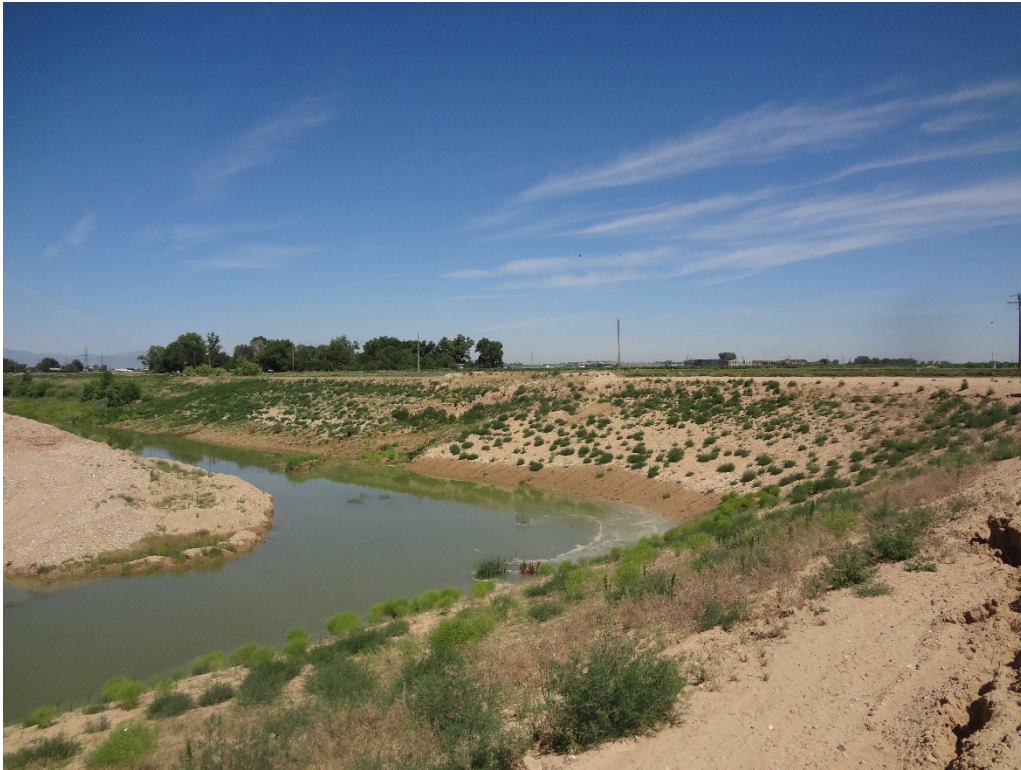
View of northeast portion of Cell 3 from NE corner looking NW at slope failure

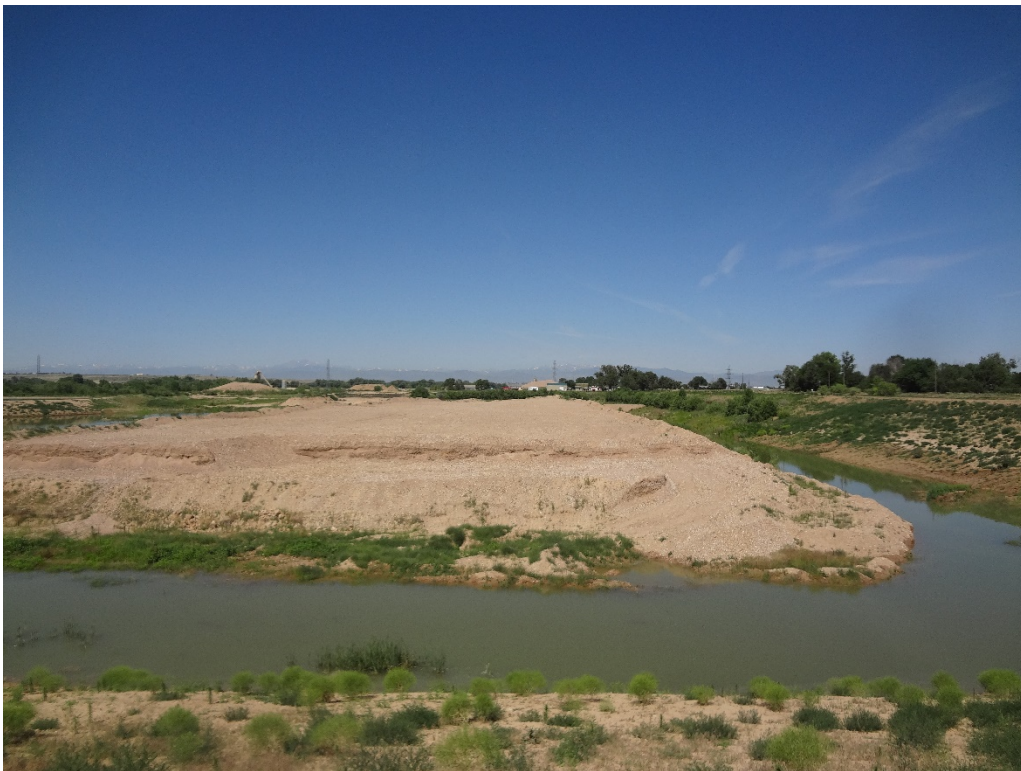
View of northeast portion of Cell 3 from east side looking west
