MINERALS PROGRAM INSPECTION REPORT
PHONE: (303) 866-3567

MINE NAME: San Luis Project	MINE/PROSPECTING ID#: M-1988-112	MINERAL: Gold and silver	COUNTY: Costilla
INSPECTION TYPE: Multi Person Inspection	INSPECTOR(S): Lucas J. West, Tim Cazier	INSP. DATE: June 20, 2018	INSP. TIME: 09:30
OPERATOR: Battle Mountain Resources, Inc.	OPERATOR REPRESENTATIVE: Julio Madrid	TYPE OF OPERATION: 112d-3 - Designated Mining Operation	
REASON FOR INSPECTION: Normal I&E Program	BOND CALCULATION TYPE: None	BOND AMOUNT: \$7,400,000.00	
DATE OF COMPLAINT: NA	POST INSP. CONTACTS: None	JOINT INSP. AGENCY: None	
WEATHER: Clear	INSPECTOR'S SIGNATURE:

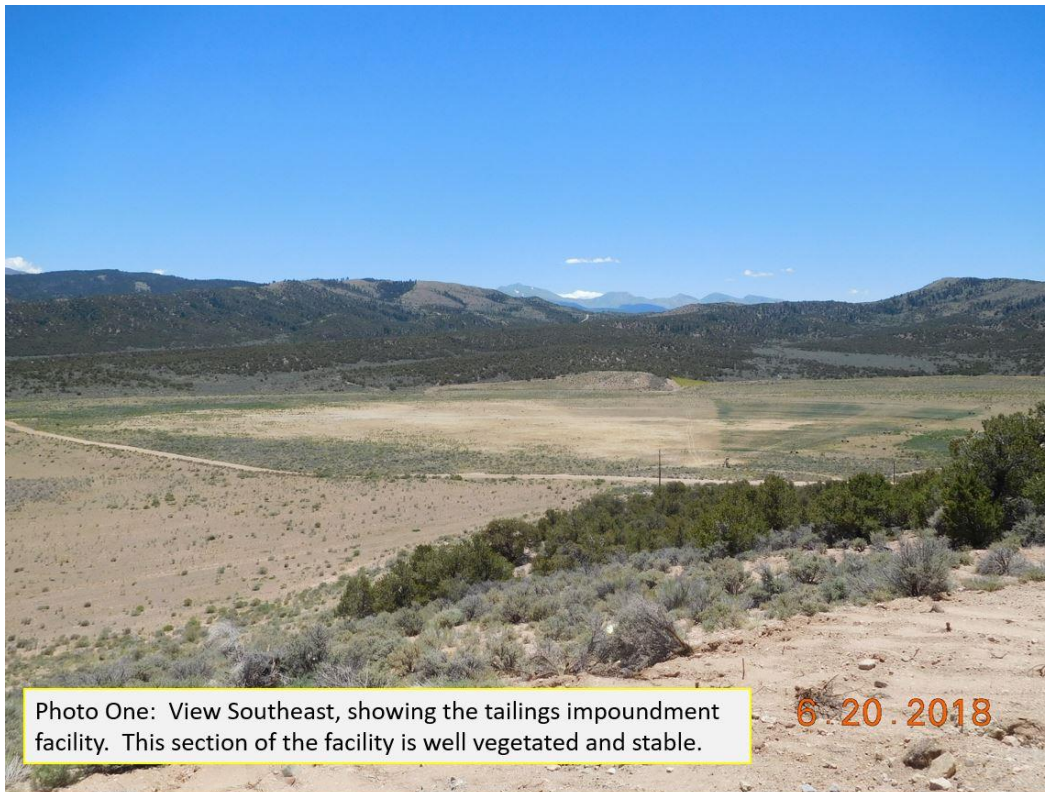
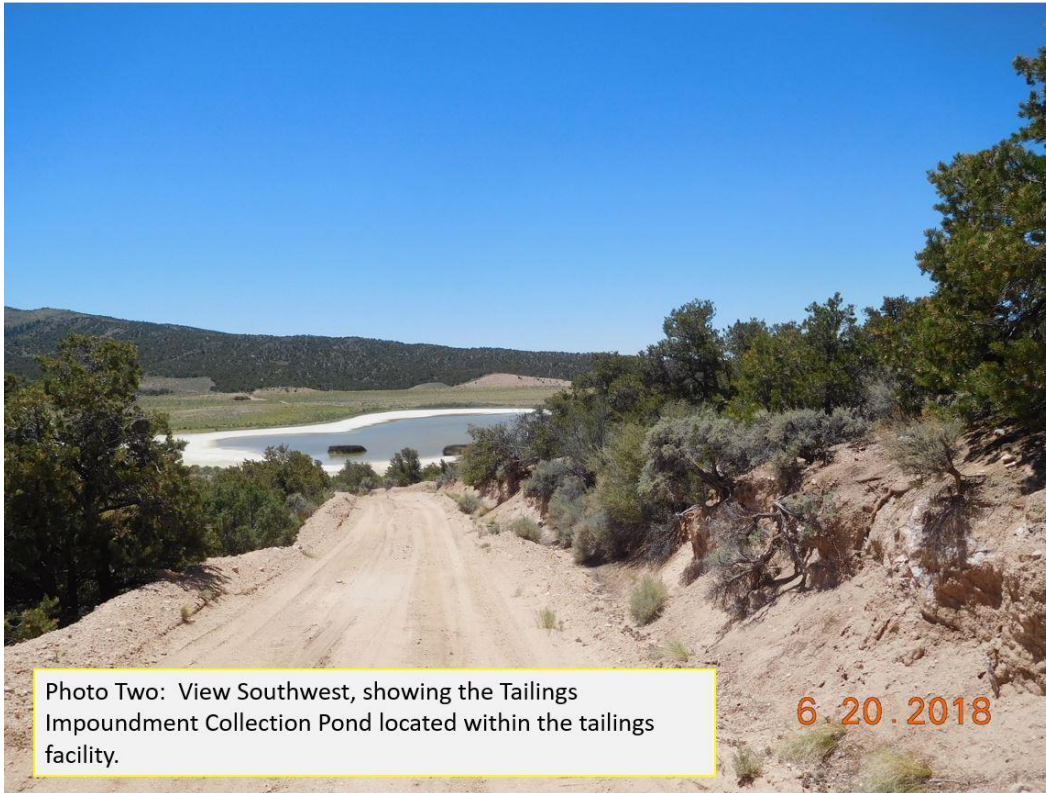
The Tailings Impoundment facility as a whole appears to be in good condition and functioning as designed. Photos One and Two show the water collection pond within the Tailings Facility as well as the sprinkler system and other facilities on the surface. Due to recent drought conditions the water level in the collection pond has been drastically reduced. The face of the dam is in good condition and shows no signs of settling, slumping or erosion. The dam face can be seen in Photo Three. The vegetation appears to be doing well and no state listed noxious weeds were noted in that area. The exposed liner that is part of the underdrain and seepage collection system is in good condition. The toe drains at the base of the tailings dam can be seen in Photo Four. The seepage collection system appears to be functioning as designed and was producing approximately 25 GPM of seepage water from the system. The manifold and pipe system has been removed for routine maintenance. The toe drain seepage collection pond and pump back system are also in good condition. The Operator has expressed interest in altering the storm water control features for the face of the tailings dam by diverting clean storm water runoff off the face of the dam and out of the lined area to discharge into nearby drainages whereby removing that volume of water from the system. Changing the storm water management plan would need to be addressed through the Technical Revision process. The details of what would be required were discussed and would need to be officially submitted for technical review.
