MINERALS PROGRAM INSPECTION REPORT
PHONE: (303) 866-3567

MINE NAME: Base Product Gravel Pit 1	MINE/PROSPECTING ID#: M-1994-053	MINERAL: Sand and gravel and material for construc	COUNTY: Montrose
INSPECTION TYPE: Preoperation Inspection	INSPECTOR(S): Lucas J. West	INSP. DATE: July 10, 2018	INSP. TIME: 10:10
OPERATOR: Rock Pile, LLC	OPERATOR REPRESENTATIVE: Doug Flowers	TYPE OF OPERATION: 112c - Construction Regular Operation	
REASON FOR INSPECTION: Pre-operation Inspection	BOND CALCULATION TYPE: None	BOND AMOUNT: \$32,303.00	
DATE OF COMPLAINT: NA	POST INSP. CONTACTS: None	JOINT INSP. AGENCY: None	
WEATHER: Clear	INSPECTOR'S SIGNATURE:

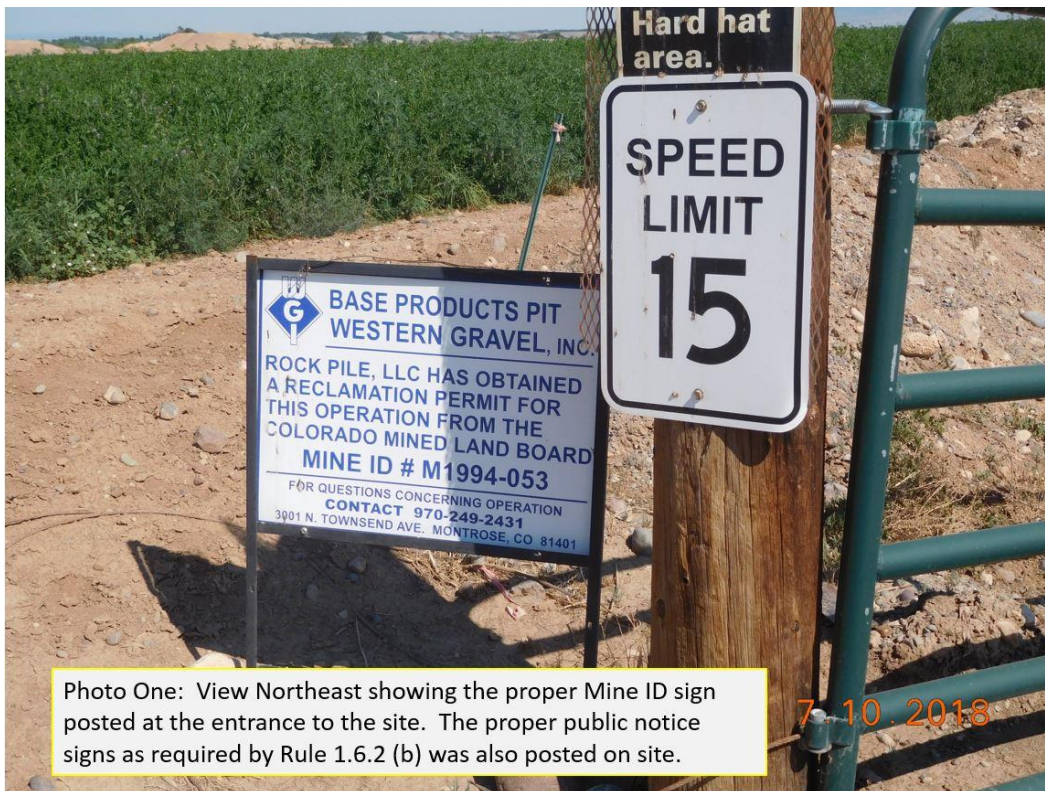
This inspection also served as the routine monitoring inspection for the active portion of the mining operation. The proper mine identification signage was posted at the entrance to the site, as seen in Photo One. The Permit Boundary is clearly marked with t-posts and natural features. The site was active the day of the inspection, stockpiled material was being hauled from the Phase One area. The mining activity is currently affecting only the Phase One area. Phase Two is currently unaffected. The active mining area consists of a benched highwall that appears to be stable and in good condition. The area can be seen in Photos Two and Three. All stockpiles located on the pit floor appear to be stable and in good condition.

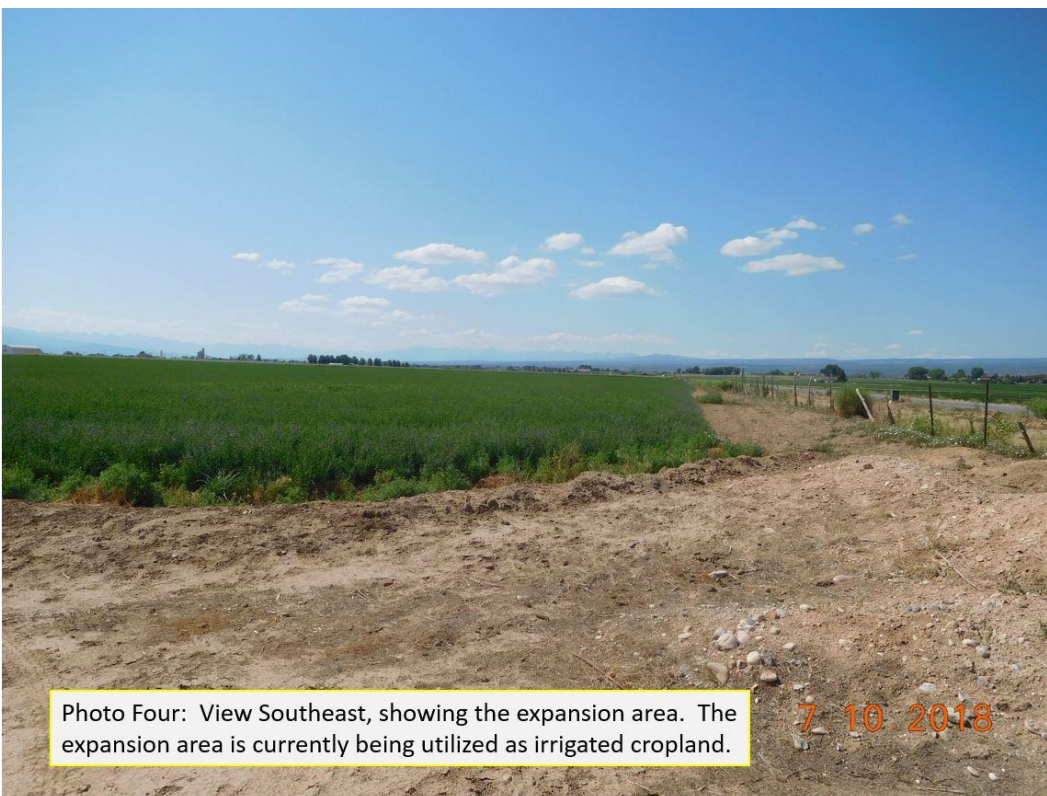
The expansion area consists of two 40 acre fields that are currently being utilized for irrigated crop land. The area can be seen in Photos Four through Seven. The proper public notice signage was posted at the entrance to the site as required by Rule 1.6.2 (b). Discussions with the operator indicate that this area is being permitted as a reserve and will likely remain unaffected for several years until both the Phase One and Phase Two areas are mined out. The expansion area is in good condition and remain to be utilized as irrigated cropland until such time as the mining activity progresses.

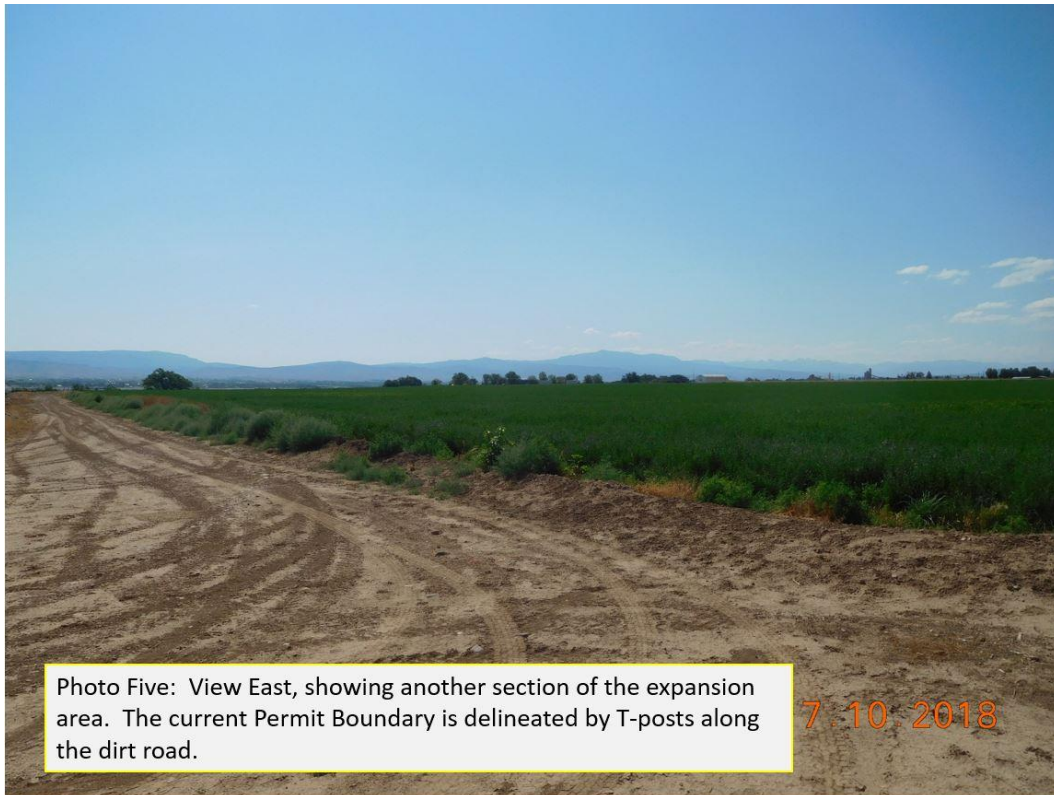
Photo Five: View East, showing another section of the expansion area. The current Permit Boundary is delineated by T-posts along the dirt road.

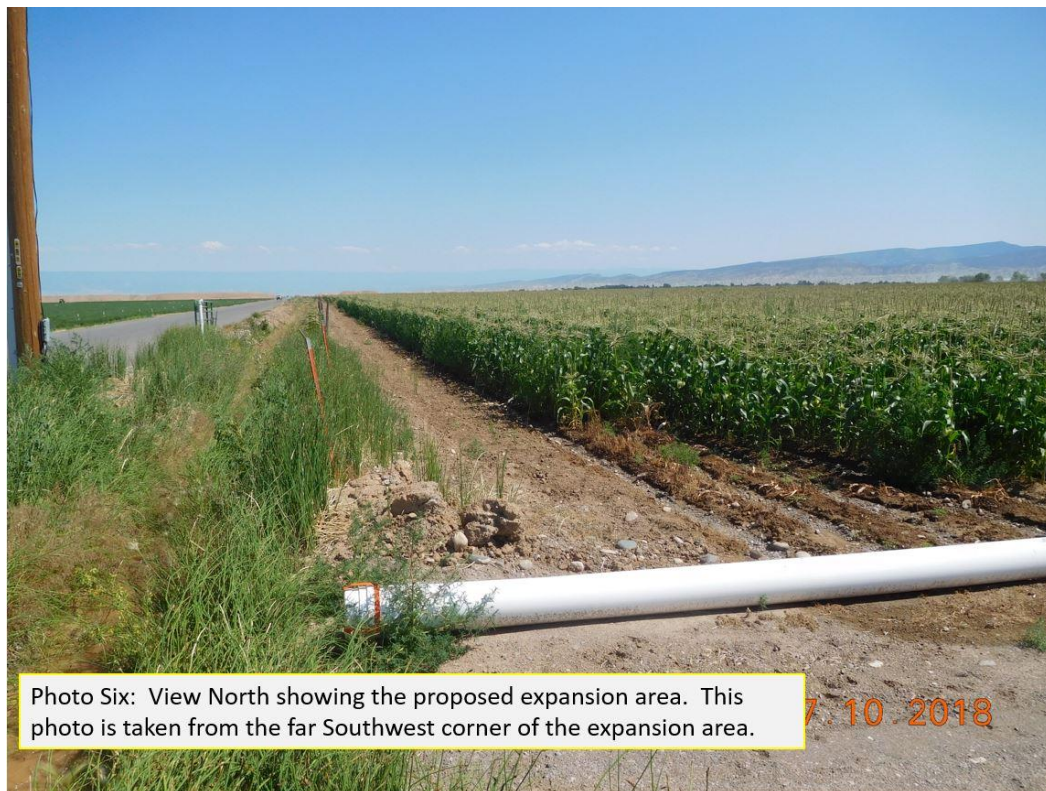
Photo Six: View North showing the proposed expansion area. This photo is taken from the far Southwest corner of the expansion area.
