MINERALS PROGRAM INSPECTION REPORT**PHONE: (303) 866-3567**

MINE NAME: West Farm Pit	MINE/PROSPECTING ID#: M-2008-078	MINERAL: Gravel and sand	COUNTY: Prowers
INSPECTION TYPE: Monitoring	INSPECTOR(S): Amy Eschberger	INSP. DATE: June 14, 2018	INSP. TIME: 13:45
OPERATOR: Prowers Aggregate Operators, LLC	OPERATOR REPRESENTATIVE: Ron Peterson	TYPE OF OPERATION: 112c - Construction Regular Operation

REASON FOR INSPECTION: Citizen Complaint	BOND CALCULATION TYPE: None	BOND AMOUNT: \$575,000.00
DATE OF COMPLAINT: June 11, 2018	POST INSP. CONTACTS: Colorado Parks & Wildlife	JOINT INSP. AGENCY: Colorado Parks & Wildlife - Jim Ramsay
WEATHER: Clear	INSPECTOR'S SIGNATURE:

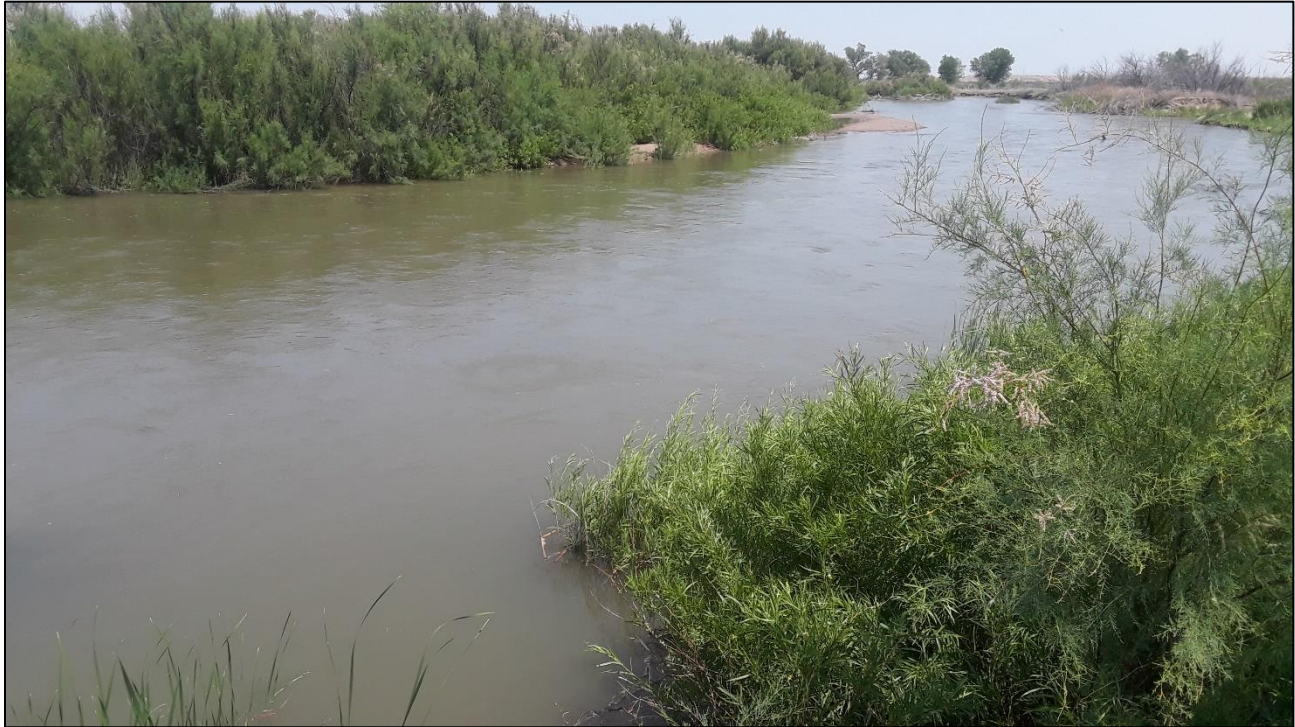
The Division and Mr. Ramsay observed the Arkansas River both upstream (near Hwy 287; **Photo 1**) and downstream (off Co Rd 13; **Photo 2**) from the mine operation, where the photos sent with CPW's complaint had been taken. CPW's photos show clear water in the river upstream from the mine site, and silty water downstream from the mine site. These photos were taken approximately two weeks prior to this inspection, during regular flows. During the inspection, the river was running high due to water being released from the John Martin Reservoir, and no visual differences in water quality were observed in the river upstream versus downstream from the mine site.

Photo 1. View looking downstream in Arkansas River at a location approximately 1.2 miles upstream from mine site (near Hwy 287). Note high water level in river due to release of John Martin Reservoir.

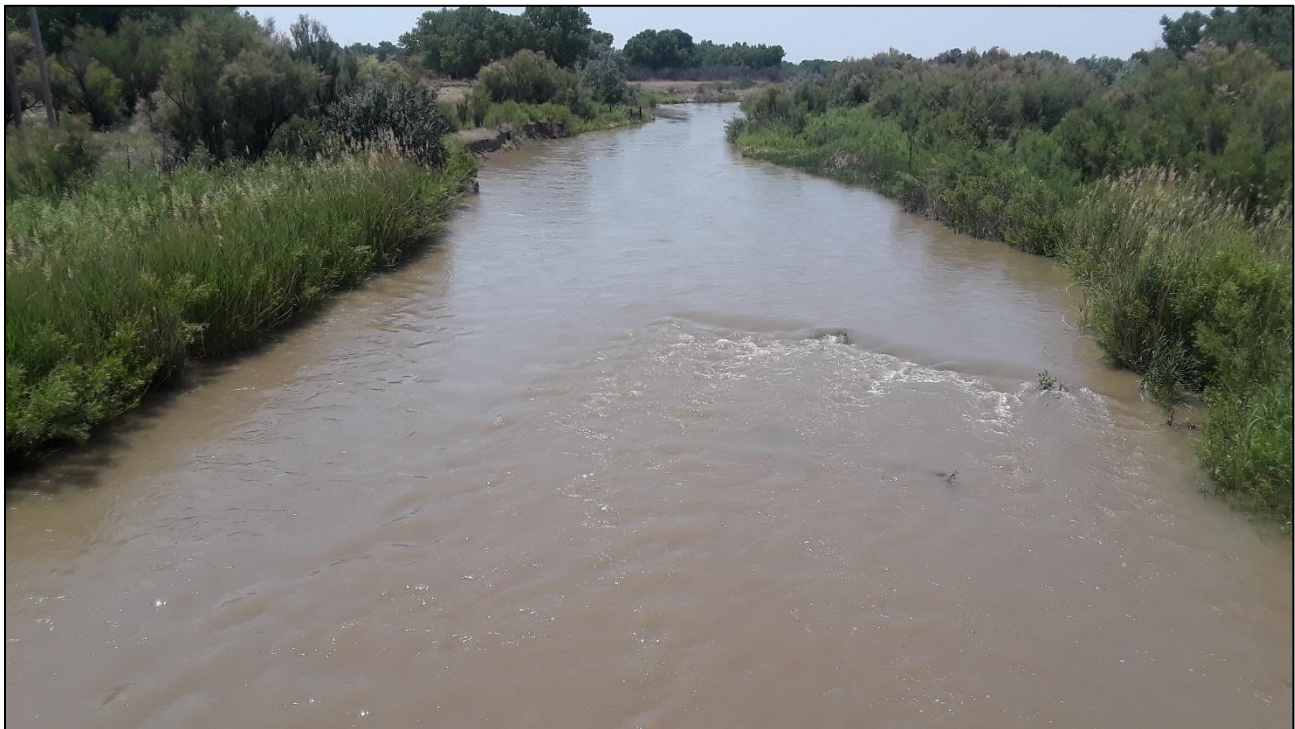
Photo 2. View looking upstream in Arkansas River at a location approximately 5 miles downstream from mine site (off County Road 13). Note high water level in river due to release of John Martin Reservoir.

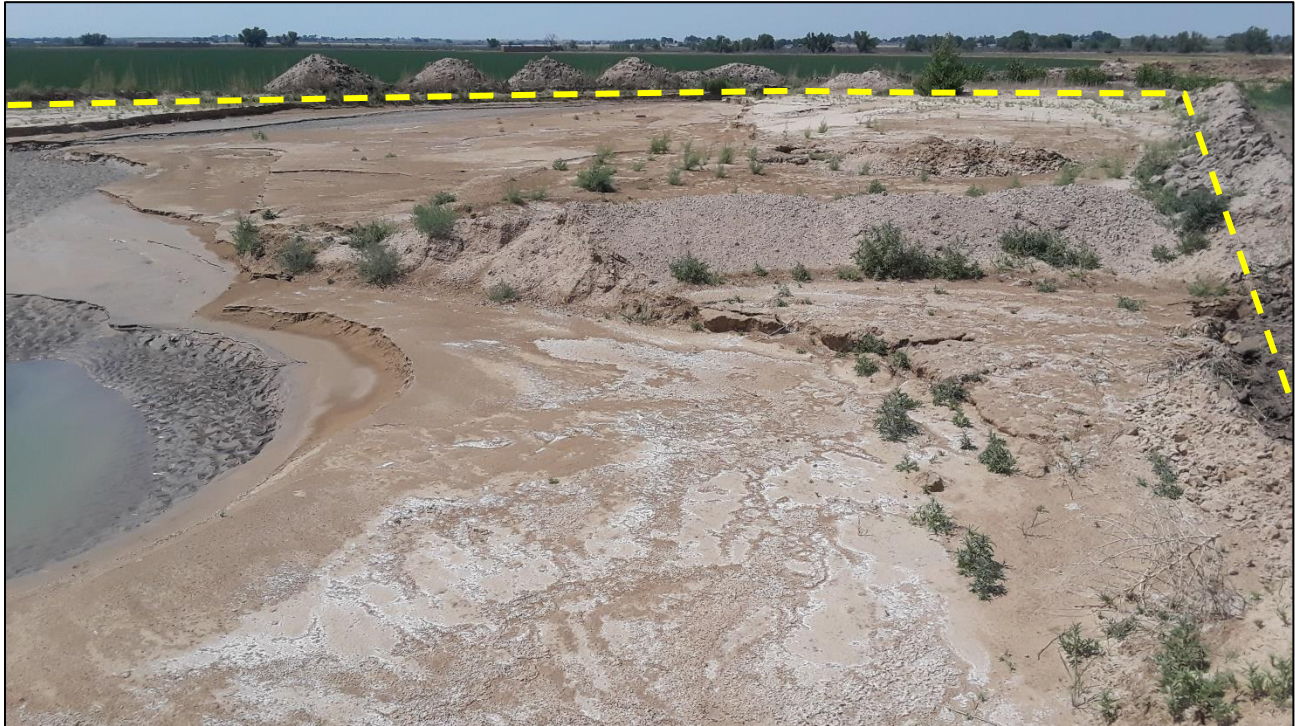
Photo 3. View looking north across wash plant settling pond, showing pond filled in with sediment. Approximate edges of pond indicated with yellow dashed line.

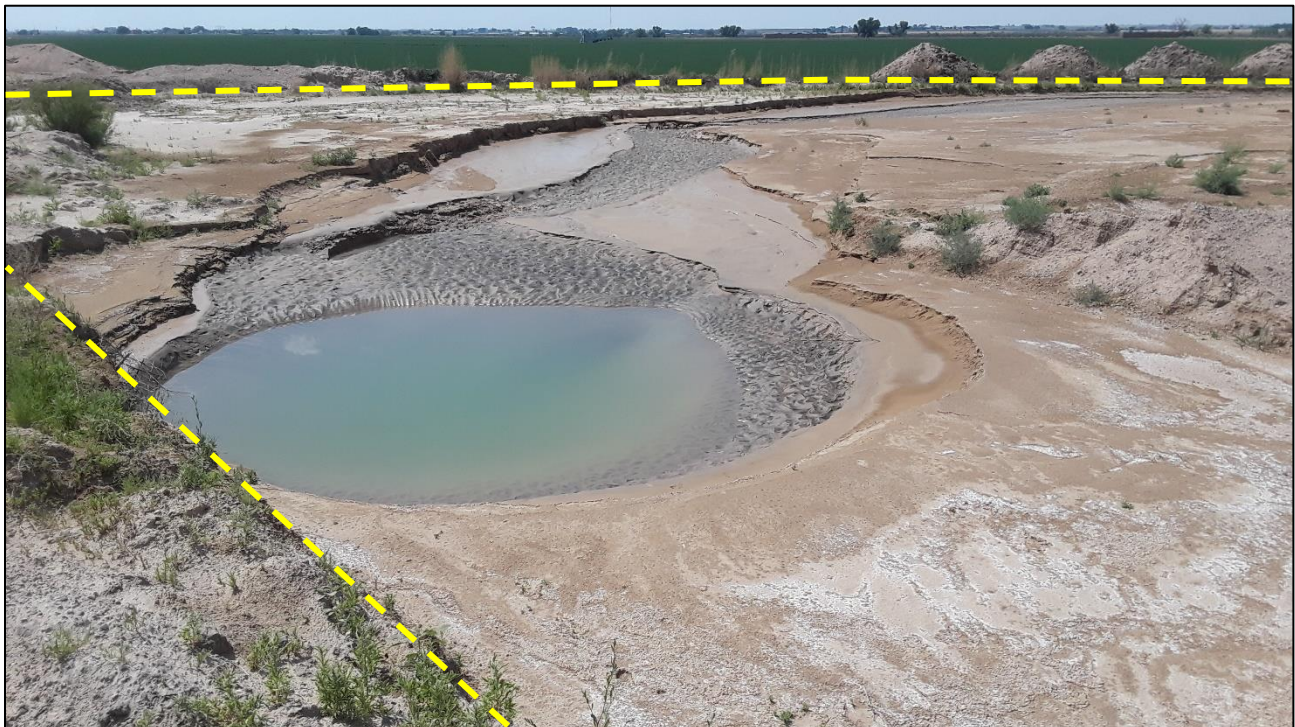
Photo 4. View looking west across wash plant settling pond, showing pond filled in with sediment. Only a small pool of water remains at the southern edge of the pond. Approximate edges of pond indicated with yellow dashed line.

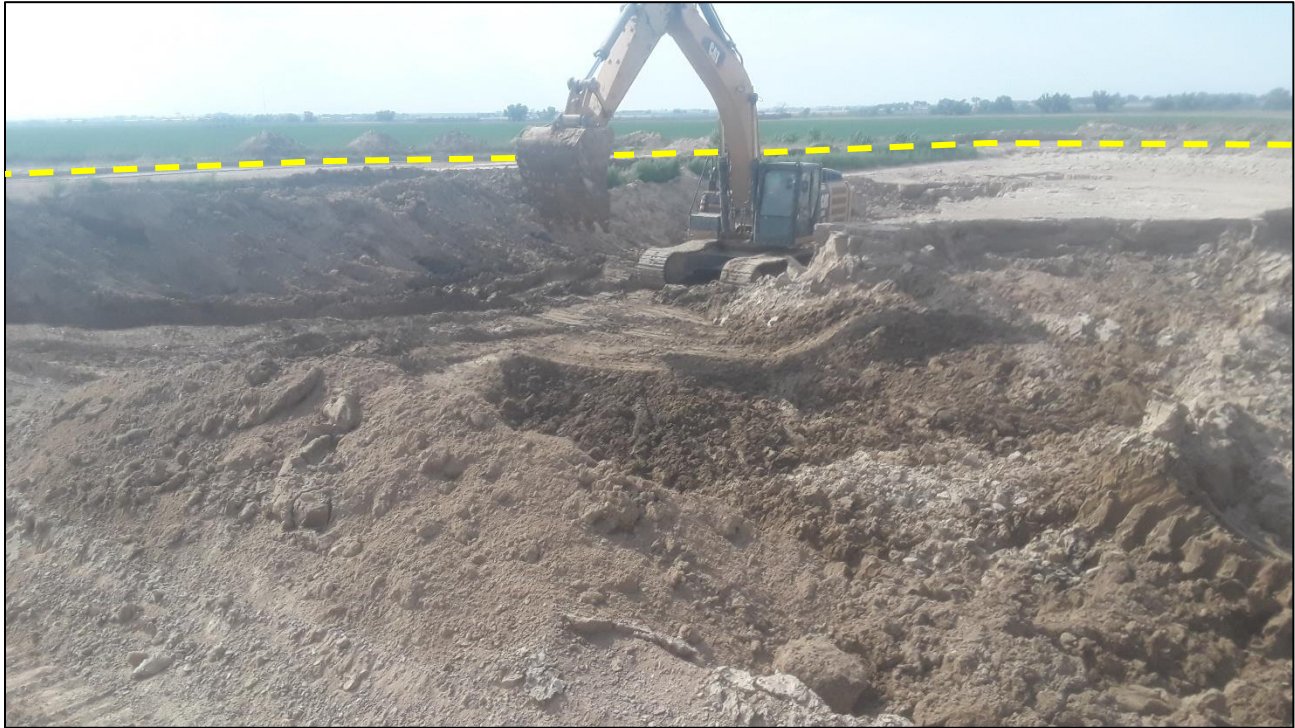
Photo 5. View looking west across wash plant settling pond filled in with sediment, which operation was digging out during inspection. Approximate edges of pond indicated with yellow dashed line.

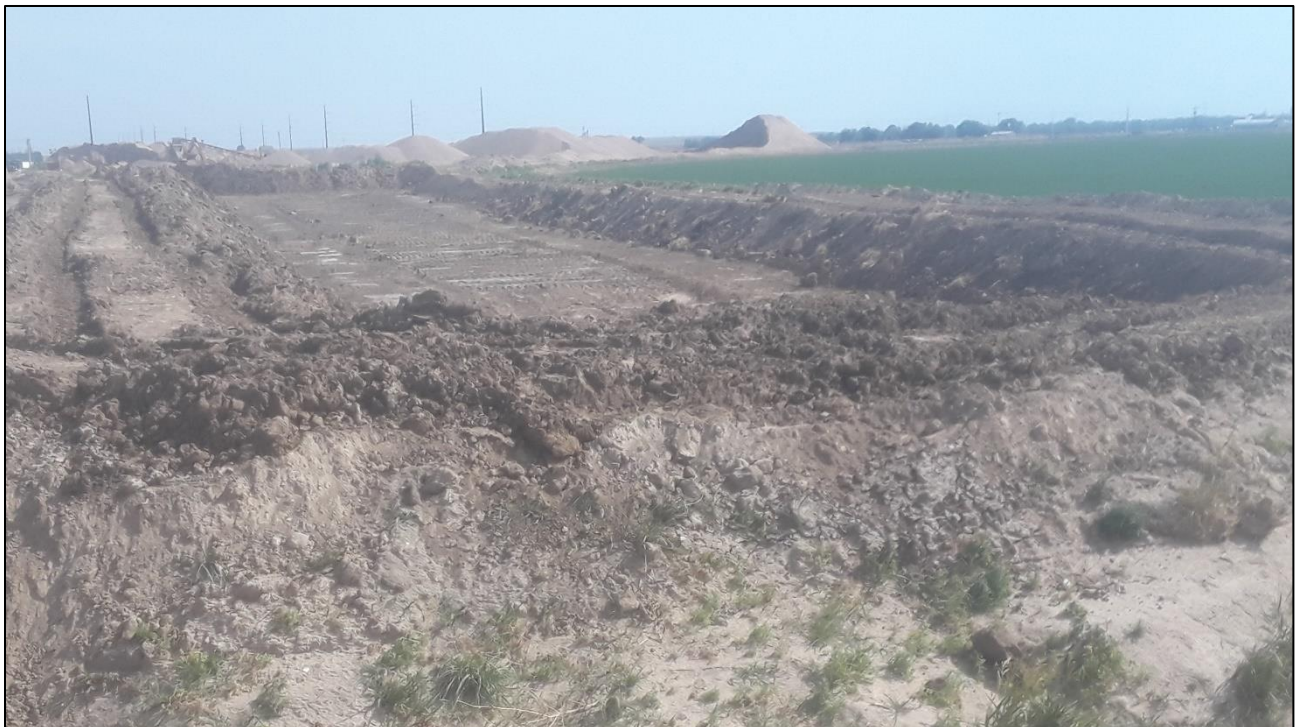
Photo 6. View looking south across new wash plant settling pond under construction (outside of approved permit boundary).

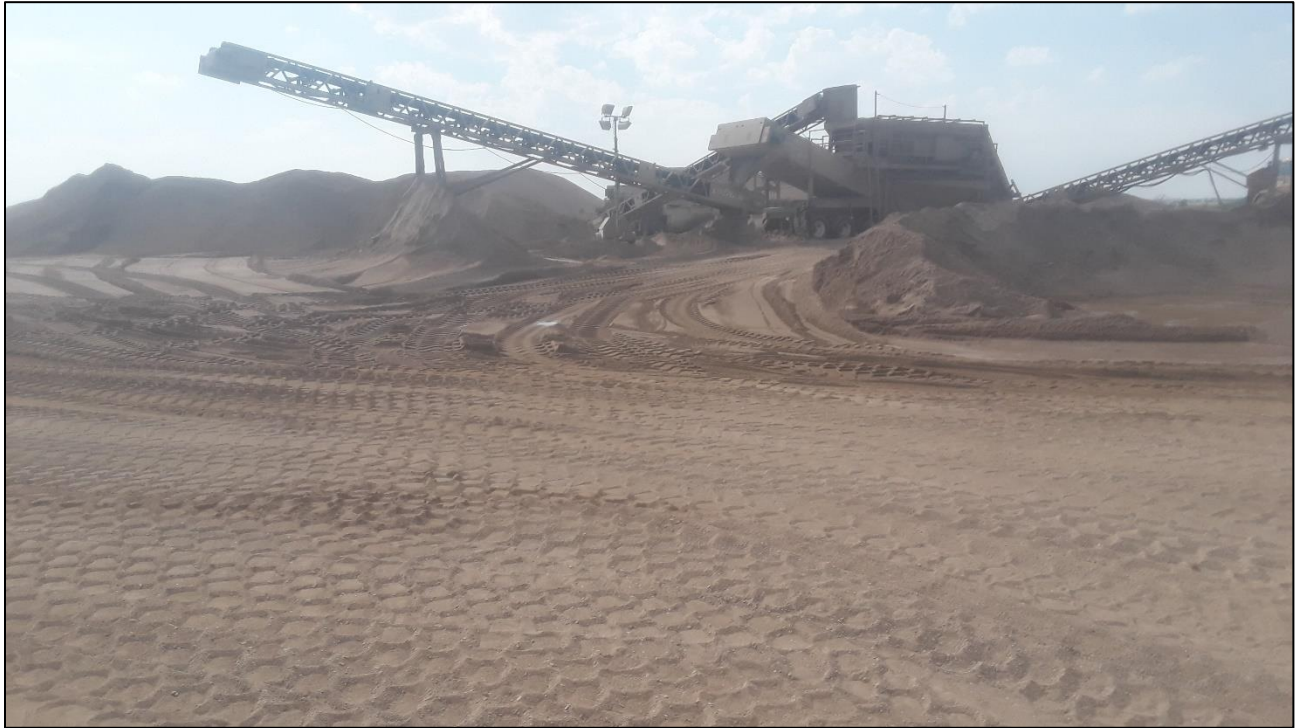
Photo 7. View looking northwest across material wash plant located in phase 13, not in operation during inspection. No continued wastewater discharge from plant was observed.

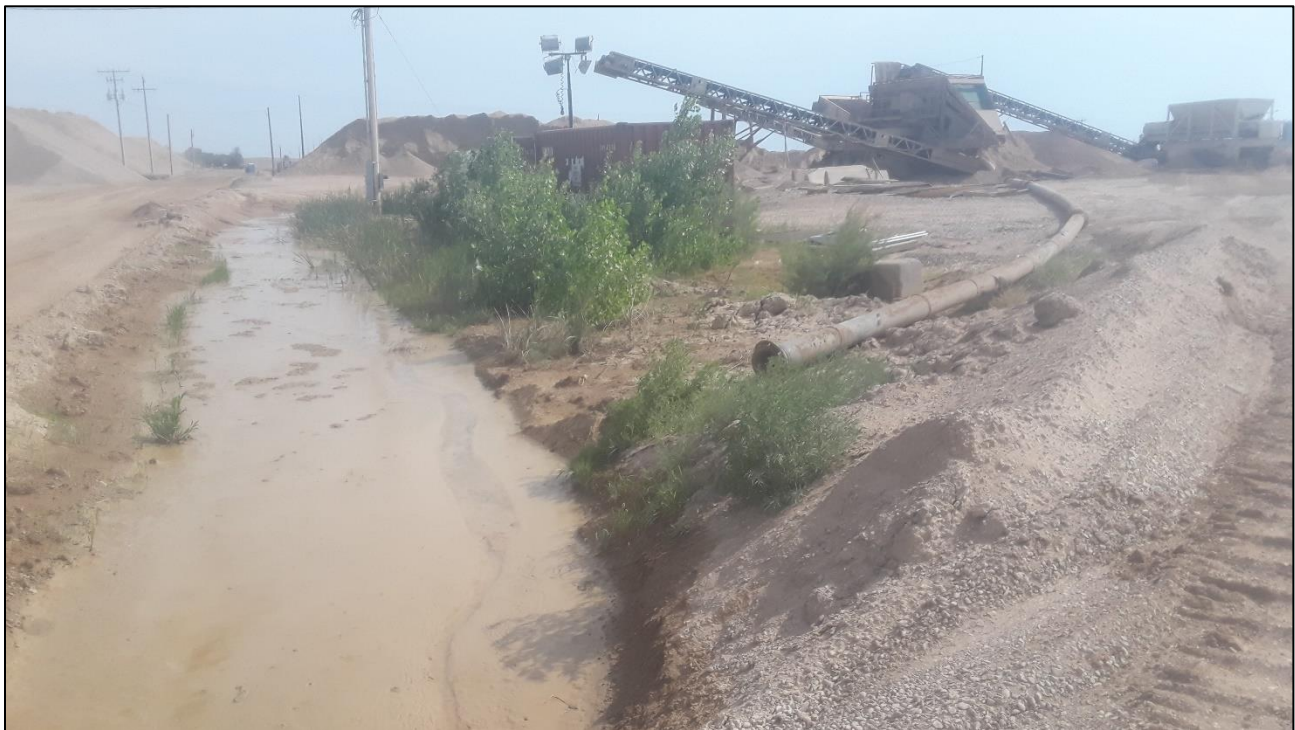
road still contained silty water and sludge (**Photos 8 and 9**). The Division and Mr. Ramsay walked the trench northward from the wash plant to the river. Portions of the trench had been dredged, with the material piled along its edges (**Photo 10**). The section of the trench closest to the river (**Photo 11**) was not holding water, but still contained wet sediment.

Photo 8. View looking south, showing material wash plant (at right; not in operation during inspection) and ditch (at left) in which wastewater was released to the river. Note ditch still holding silty water and sludge during inspection.

Mr. Peterson committed to not continuing the unauthorized discharge from the wash plant. The operator must demonstrate compliance with Rule 3.1.6(1)(b) by obtaining the necessary permit(s) from CDPHE, WQCD for all discharge activities. Additionally, the operator will need to revise the mining plan to provide more details on the wash plant and associated facilities, including a plan for maintaining the settling ponds. The operator must demonstrate the wash plant facilities are appropriately designed to prevent any unauthorized release of wastewater and/or offsite damage. This information will need to be included in a Technical Revision or permit Amendment. A Possible Violation is cited in this report for failure to minimize disturbances to the prevailing hydrologic balance of the affected land and of the surrounding area and to the quantity or quality of water in surface systems during the mining operation. This Possible Violation will require a hearing before the Mined Land Reclamation Board. Details for the Board hearing will be mailed separately via Certified Mail.

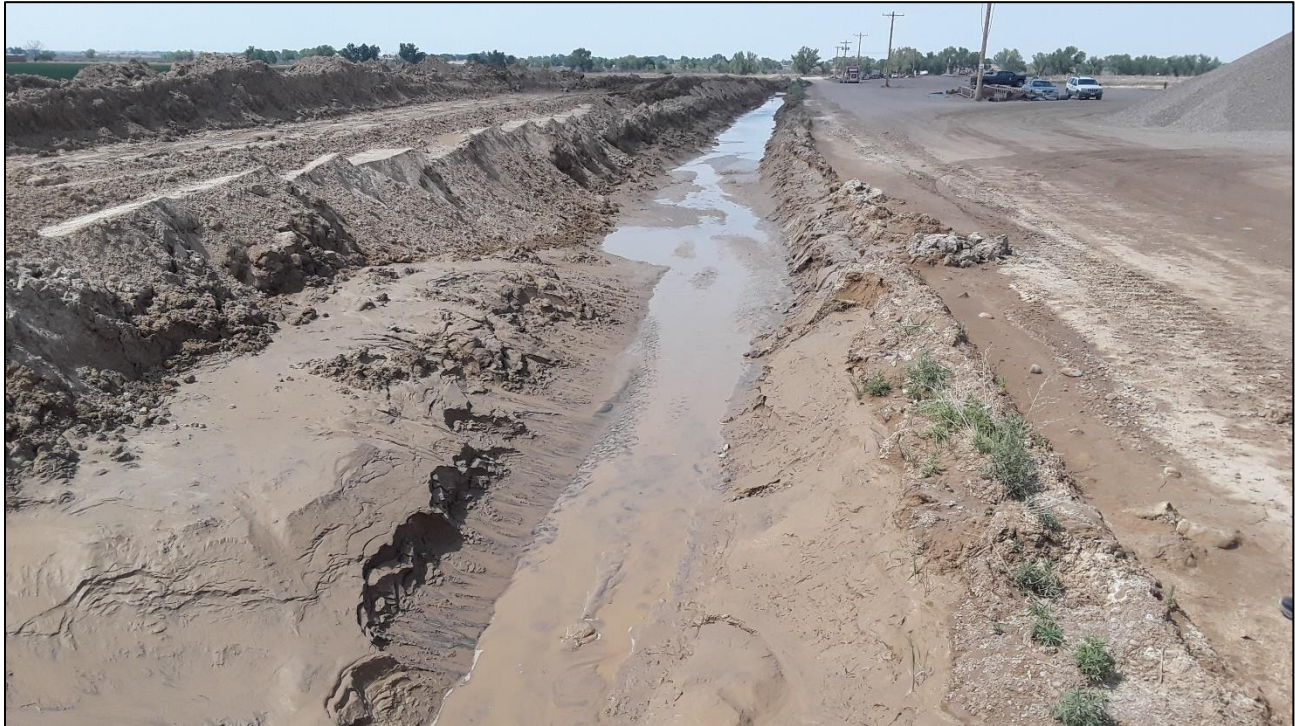
Photo 9. View looking north from wash plant area, showing ditch in which wastewater was released to the river. Note ditch still holding silty water and sludge during inspection.

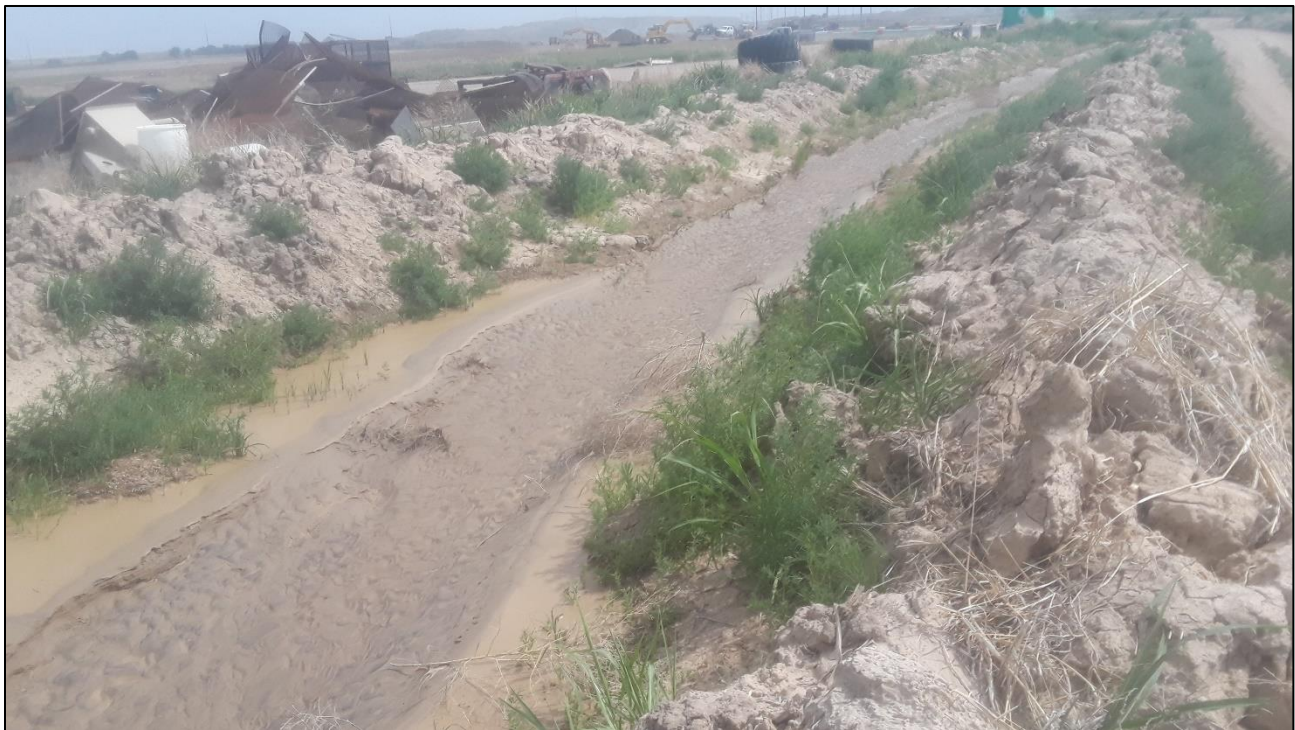
Photo 10. View looking south across ditch in which wash plant wastewater was released to the river. Note material dredged from ditch piled along its edges. Also note this portion of the ditch (closer to river than in Photo 9 and outside of approved permit boundary) was not holding water during inspection.

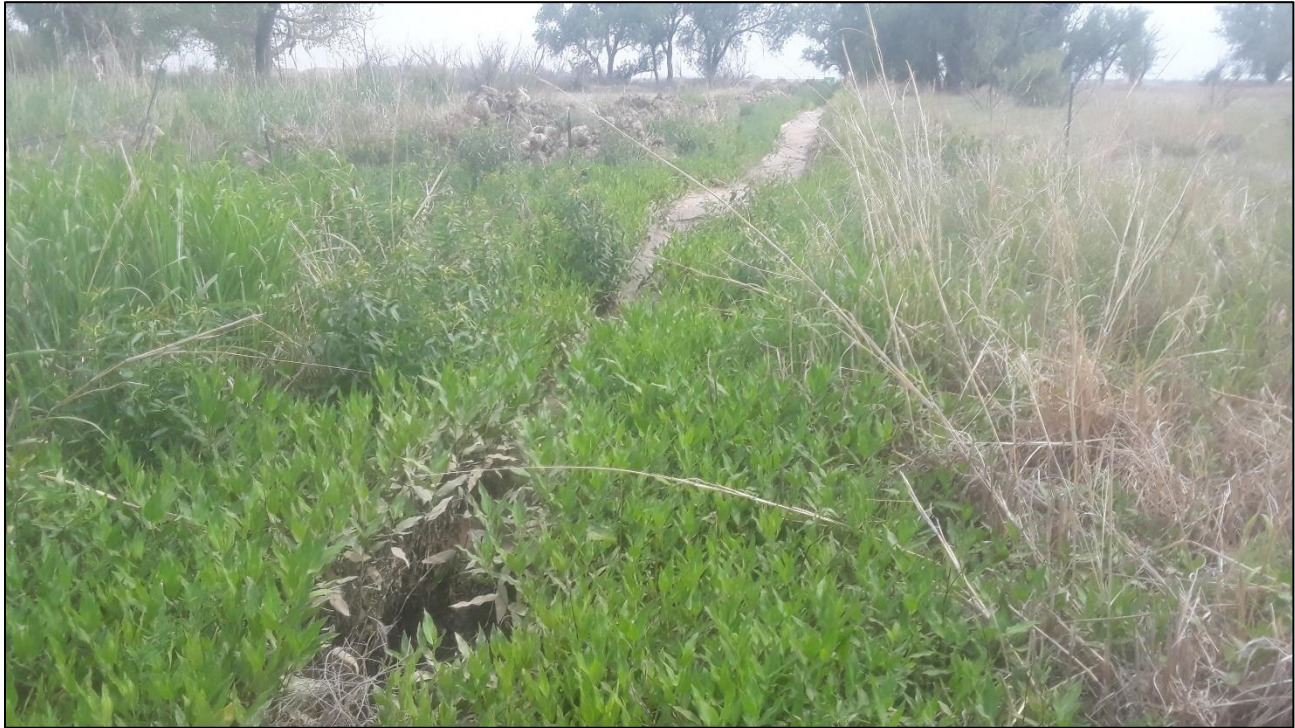
Photo 11. View looking south across ditch in which wash plant wastewater was released to the river. This portion of the ditch (closer to river than in Photo 10 and outside of approved permit boundary) was not holding water during the inspection, but still contained wet sediment.

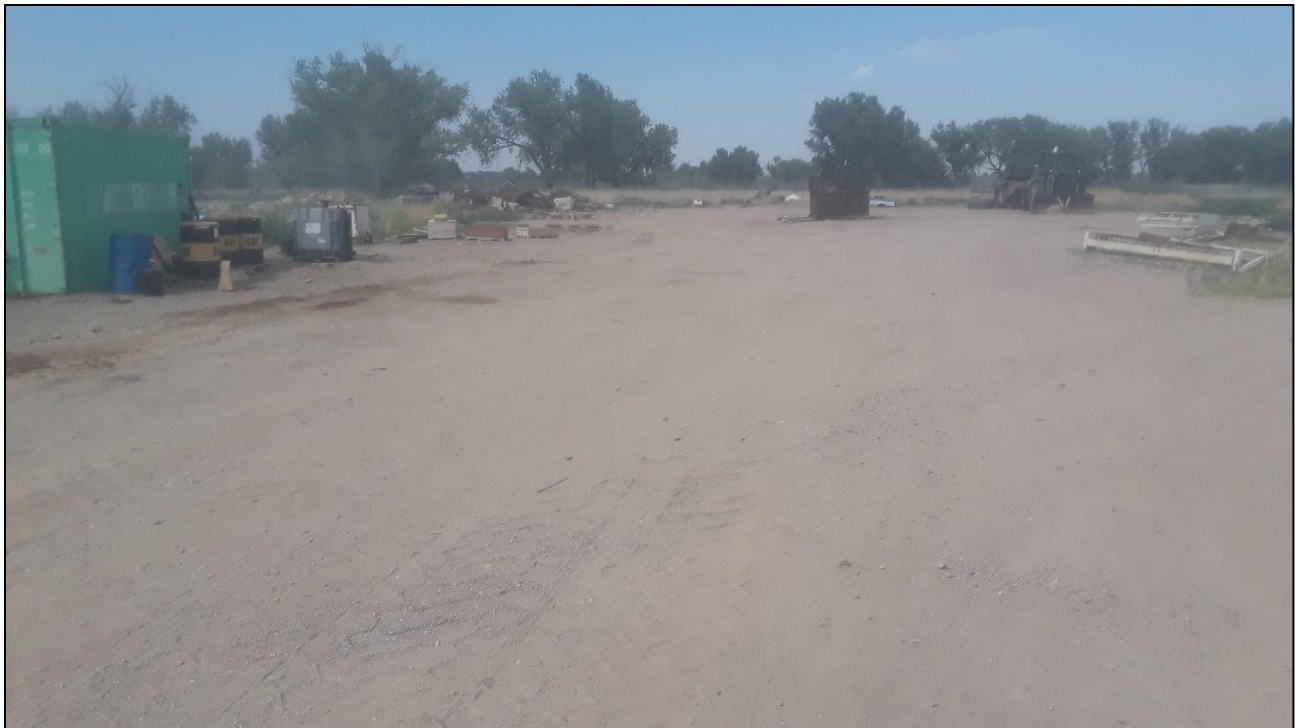
Photo 12. View looking north across equipment/truck storage area located north of mine site (outside of approved permit boundary).

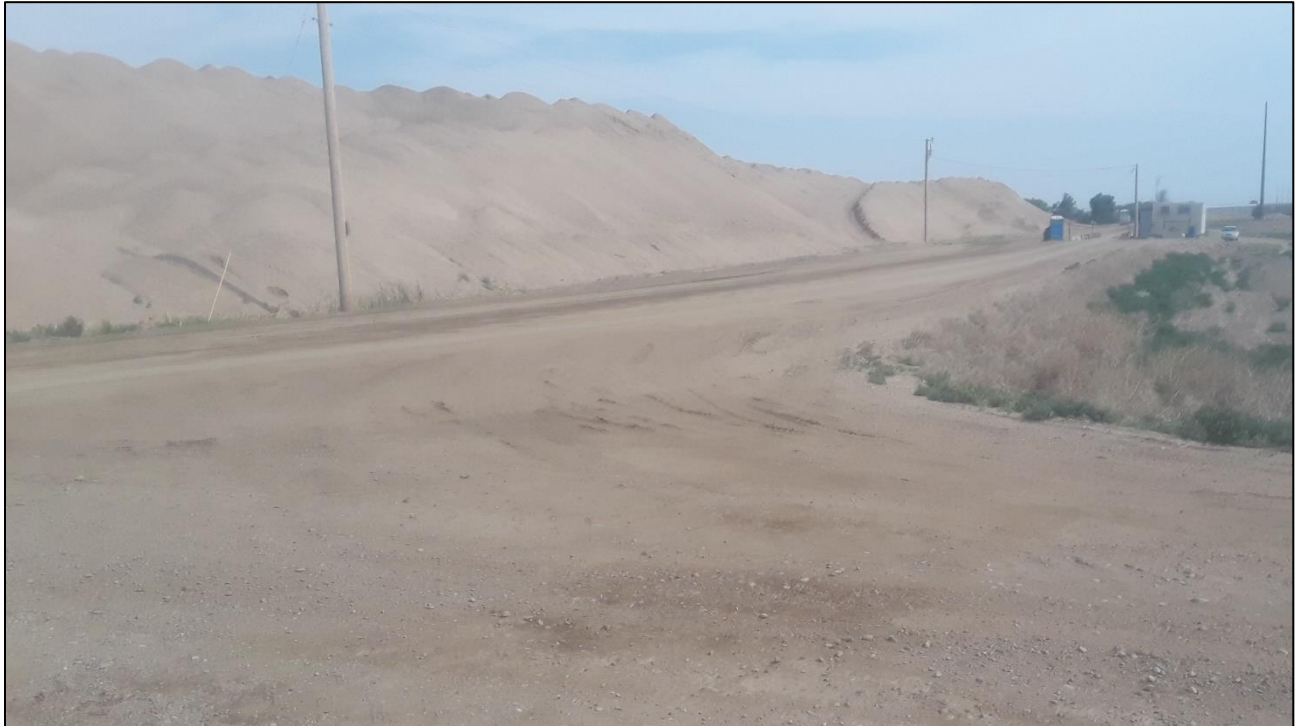
Photo 13. View looking south, showing main access road, scale house (at background right), and material stockpiles partially located outside approved permit boundary.

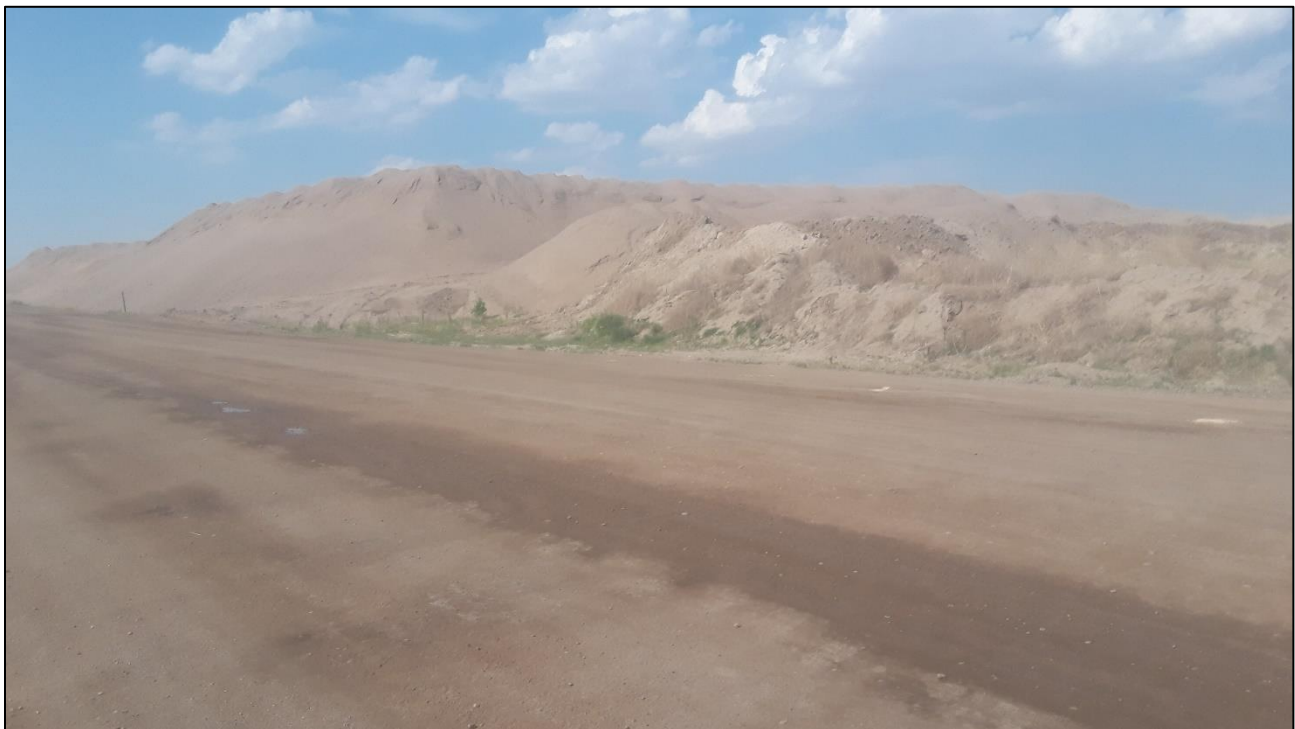
Photo 14. View looking northeast across main access road, at material and topsoil/overburden stockpiles partially located outside approved permit boundary.

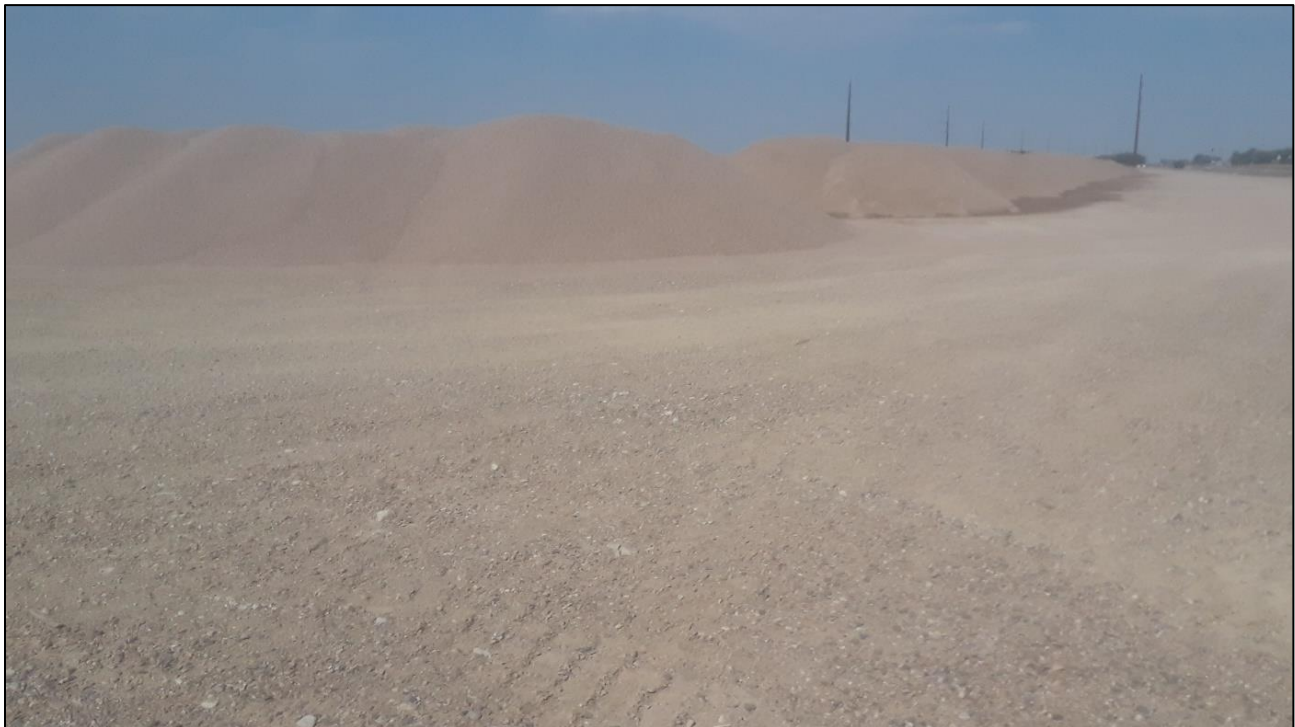
The Division estimates the operation has disturbed a total of 177 acres (see enclosed Google Earth images of site). Disturbance in the North Mining Area includes two slurry wall installations, two mined pits, a material crushing/screening plant, a material wash plant and associated facilities (i.e., settling ponds, ditches), material stockpiling areas, equipment/truck storage areas, and haul roads. Disturbance in the South Mining Area includes material stockpiling areas, topsoil/overburden storage areas, a scale house, and haul roads. The Division estimates 37.52 acres of the disturbance occurred outside of the approved permit boundary. The off-site disturbance includes at least one of the settling ponds, the ditch in which the wash plant wastewater was released to the river, an equipment/truck storage area located north of the mine (**Photo 12**), the scale house area (**Photo 13**), the western edge of the material and topsoil/overburden stockpiles in the South Mining Area (**Photo 14**; also shown in Photo 13), haul roads (agricultural roads widened for mine traffic), and a 26.8 acre area located just southwest of the mine site where sand is being stockpiled adjacent to the railroad (**Photos 15 and 16**).

Photo 16. View looking east across 26.8 acre disturbed area where operation is storing sand near the railroad. Area is located just southwest of mine site and outside of approved permit boundary.

The Division considers the amount of off-site damage to be substantial pursuant to C.R.S. 34-32.5-123(2). All affected lands must be incorporated into the permit area through submittal of a permit Amendment. A Possible Violation is cited in this report for failure to first obtain from the MLRB or Office a reclamation permit prior to engaging in a new operation as required by C.R.S. 34-32.5-109(1). This Possible Violation will require a hearing before the Mined Land Reclamation Board. Details for the Board hearing will be mailed separately via Certified Mail.

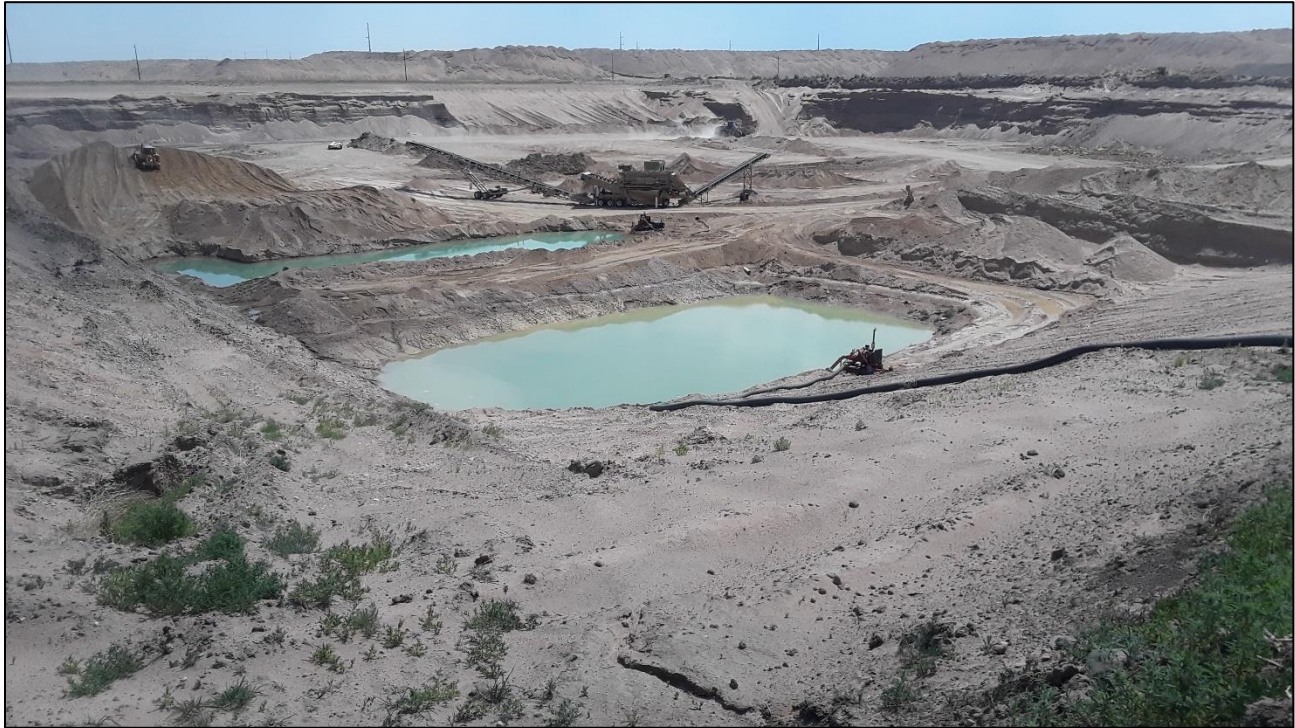
Photo 17. View looking southwest across new pit excavation in phases 8 and 11.

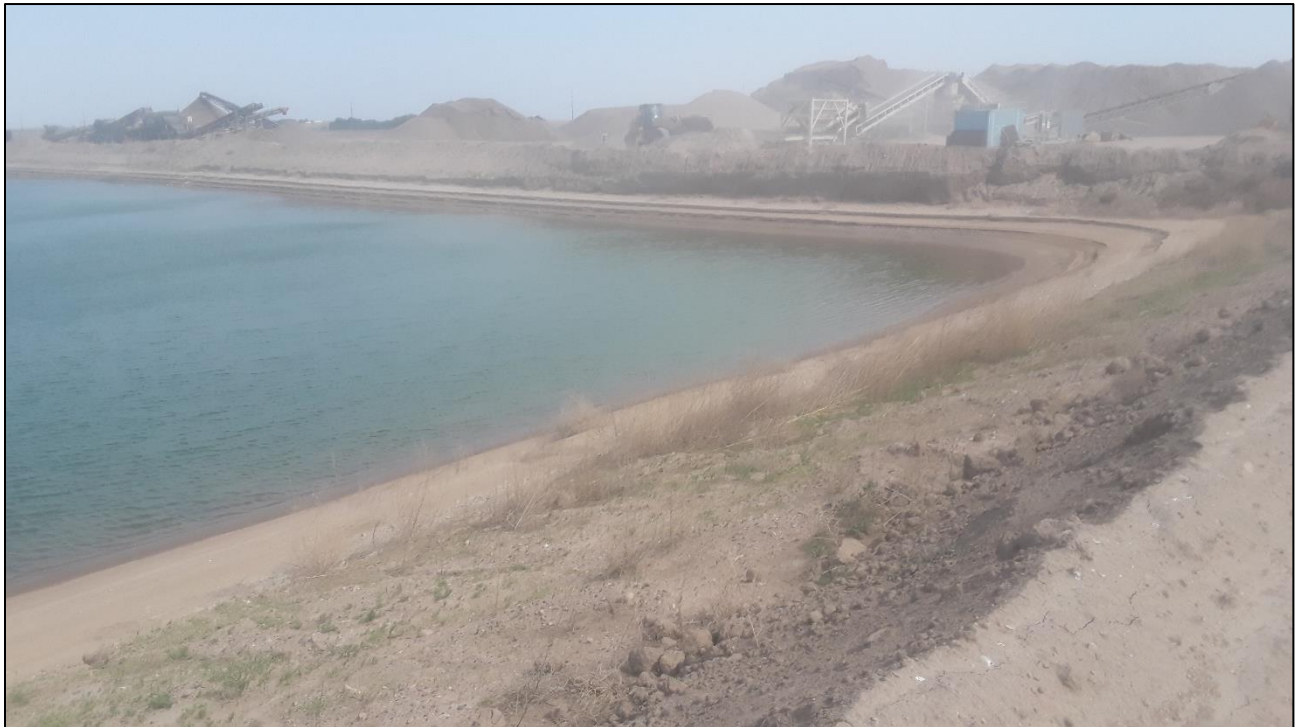
Photo 18. View looking southeast showing material crushing/screening plant operating in phase 9, just south of lined reservoir (in background).

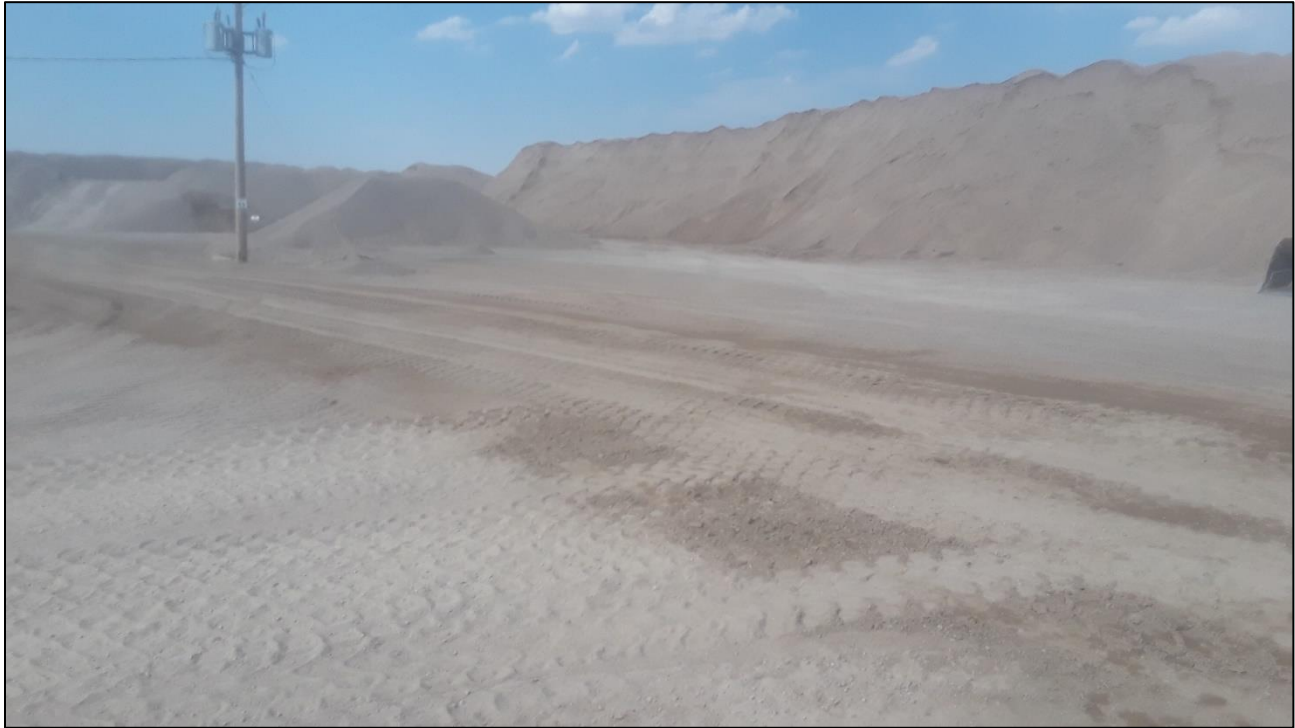
Photo 19. View looking east across material stockpiles stored in phases 9 and 12.

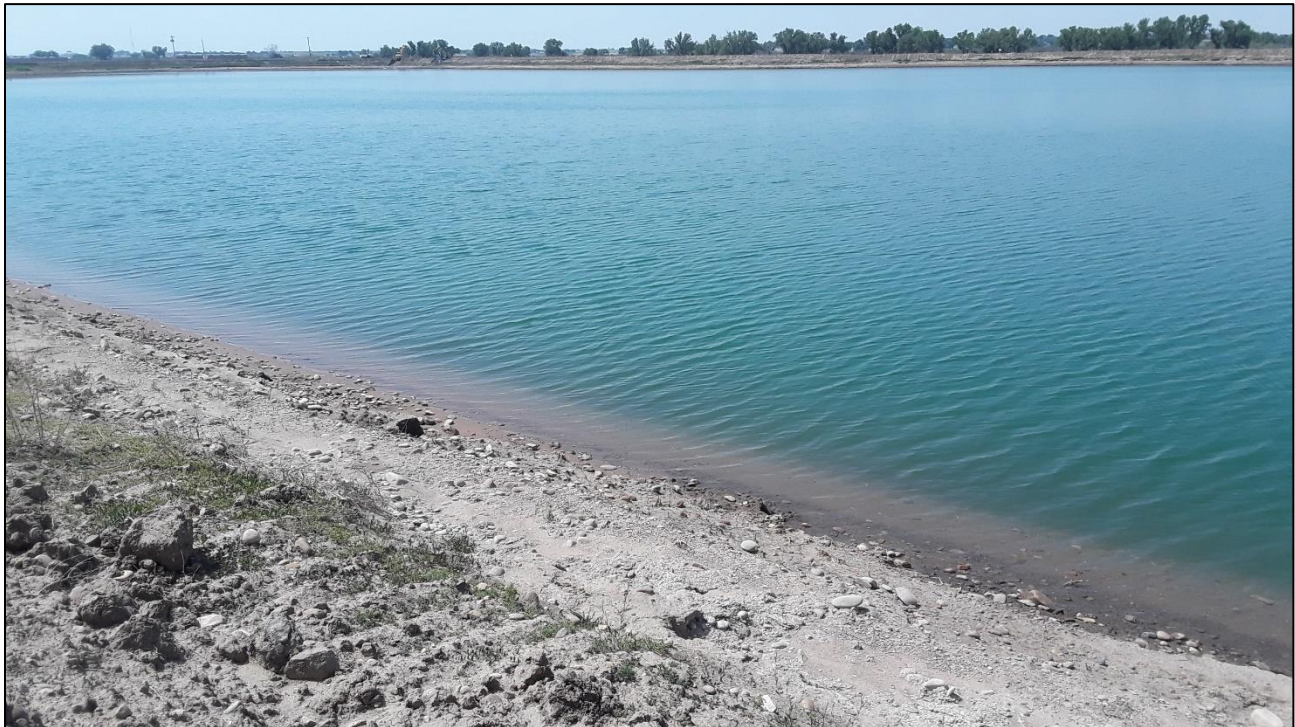
Photo 20. View looking northwest from southern edge of slurry wall lined pit in phases 1-4, now filled with water. Pit is approximately 65 feet deep with 3H:1V slopes down to pit floor.

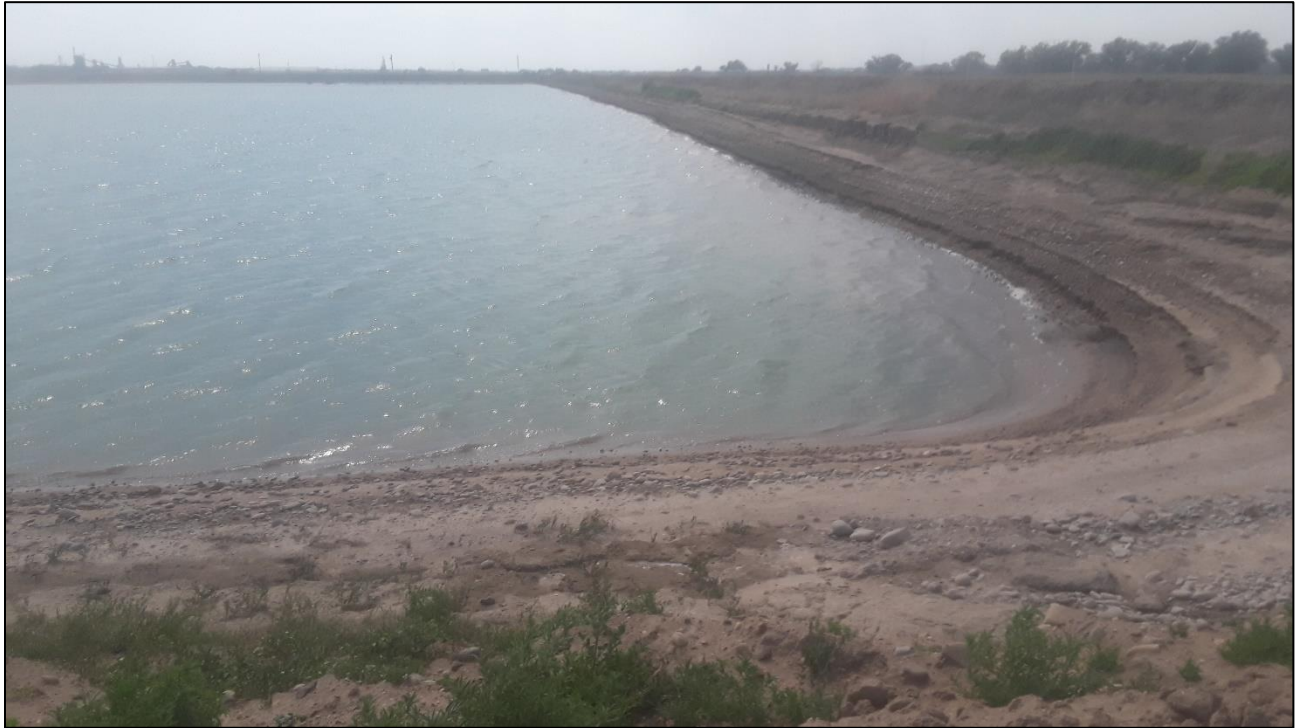
Photo 21. View looking west from eastern edge of slurry wall lined pit in phases 1-4, now filled with water. Pit is approximately 65 feet deep with 3H:1V slopes down to pit floor.

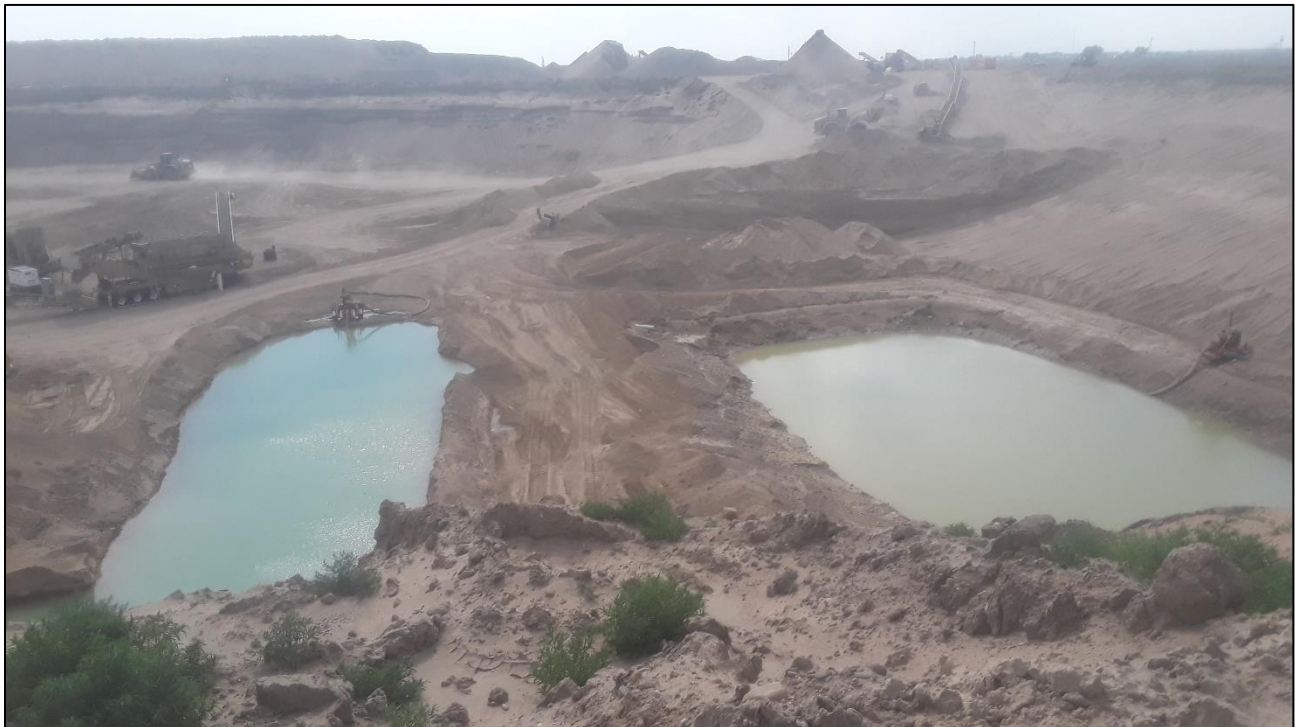
The operation has disturbed 177 acres, which is 60 acres more than the approved maximum disturbed area of 117 acres. Additionally, the operation is not following the mine phasing plan approved by Technical Revision No. 4 (TR-4), which proposed disturbances only in phases 1-4 and 13-18 at this time. The operation has created major disturbances (new pit, processing plant, large material stockpiles) in phases 8, 9, 11, and 12 (**Photos 17-19**), and minor disturbances (slurry wall installation) in phases 5, 6, 7, and 10. TR-4 authorized mining to occur only within the slurry-wall enclosed area of phases 1-4 (now filled with water; **Photos 20 and 21**). However, the operation completed mining the phase 1-4 area, and has begun excavating another pit in phases 8 and 11. The operation is pumping water from two pit floor sumps in the new pit and discharging the water to an adjacent ditch (**Photos 22 and 23**) which discharges to the river northeast of the mine site (east of the Lamar

Photo 22. View looking west across new pit excavation, showing two pit floor sumps from which operation is pumping water to a nearby ditch for discharge to the river.
