MINERALS PROGRAM INSPECTION REPORT**PHONE: (303) 866-3567**

MINE NAME: West Farm Pit	MINE/PROSPECTING ID#: M-2008-078	MINERAL: Gravel and sand	COUNTY: Prowers
INSPECTION TYPE: Monitoring	INSPECTOR(S): Amy Eschberger	INSP. DATE: June 14, 2018	INSP. TIME: 13:45
OPERATOR: Prowers Aggregate Operators, LLC	OPERATOR REPRESENTATIVE: Ron Peterson	TYPE OF OPERATION: 112c - Construction Regular Operation

REASON FOR INSPECTION: Citizen Complaint	BOND CALCULATION TYPE: None	BOND AMOUNT: \$575,000.00
DATE OF COMPLAINT: June 11, 2018	POST INSP. CONTACTS: Colorado Parks & Wildlife	JOINT INSP. AGENCY: Colorado Parks & Wildlife - Jim Ramsay
WEATHER: Clear	INSPECTOR'S SIGNATURE:

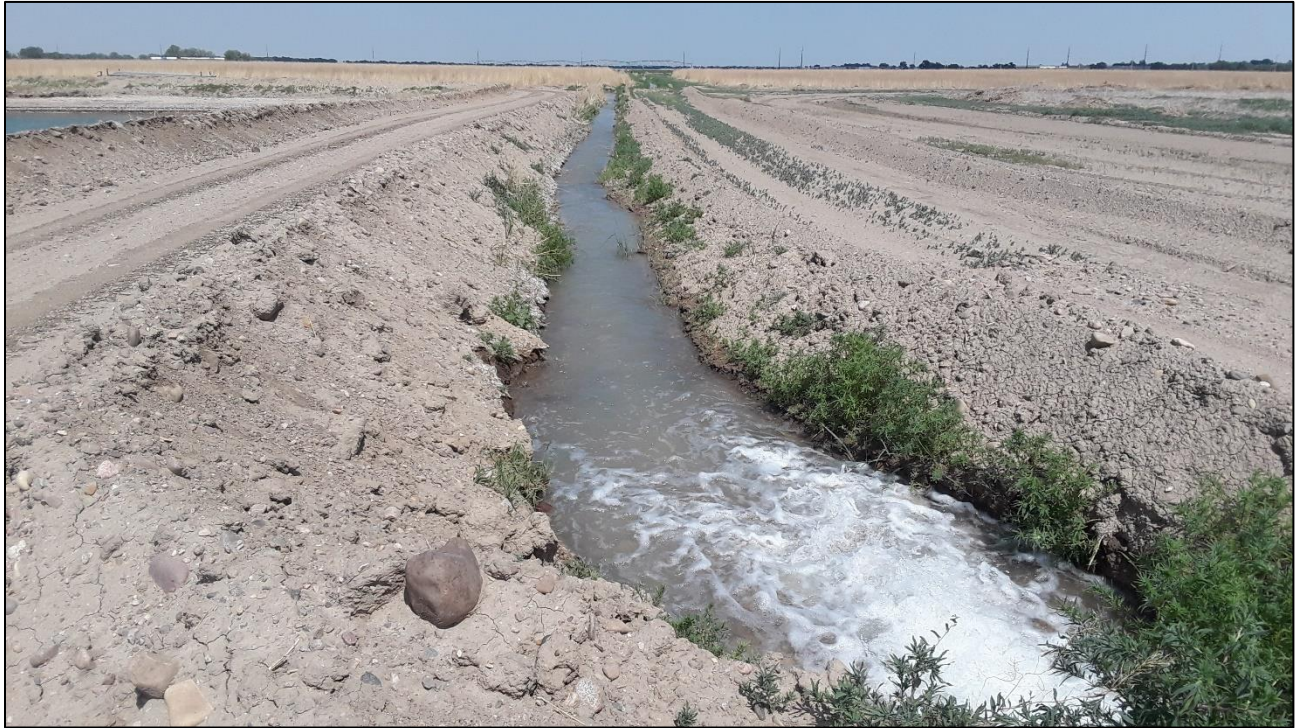
The operation has disturbed 177 acres, which is 60 acres more than the approved maximum disturbed area of 117 acres. Additionally, the operation is not following the mine phasing plan approved by Technical Revision No. 4 (TR-4), which proposed disturbances only in phases 1-4 and 13-18 at this time. The operation has created major disturbances (new pit, processing plant, large material stockpiles) in phases 8, 9, 11, and 12 (**Photos 17-19**), and minor disturbances (slurry wall installation) in phases 5, 6, 7, and 10. TR-4 authorized mining to occur only within the slurry-wall enclosed area of phases 1-4 (now filled with water; **Photos 20 and 21**). However, the operation completed mining the phase 1-4 area, and has begun excavating another pit in phases 8 and 11. The operation is pumping water from two pit floor sumps in the new pit and discharging the water to an adjacent ditch (**Photos 22 and 23**) which discharges to the river northeast of the mine site (east of the Lamar

Sewer Lagoons). This discharge activity is covered by the current discharge permit.

Photo 23. View looking east across ditch in which operation is currently discharging water from new pit excavation (shown in Photos 17 and 22). This activity is authorized by the current discharge permit.

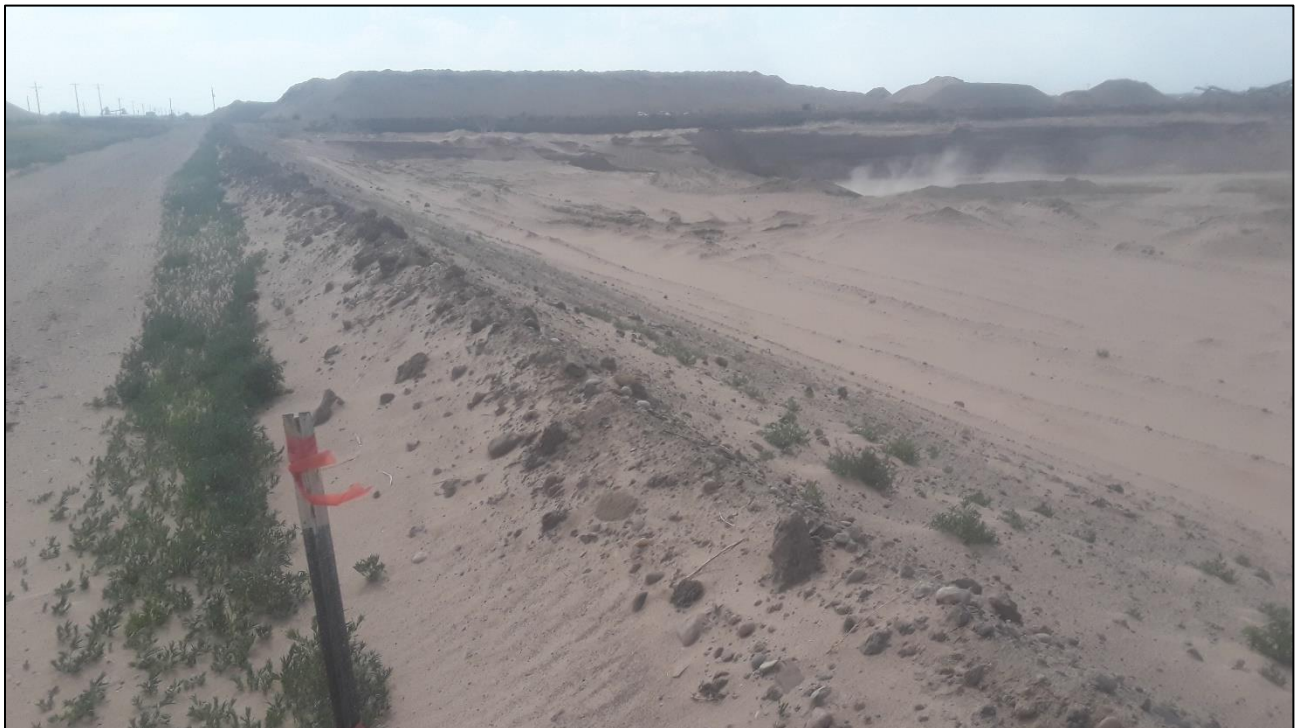
During the inspection, the Division found that an additional slurry wall had been installed in the North Mining Area (**Photo 24**), creating an L-shaped enclosure adjacent to the existing slurry-wall enclosed pit now being utilized as a reservoir. At the time of the inspection, the Division had not received any information on the new slurry wall, including design plans, specifications, or a quality assurance program. According to Mr. Peterson, the slurry wall was completed last year, and since then, the 90-day leak test was completed and the liner accepted by the SEO. However, at the time of the inspection, the Division had not received a final construction report including the results of any post-construction testing or as-built drawings of the slurry wall. The Division also had not received a copy of the SEO acceptance letter.

Photo 24. View looking west from southern edge of new pit excavation, showing new slurry wall installation (outlined by berm) that encloses phases 5-12. Metal stake in foreground marks outside edge of slurry wall.

After the inspection, the operator also emailed the Issued for Construction drawings for the new slurry wall enclosure. Based on the drawings submitted, the operator is now proposing to leave two slurry wall enclosed reservoirs in the North Mining Area. The approved reclamation plan calls for leaving only one slurry wall lined reservoir in the North Mining Area. Additionally, the approved reclamation plan map shows phase 13 (the wash plant area) to be included in the lined area. However, the new slurry wall enclosure does not include phase 13. The operator will need to revise the mining and reclamation plan maps to show the proposed operational and final configuration of the slurry walls.

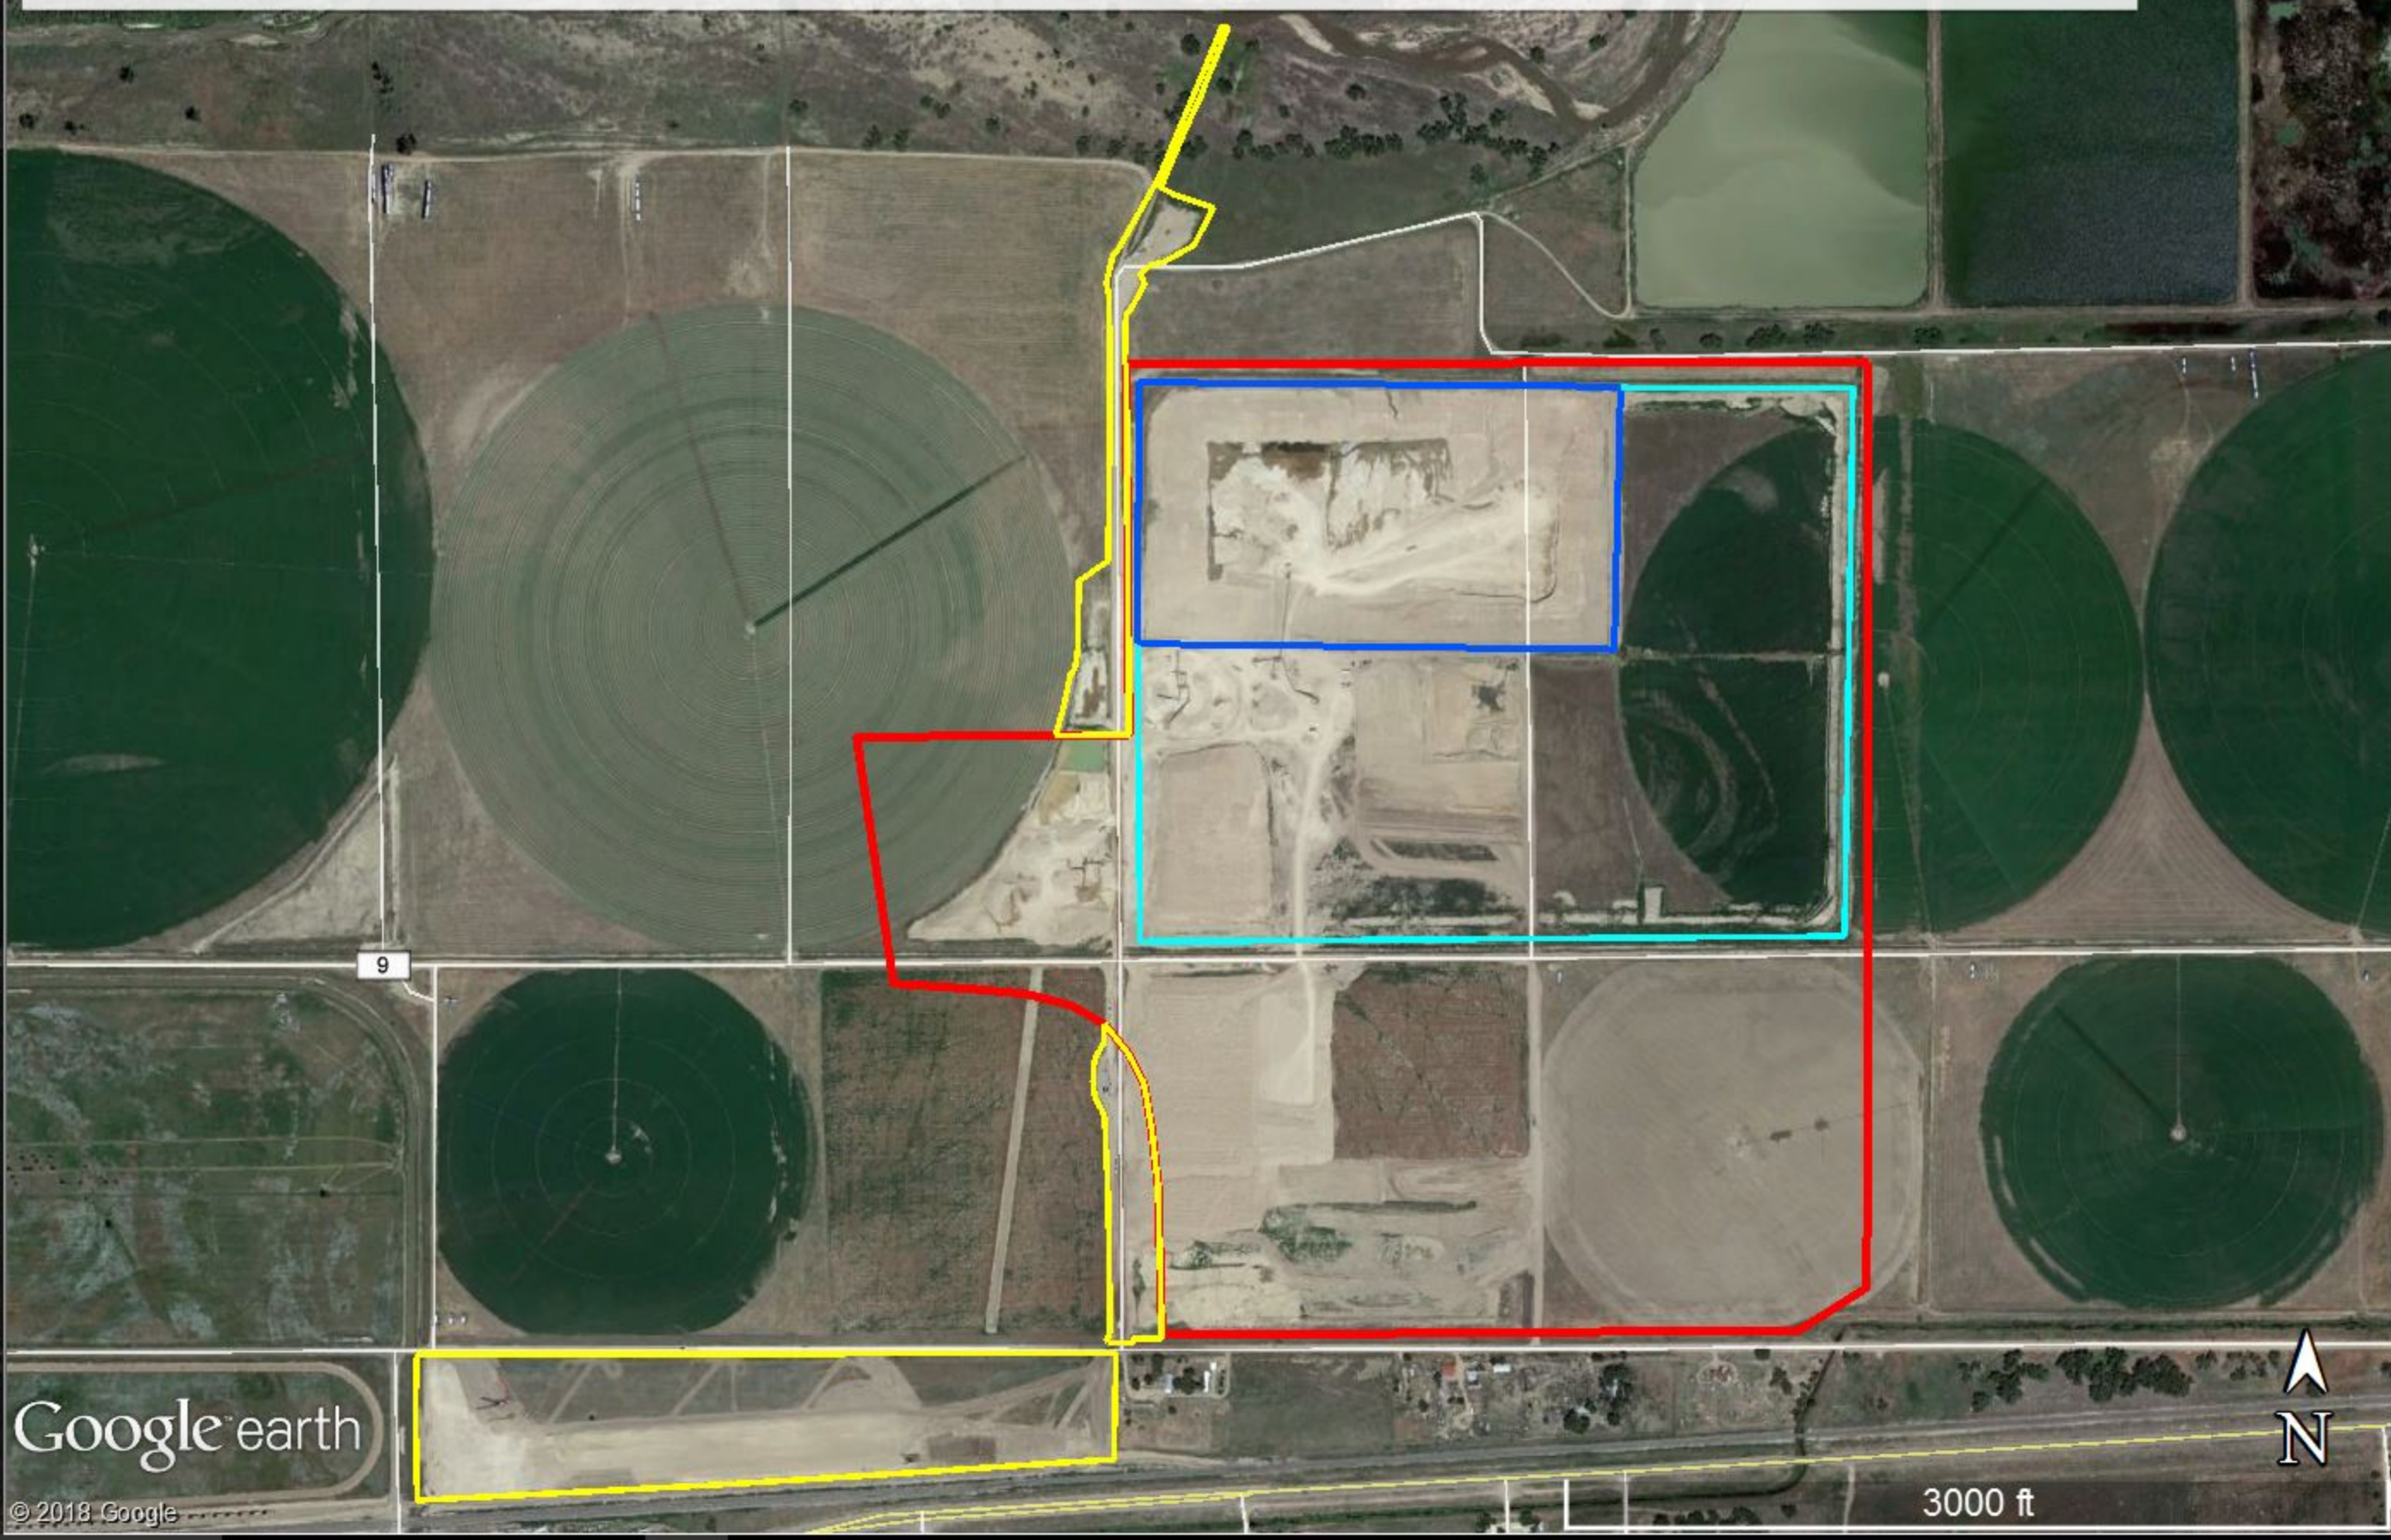
Red Outline = 233.40 acres = Approved Permit Area

Dark Blue Outline = 37.77 acres = Old Slurry Wall Enclosure (Phases 1-4)

Light Blue Outline = 81 acres = Approx. Location of New Slurry Wall Enclosure (Phases 5-12)

Yellow Outline = 37.52 acres = Off-site Affected Lands
