MINERALS PROGRAM INSPECTION REPORT
PHONE: (303) 866-3567

MINE NAME: Climax Mine	MINE/PROSPECTING ID#: M-1977-493	MINERAL: Molybdenum	COUNTY: Summit
INSPECTION TYPE: Multi Person Inspection	INSPECTOR(S): Lucas J. West	INSP. DATE: July 11, 2018	INSP. TIME: 09:00
OPERATOR: Climax Molybdenum Company	OPERATOR REPRESENTATIVE: Ray Lazuk, Diana Kelts, James Haag	TYPE OF OPERATION: 112d-3 - Designated Mining Operation	
REASON FOR INSPECTION: Normal I&E Program	BOND CALCULATION TYPE: None	BOND AMOUNT: \$78,246,088.00	
DATE OF COMPLAINT: NA	POST INSP. CONTACTS: None	JOINT INSP. AGENCY: None	
WEATHER: Clear	INSPECTOR'S SIGNATURE:

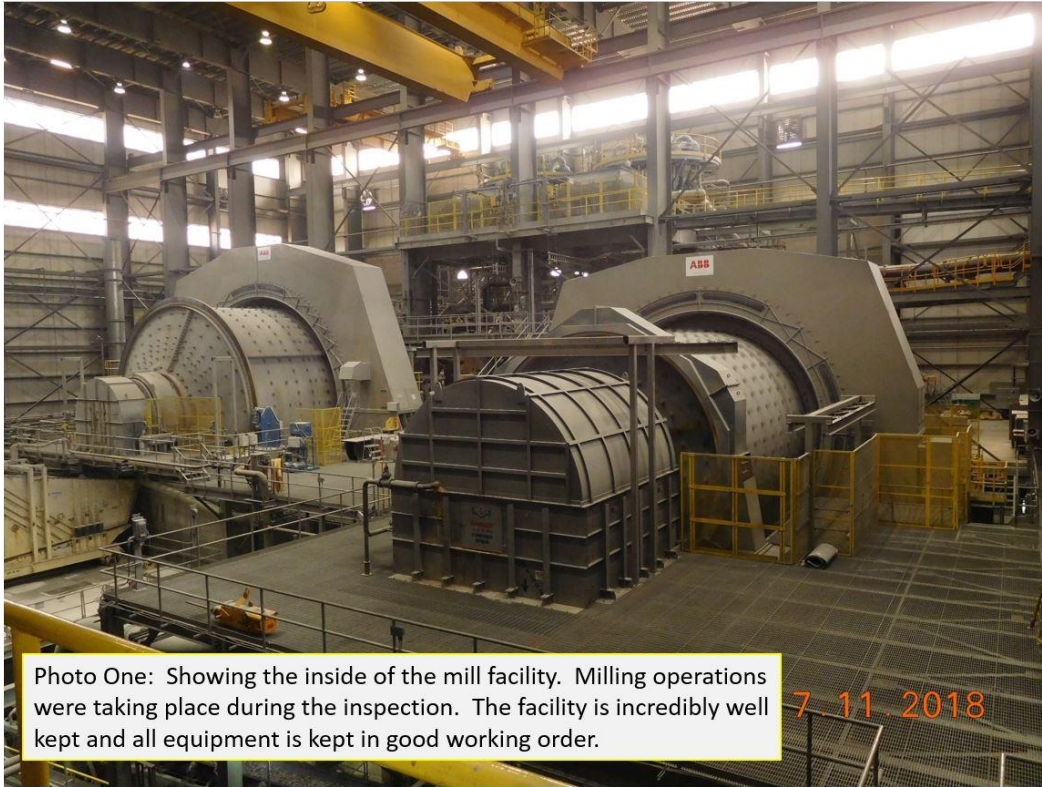
The purpose of this inspection was to familiarize Russ Means the Minerals Program Director with the operations of the site. This inspection was a full site tour and facilities inspection. The site was active during the inspection. The tour began in the mill facility, starting with the crusher gallery and mill room, leading into the floatation circuits. Photos One and Two show these facilities. The mill are and floatation circuit were operating during the inspection and appear to be functioning as designed. The facility as a whole was clean and well kept, all safety features, secondary containment structures and equipment observed was in good working order and no problems were noted in this facility.

Photo One: Showing the inside of the mill facility. Milling operations were taking place during the inspection. The facility is incredibly well kept and all equipment is kept in good working order.

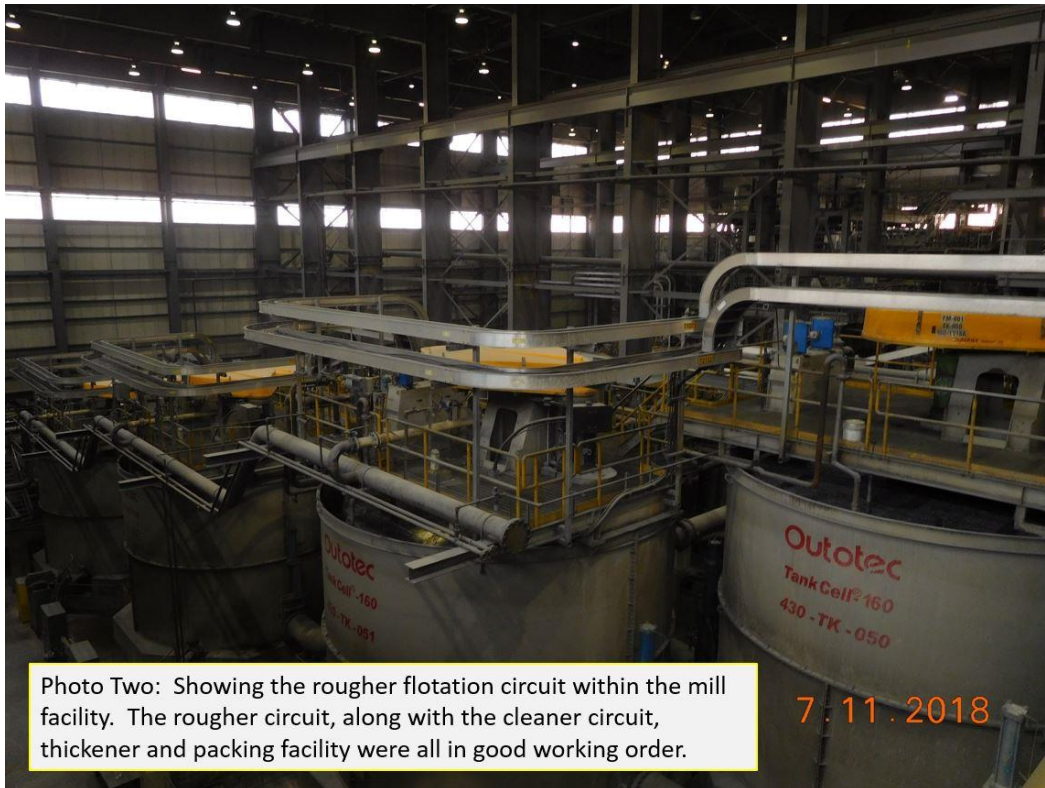
Photo Two: Showing the rougher flotation circuit within the mill facility. The rougher circuit, along with the cleaner circuit, thickener and packing facility were all in good working order.

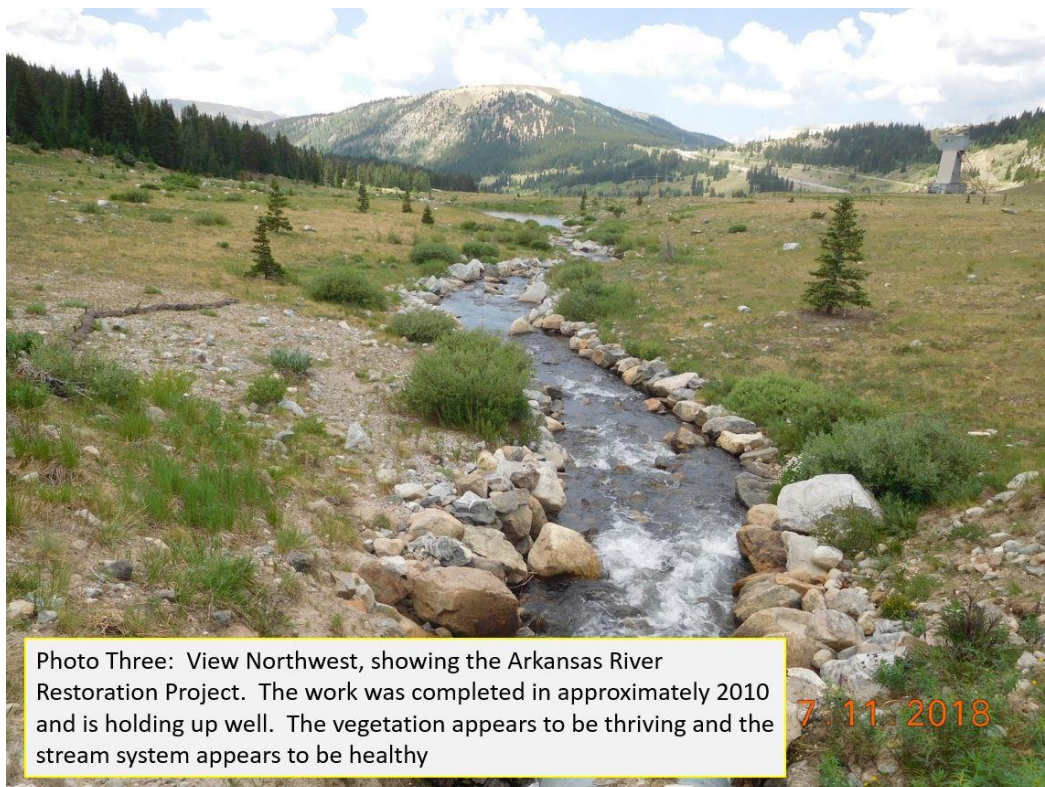
Photo Three: View Northwest, showing the Arkansas River Restoration Project. The work was completed in approximately 2010 and is holding up well. The vegetation appears to be thriving and the stream system appears to be healthy

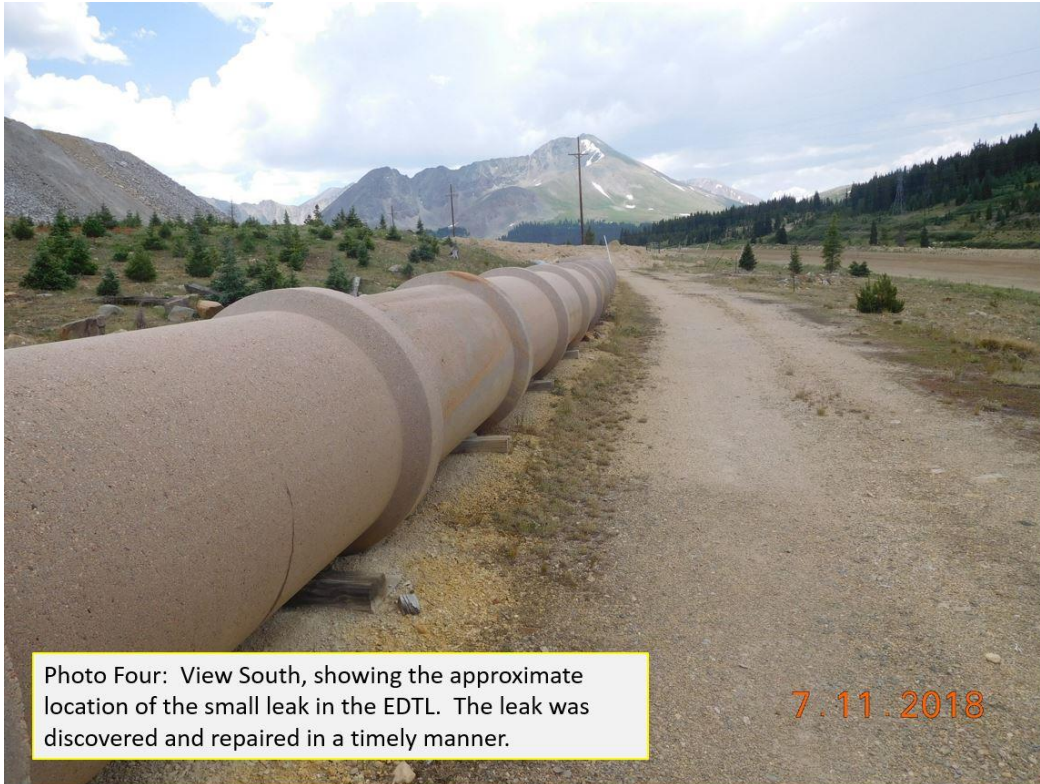
All water management systems including monitoring wells, fresh water storage ponds and pump back systems located in the Arkansas River Basin were also observed. All systems appeared to be functioning as designed and the Arkansas River Restoration Project area is in good condition. The vegetation in the restoration area appears healthy and thriving. The restoration area can be seen in Photo Three. Recently a small leak in the EDTL near the entrance to the site was reported, and repaired. The approximate area of the leak was observed and no signs of damage, erosion or slumping was observed. The leak happened in a section of the line that is contained within a secondary EPF that reports to the process water system. The approximate location of the leak can be seen in Photo Four.
