MINERALS PROGRAM INSPECTION REPORT
PHONE: (303) 866-3567

MINE NAME: Butala Pit	MINE/PROSPECTING ID#: M-1987-127	MINERAL: Limestone (general)	COUNTY: Chaffee
INSPECTION TYPE: Monitoring	INSPECTOR(S): Dustin M. Czaplá	INSP. DATE: July 11, 2018	INSP. TIME: 13:00
OPERATOR: Butala Construction Company	OPERATOR REPRESENTATIVE: Thomas Eve	TYPE OF OPERATION: 110c - Construction Limited Impact	
REASON FOR INSPECTION: Normal I&E Program	BOND CALCULATION TYPE: Complete Bond	BOND AMOUNT: \$54,336.00	
DATE OF COMPLAINT: NA	POST INSP. CONTACTS: None	JOINT INSP. AGENCY: None	
WEATHER: Clear	INSPECTOR'S SIGNATURE:

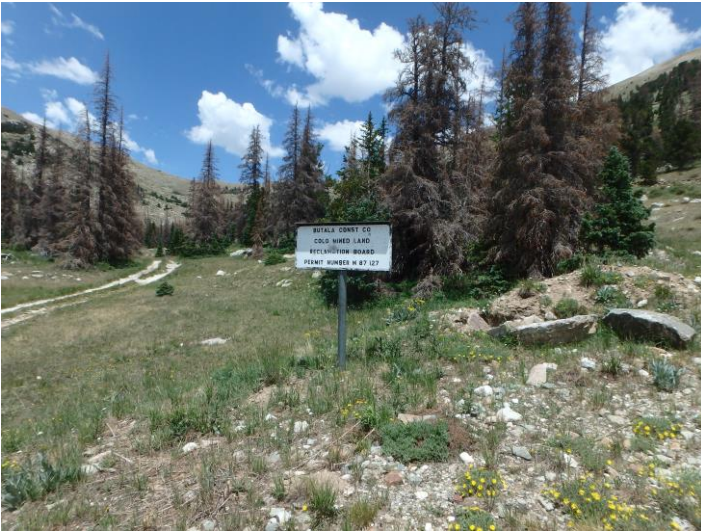
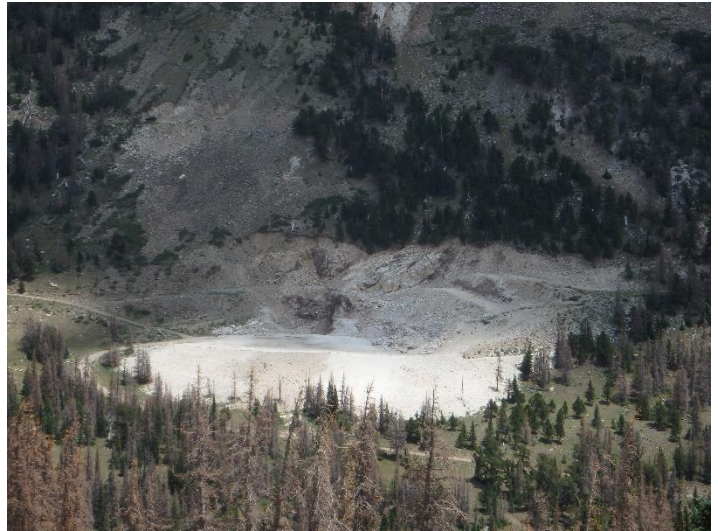
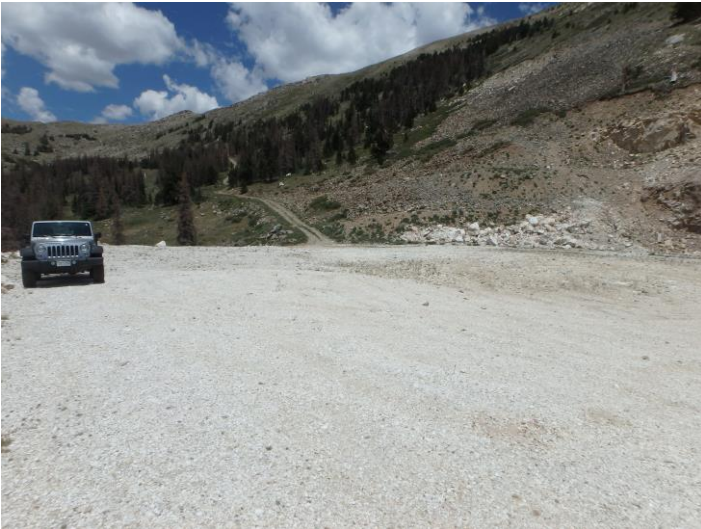
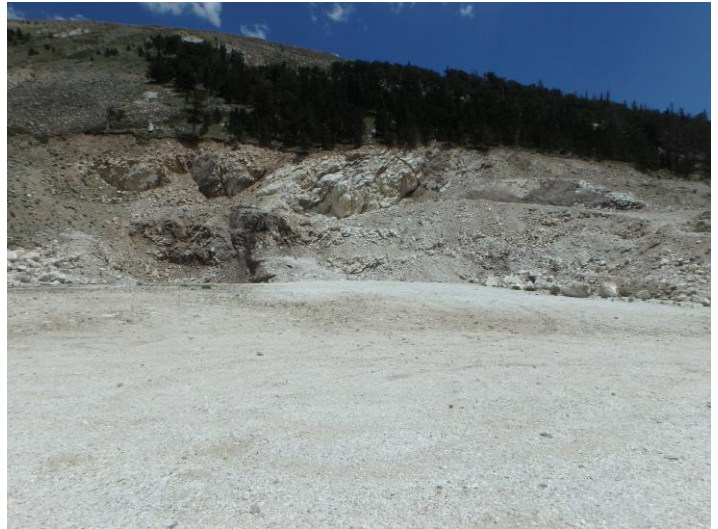
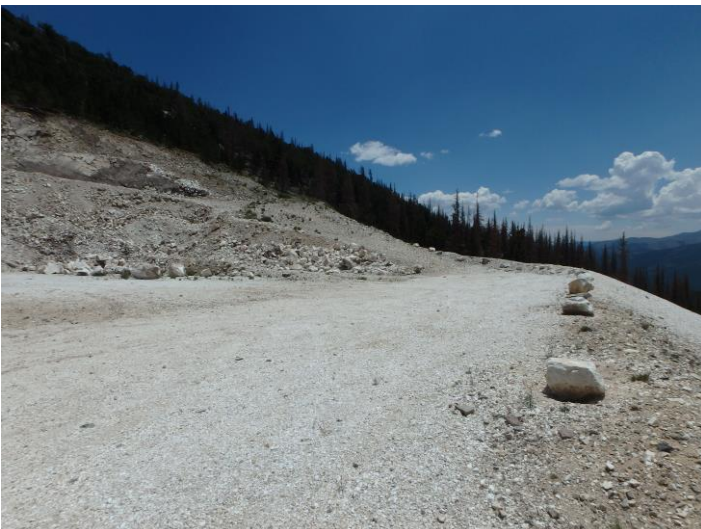
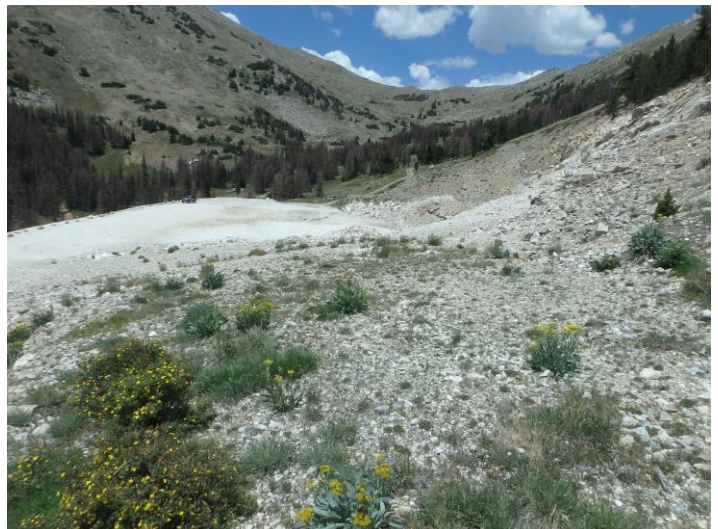
The highwall is approximately 65 feet high, spanning approximately 350 linear feet. Overburden and waste material is piled at the base of the wall.

Slopes around the mine bench are stable. No signs of excessive erosion were observed.
