MINERALS PROGRAM INSPECTION REPORT
PHONE: (303) 866-3567

| MINE NAME: Gold Links Mine | MINE/PROSPECTING ID#: M-1987-143 | MINERAL: Silver and gold | COUNTY: Gunnison |
| INSPECTION TYPE: Monitoring | INSPECTOR(S): Dustin M. Czaplá | INSP. DATE: June 19, 2018 | INSP. TIME: 13:00 |

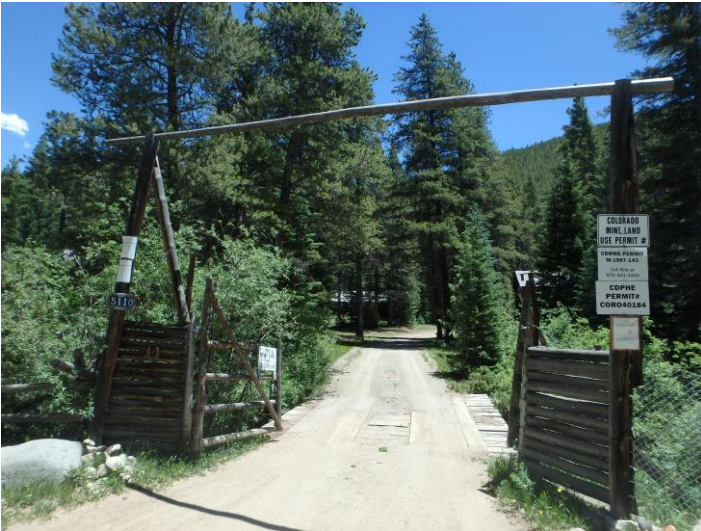
Adequate mine identification signage was noted at the entrance to the site.

Site entrance

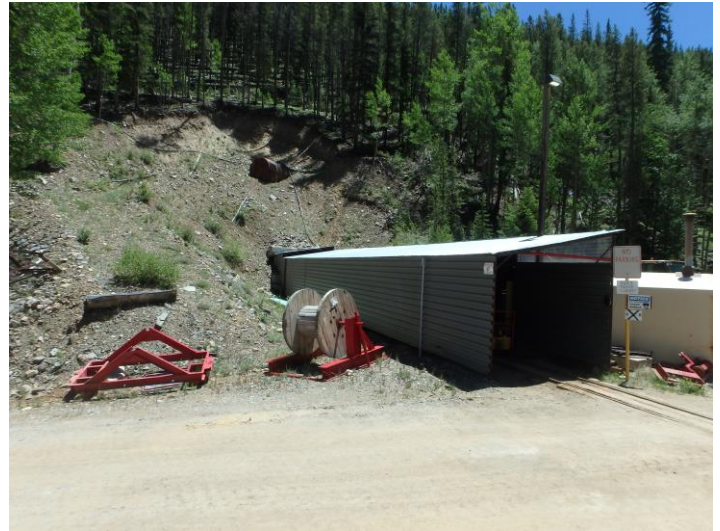
Portal secured with steel gate

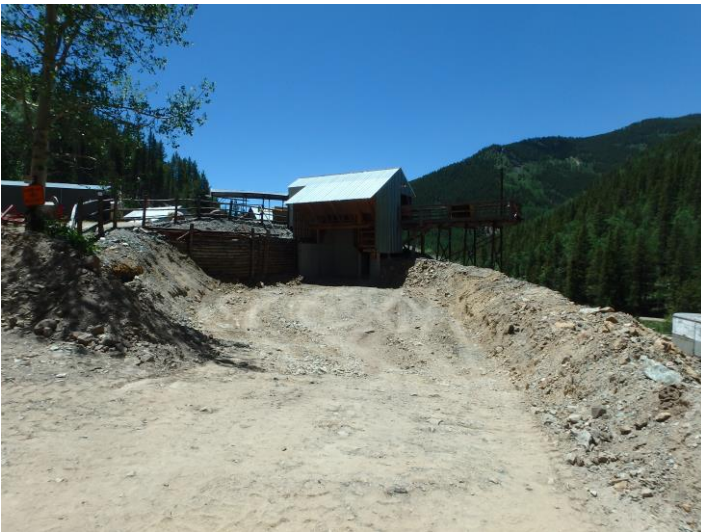
Load out area

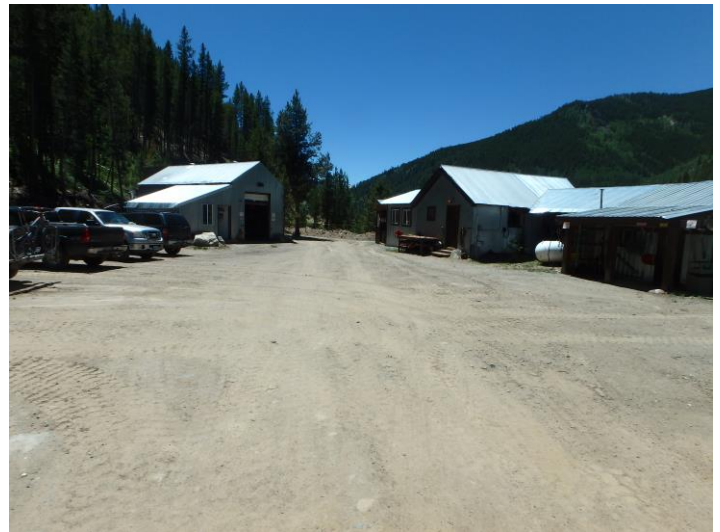
Parking/operations area

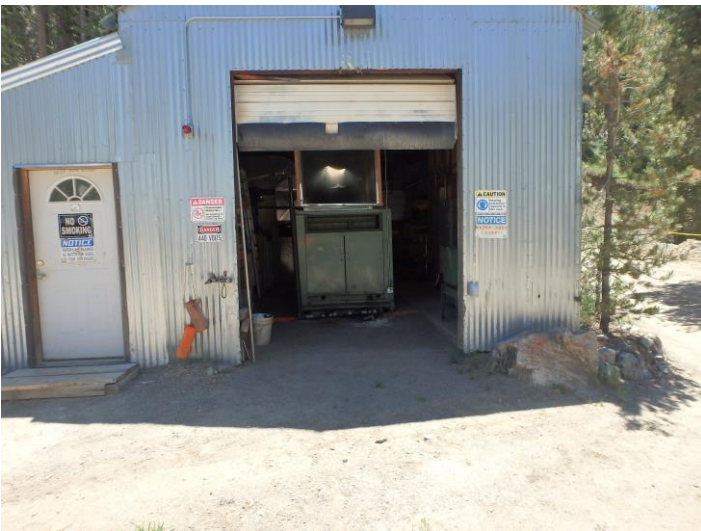
Generator building

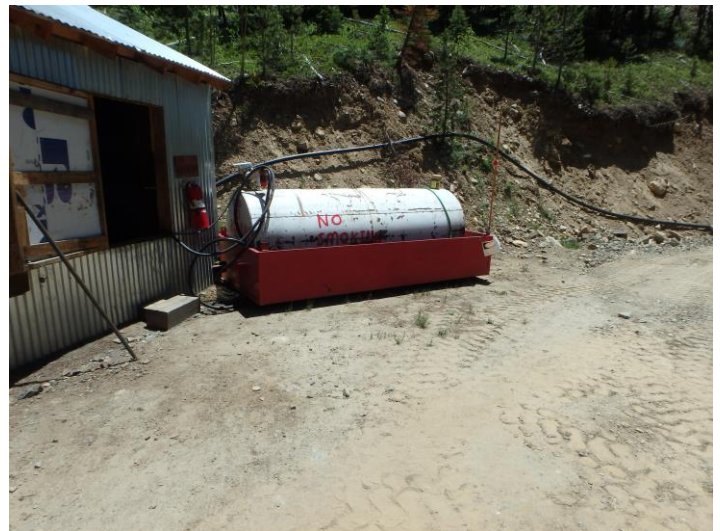
Fuel storage outside generator building

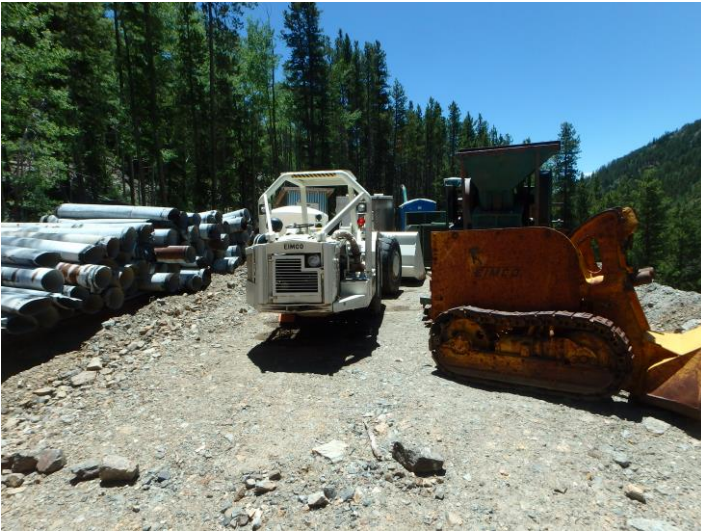
Storage area on south end of permit area

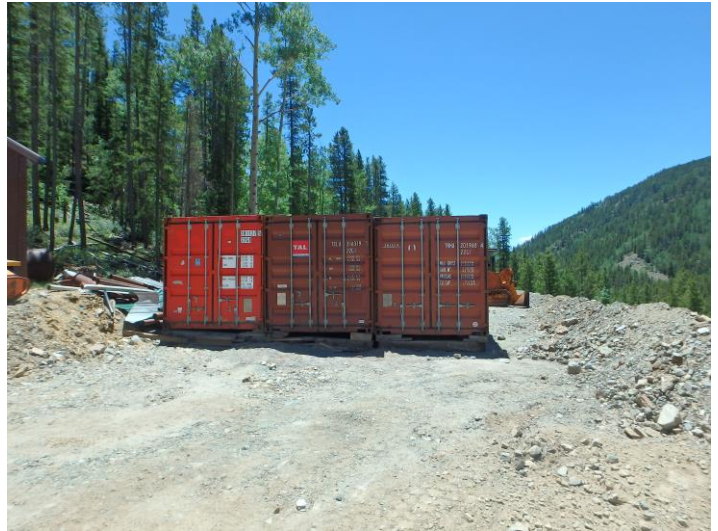
Storage area on south end of permit area

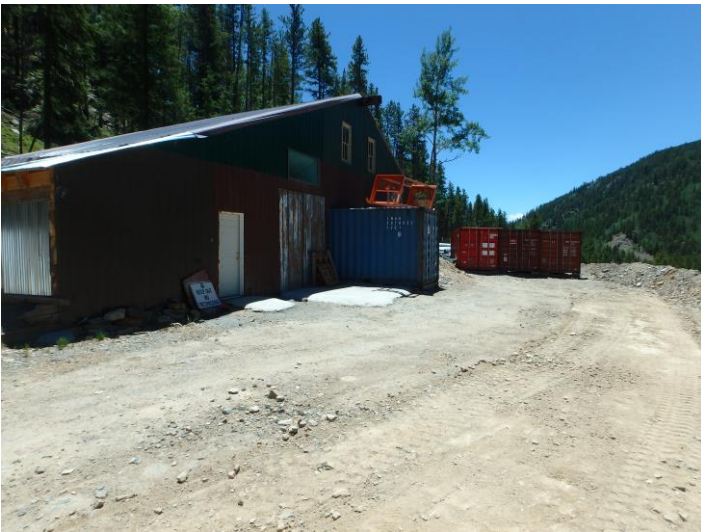
Concentrator building

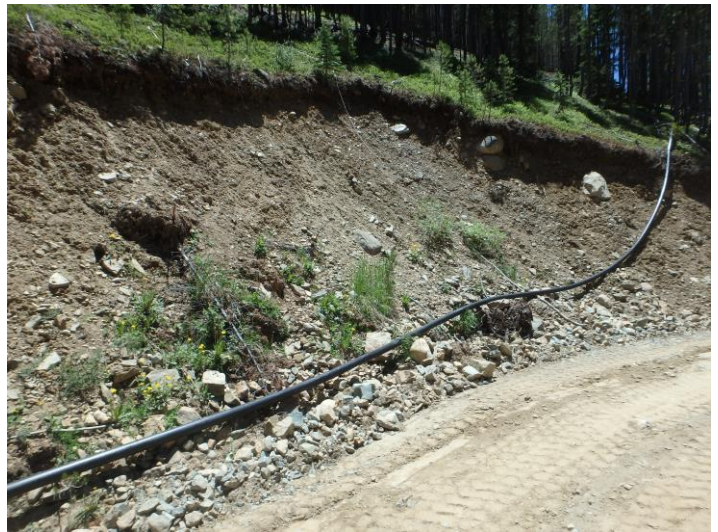
Location for TR-2 "storage" portal that was not constructed
