**MINERALS PROGRAM INSPECTION REPORT****PHONE: (303) 866-3567**

<b>MINE NAME:</b> Hopemore Shaft	<b>MINE/PROSPECTING ID#:</b> M-2013-026	<b>MINERAL:</b> Gold	<b>COUNTY:</b> Lake
<b>INSPECTION TYPE:</b> Monitoring	<b>INSPECTOR(S):</b> Dustin M. Czaplá	<b>INSP. DATE:</b> June 26, 2018	<b>INSP. TIME:</b> 11:00
<b>OPERATOR:</b> Lockland, LLC	<b>OPERATOR REPRESENTATIVE:</b> Robert Caulder	<b>TYPE OF OPERATION:</b> 110(2) - Hard Rock Limited Impact	
<b>REASON FOR INSPECTION:</b> Normal I&E Program	<b>BOND CALCULATION TYPE:</b> Complete Bond	<b>BOND AMOUNT:</b> \$32,500.00	
<b>DATE OF COMPLAINT:</b> NA	<b>POST INSP. CONTACTS:</b> None	<b>JOINT INSP. AGENCY:</b> None	
<b>WEATHER:</b> Clear	<b>INSPECTOR'S SIGNATURE:</b>

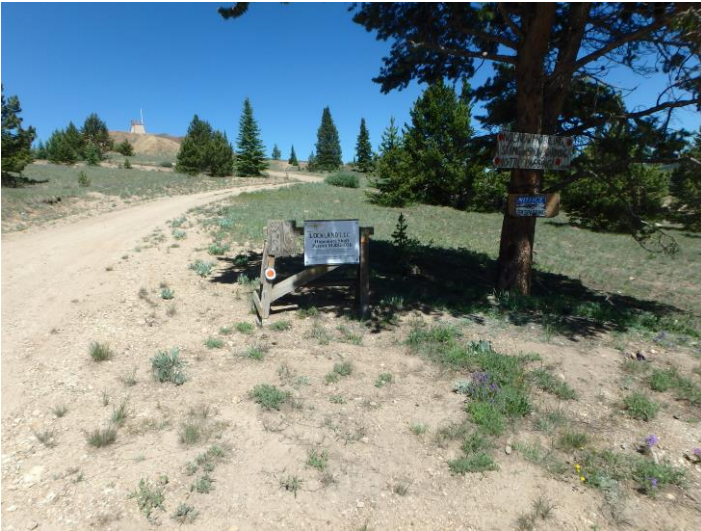
Mine Entrance

Adequate mine identification signage was noted at the entrance to the site.

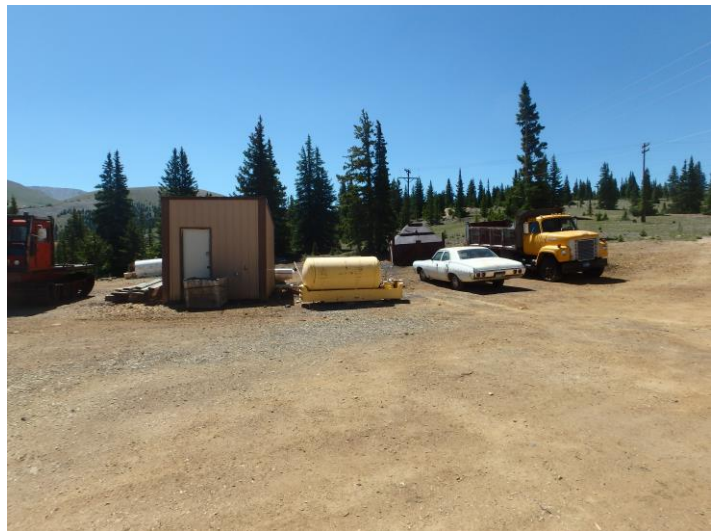
Storage around Hopemore building
