# MINERALS PROGRAM INSPECTION REPORT PHONE: (303) 866-3567

MINE/PROSPECTING ID#:	MINERAL:	COUNTY:		
M-2016-084	Gold and silver	Gunnison		
<b>INSPECTOR(S):</b>	INSP. DATE:	INSP. TIME:		
Dustin M. Czapla	June 19, 2018	14:00		
OPERATOR REPRESENTATIVE:	TYPE OF OPERATION:			
Jake Wilkinson	110(2) - Hard Rock Limited Impact			
REASON FOR INSPECTION: BOND CALCULATION TYPE: BOND AMOUNT:				
BOND CALCULATION TYPE:	BOND AMOUNT:			
None	\$7,600.00			
POST INSP. CONTACTS:	JOINT INSP. AGE	NCY:		
None	None			
INSPECTOR'S SIGNATURE:	SIGNATURE DAT	<b>E:</b>		
06	July 9, 2018			
The				
	M-2016-084 INSPECTOR(S): Dustin M. Czapla OPERATOR REPRESENTATIVE: Jake Wilkinson  BOND CALCULATION TYPE: None POST INSP. CONTACTS: None	M-2016-084  INSPECTOR(S): Dustin M. Czapla  OPERATOR REPRESENTATIVE: Jake Wilkinson  BOND CALCULATION TYPE: None POST INSP. CONTACTS: None INSPECTOR'S SIGNATURE:  Gold and silver INSP. DATE: TYPE OF OPERA 110(2) - Hard Rock  BOND AMOUNT: \$7,600.00 JOINT INSP. AGE None INSPECTOR'S SIGNATURE:

PERMIT #: M-2016-084 INSPECTOR'S INITIALS: DMC INSPECTION DATE: June 19, 2018

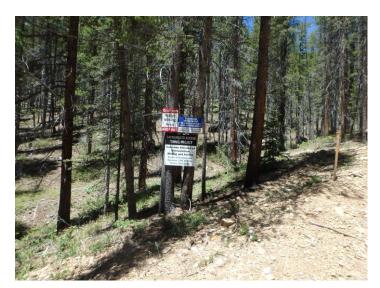
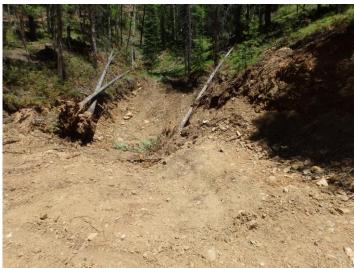
The Sacramento Access Tunnel is located approximately five miles north of Ohio City and accessed from FR 879. The site is a 110(2) operation that includes a total of 5.55 permitted acres. The Division currently holds a financial warranty amount of \$7,600.00 for this site. The application was approved February 10, 2017. The only activity that has occurred at the site so far is some minor clearing/grading in the portal area.

Adequate mine identification signage was noted at the entrance to the site.
