Division of Reclamation,
Mining and Safety

MINERALS PROGRAM INSPECTION REPORT

MINE NAME: Olathe Pit	MINE/PROSPECTING ID#: M-1984-108	MINERAL: Sand and gravel	COUNTY: Montrose
INSPECTION TYPE: Monitoring	INSPECTOR(S): Dustin M. Czapla	INSP. DATE: June 20, 2018	INSP. TIME: 13:00
OPERATOR: Western Gravel, Inc.	OPERATOR REPRESENTATIVE: None	TYPE OF OPERATION: 110c - Construction Limited Impact

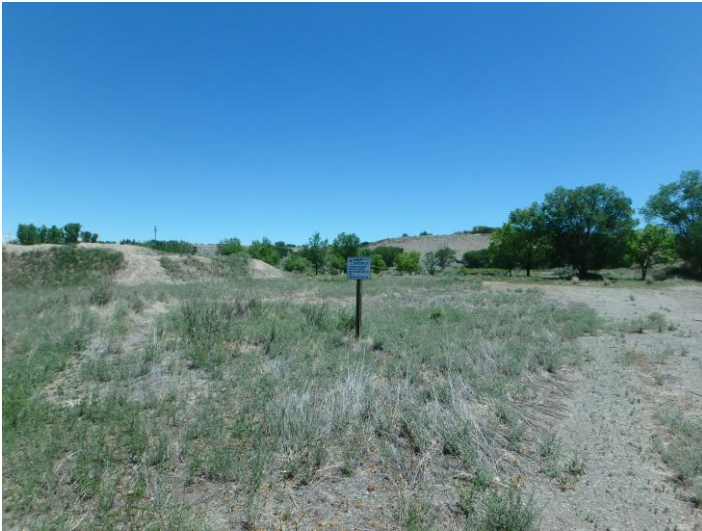
Adequate mine identification signage was noted at the entrance to the site.

Mine ID at entrance and knapweed infestation.

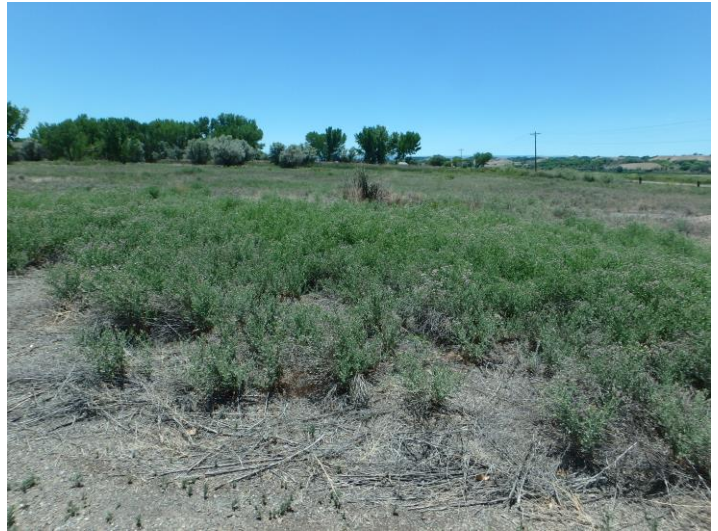
PROBLEM/POSSIBLE VIOLATION: Problem: There are state-listed noxious weeds (knapweed) present on site. This is a problem for failure to employ weed control methods for state listed noxious weed species within the permitted area, and to reduce the spread of weeds to nearby areas as required by Section 3.1.10 (6) of the rule.

It appears that nearly all of the upland areas within the permit boundary are heavily infested with Russian knapweed, a state listed noxious weed. This is considered a serious problem, and is listed as such along with corrective actions on page one of this report.

Knapweed infestation

CORRECTIVE ACTIONS: Employ weed control measures to treat the knapweed infestations and provide proof to the Division that this has been done.

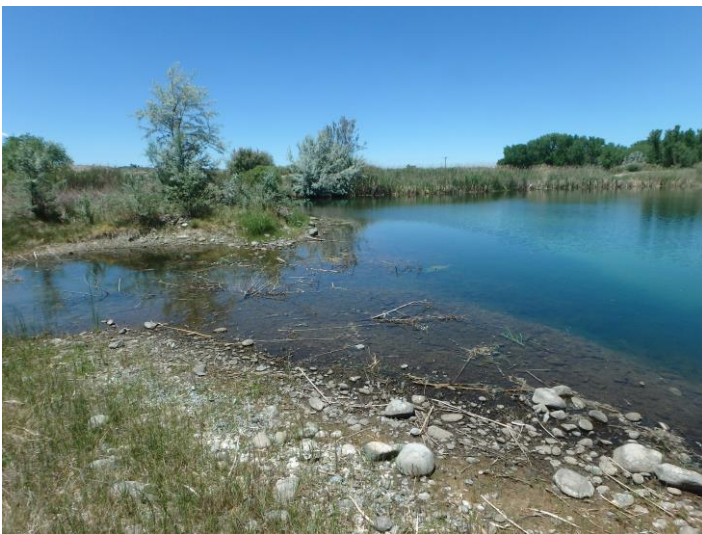
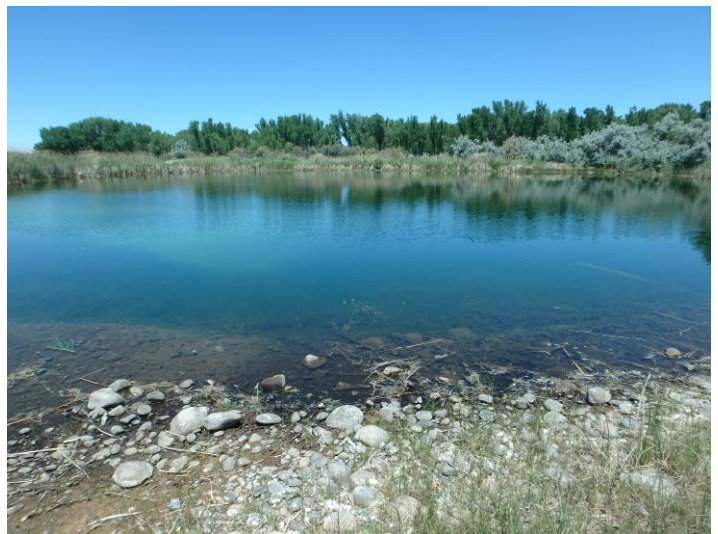
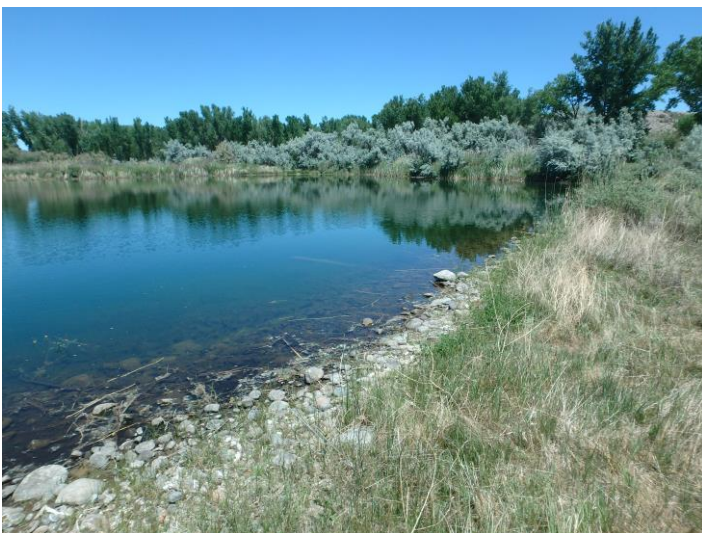
The north pond has been reclaimed. Slopes are graded to 3H:1V or flatter, and are well vegetated. Noxious weed infestations were not noted around the pond slopes, however, upland areas surrounding the pond are heavily infested with Russian knapweed.

North pond

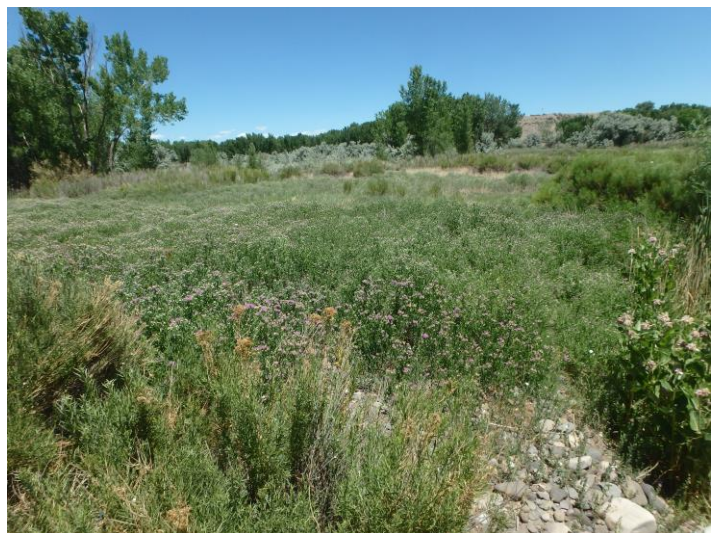
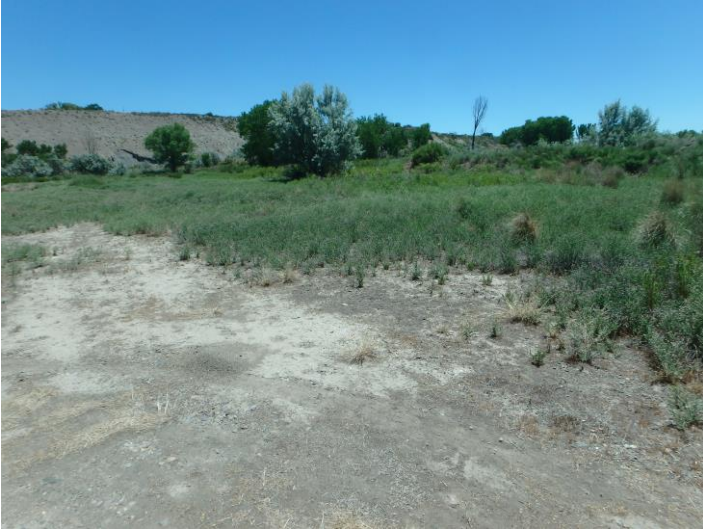
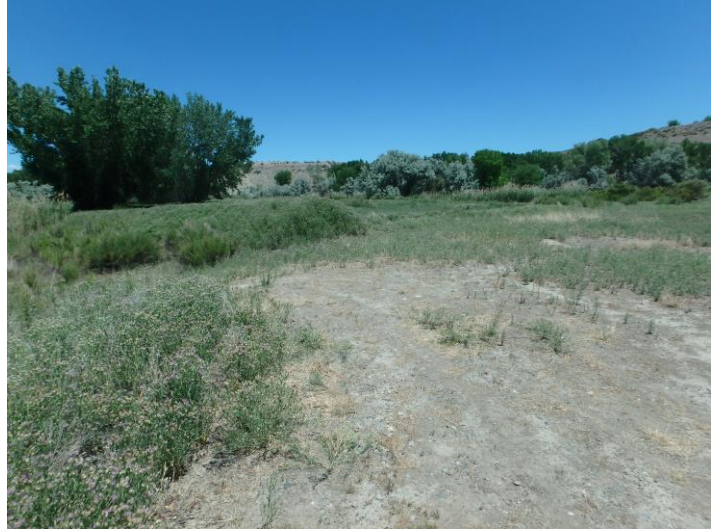
Knapweed infestation between ponds

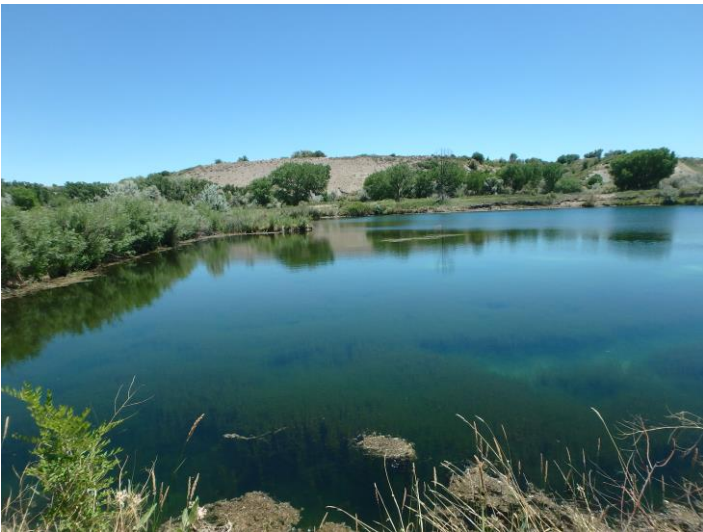
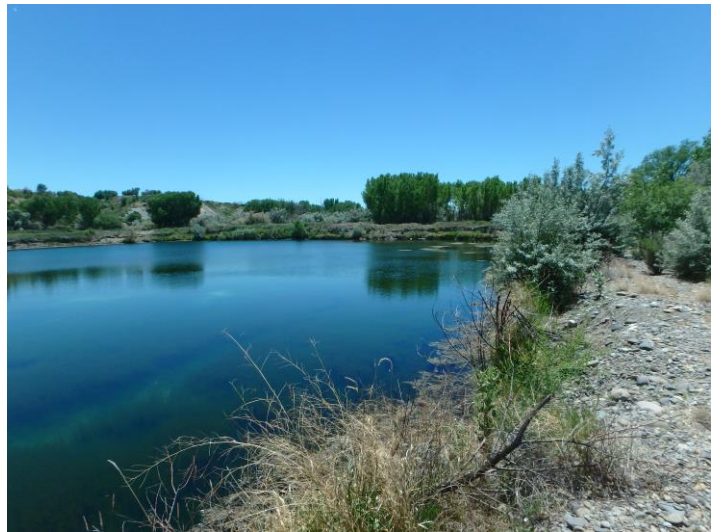
The south pond is not reclaimed. Pond slopes range from near vertical to roughly 1H:1V where sloughing has occurred. The pond appears to be three to four feet deep, below the water level. The upland areas around the south pond are also heavily infested with Russian knapweed.

South pond
