MINERALS PROGRAM INSPECTION REPORT

MINE NAME: Tamarcaz Pit	MINE/PROSPECTING ID#: M-1985-072	MINERAL: Sand and gravel	COUNTY: Gunnison
INSPECTION TYPE: Monitoring	INSPECTOR(S): Dustin M. Czapla	INSP. DATE: June 19, 2018	INSP. TIME: 09:30
OPERATOR: Gunnison County	OPERATOR REPRESENTATIVE: None	TYPE OF OPERATION: 110c - Construction Limited Impact

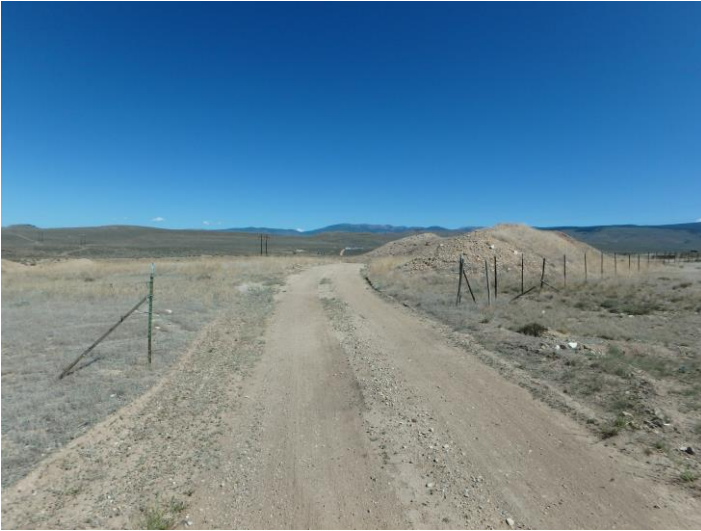
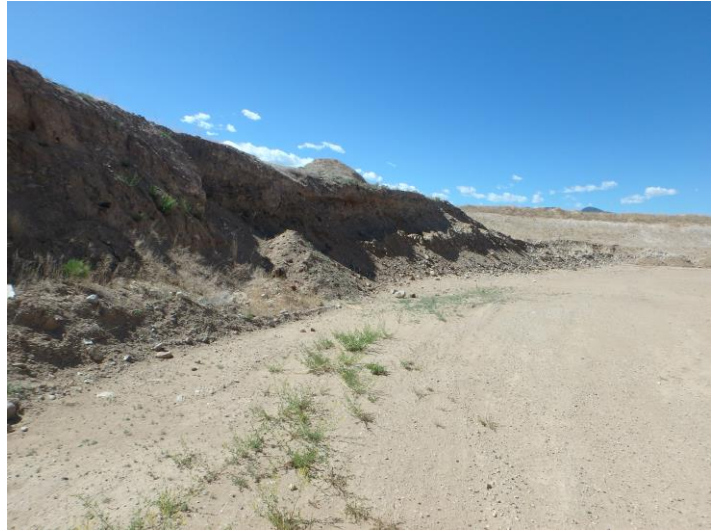
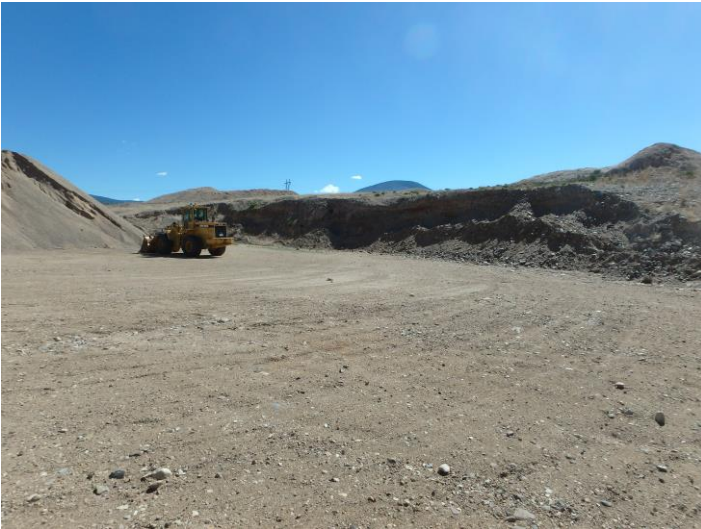
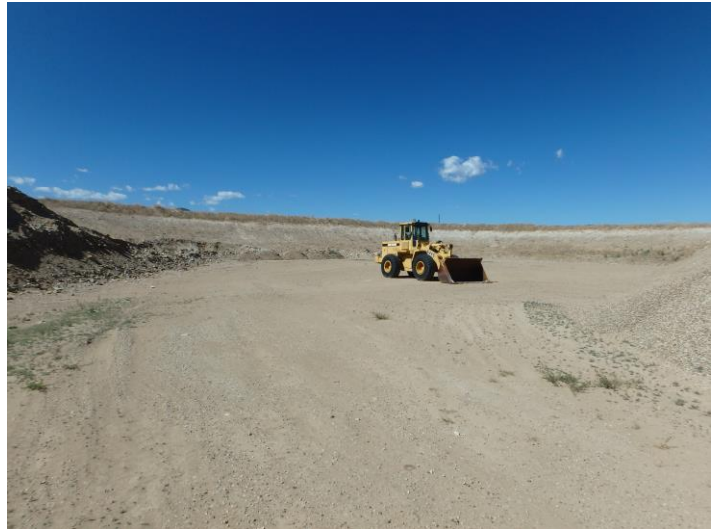
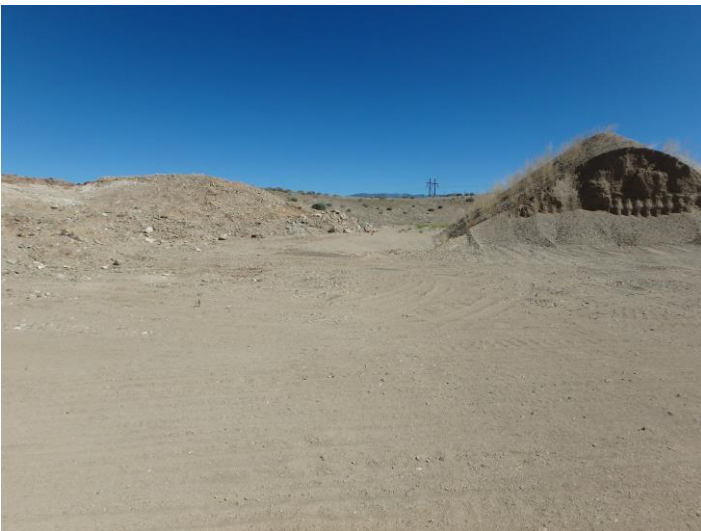
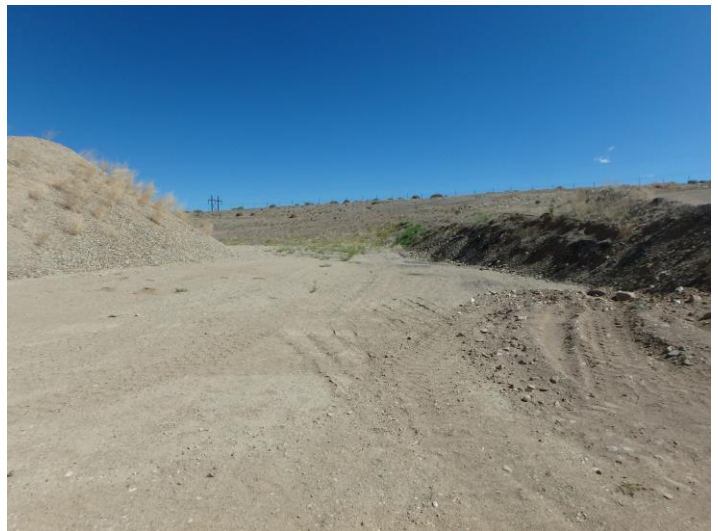
PHOTOGRAPHS

Adequate mine identification signage was not noted at the entrance to the site. This has been noted as a problem.

The affected area was marked by fencing that was clearly visible and adequate to delineate the affected area boundary.

The county typically mines and crushes enough material to last for approximately three years, so active mining/processing is infrequent at this site. Most of the slopes around the pit have been graded to 2H:1V or less. A portion of the east highwall is near vertical and 10-15 feet high. The slopes that have been reseeded show minimal growth at this time.

Gravel stockpiles were located on the pit floor. Topsoil stockpiles were located at the northeast rim of the pit.
