**COLORADO**Division of Reclamation,  
Mining and Safety

**MINERALS PROGRAM INSPECTION REPORT****PHONE: (303) 866-3567**

<b>MINE NAME:</b> Lily Mines	<b>MINE/PROSPECTING ID#:</b> M-1987-028	<b>MINERAL:</b> Marble	<b>COUNTY:</b> Chaffee
<b>INSPECTION TYPE:</b> Monitoring	<b>INSPECTOR(S):</b> Dustin M. Czaplá	<b>INSP. DATE:</b> July 11, 2018	<b>INSP. TIME:</b> 12:00
<b>OPERATOR:</b> Monarch Mountain Minerals and Aggregates,	<b>OPERATOR REPRESENTATIVE:</b> Eric Leigh	<b>TYPE OF OPERATION:</b> 112c - Construction Regular Operation

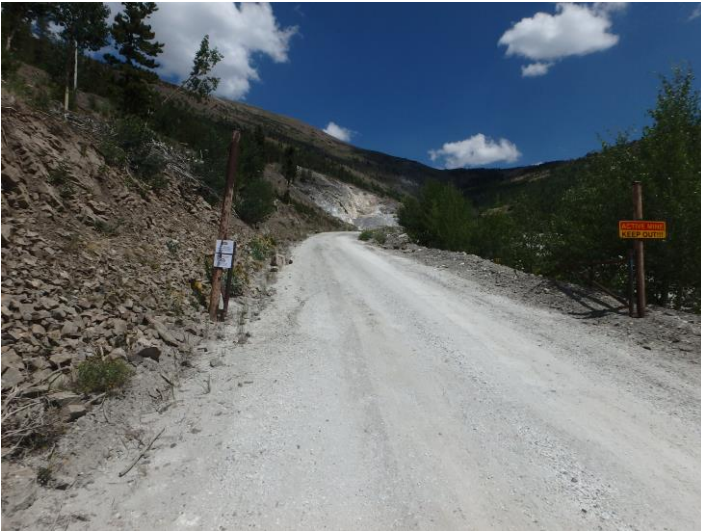
Adequate mine identification signage was noted at the entrance to the site.

Adequate sign at mine entrance

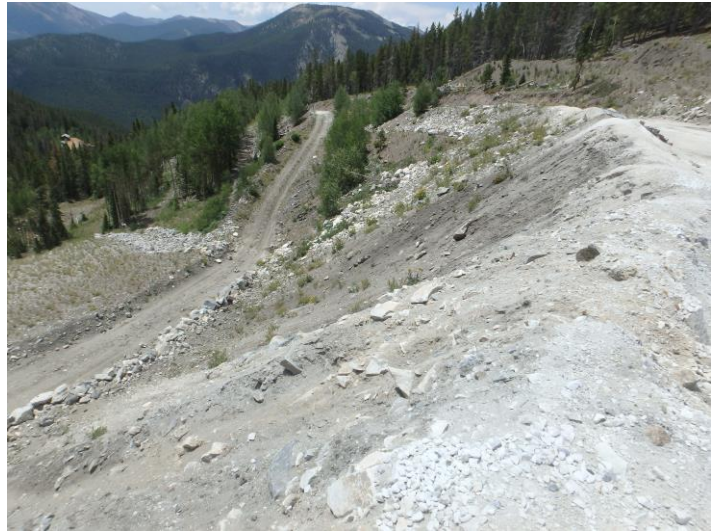
View from the stockpile bench

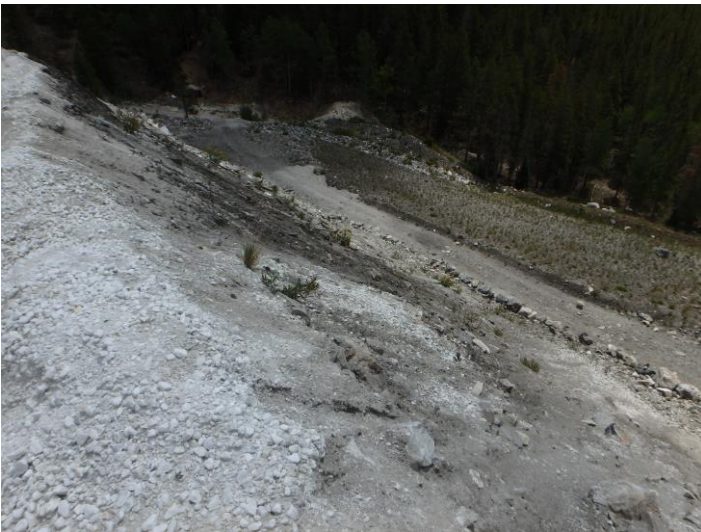
View from the stockpile bench

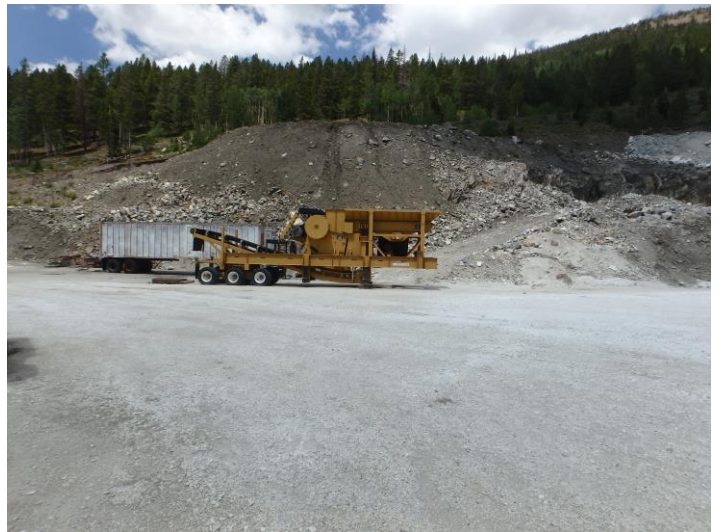
Stockpile bench

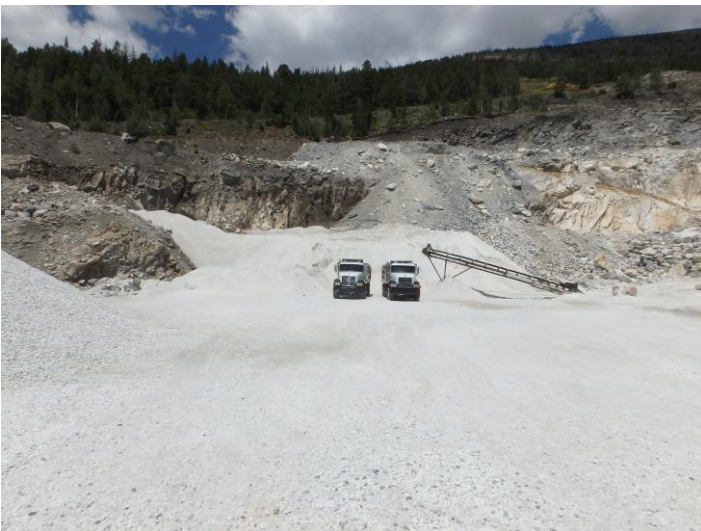
Stockpile bench

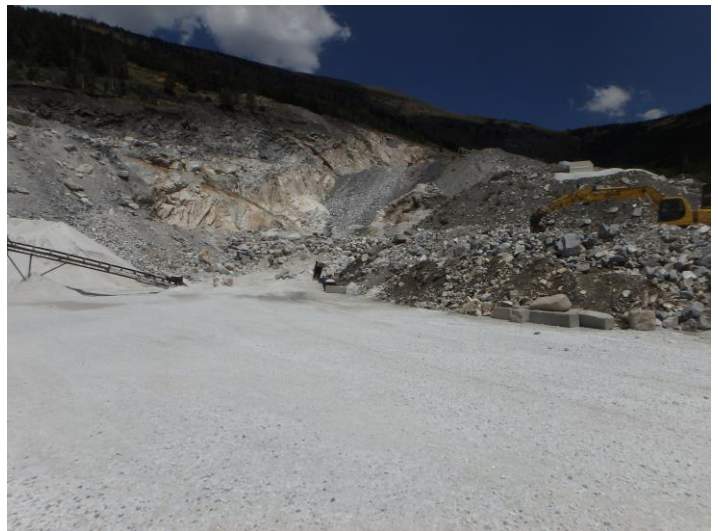
Stockpile bench

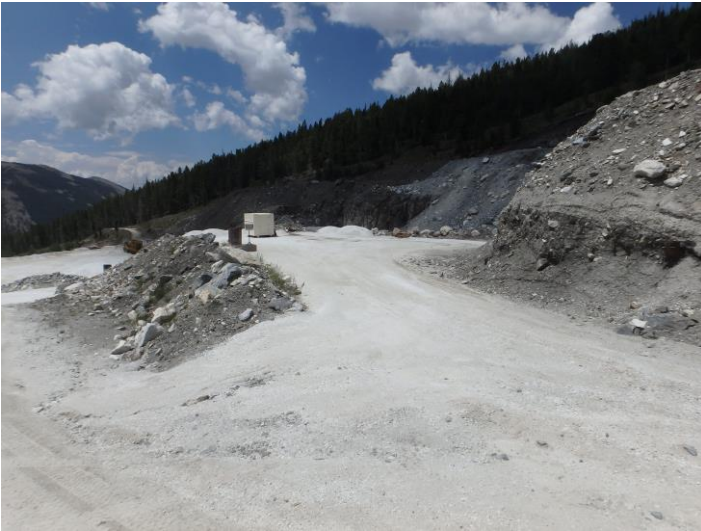
Explosives storage located on bench below active mining area

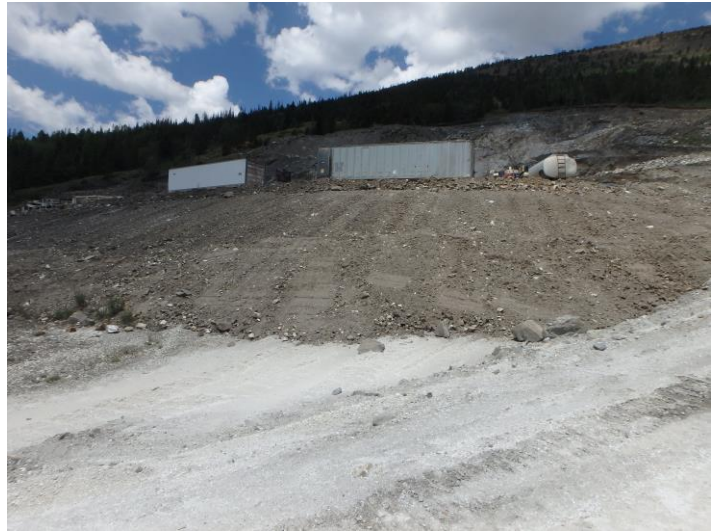
Slope below active operations bench

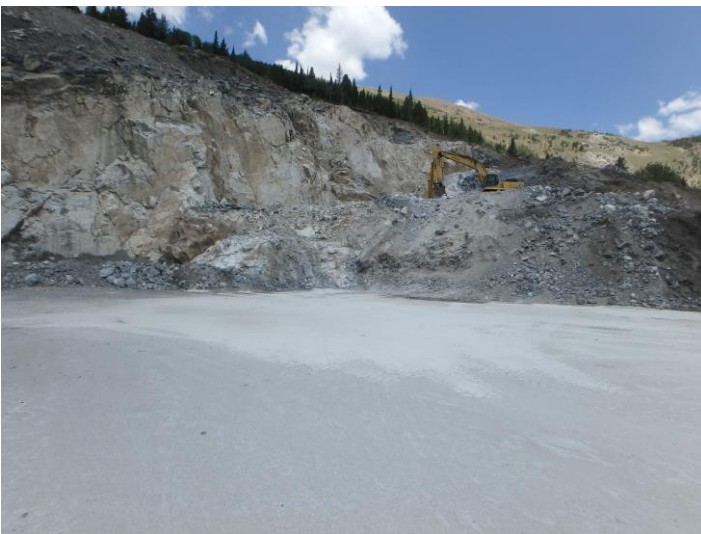
Current mining/operations area

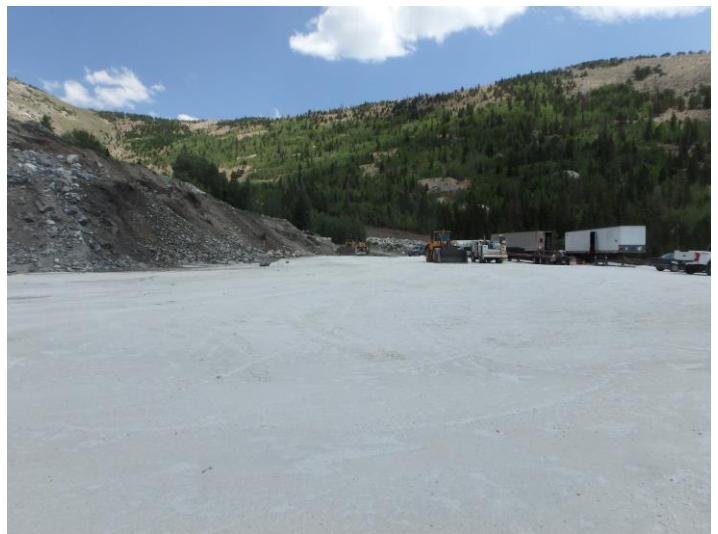
Current mining/operations area

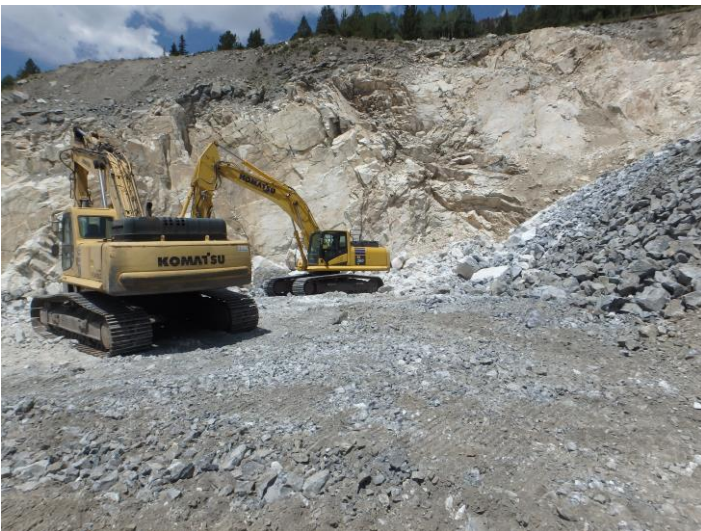
Current mining area

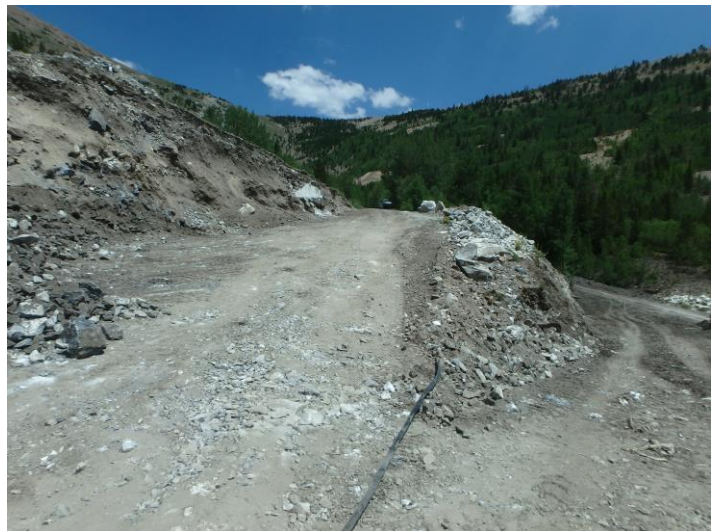
Current mining area

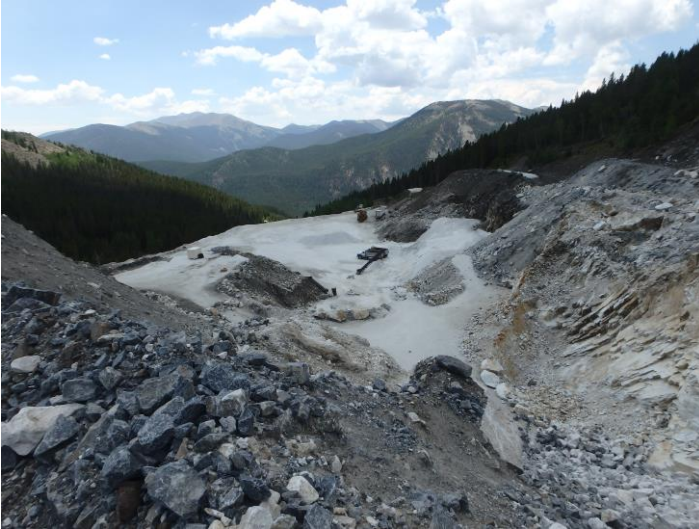
View from upper mine bench

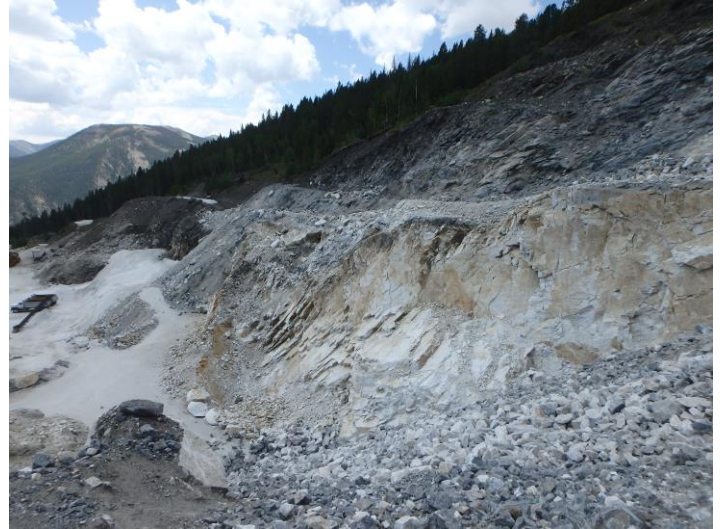
View from upper mine bench
