**COLORADO**Division of Reclamation,
Mining and Safety

MINERALS PROGRAM INSPECTION REPORT**PHONE: (303) 866-3567**

MINE NAME: Upper Gold Links Mine	MINE/PROSPECTING ID#: M-2016-083	MINERAL: Silver and gold	COUNTY: Gunnison
INSPECTION TYPE: Monitoring	INSPECTOR(S): Dustin M. Czapla	INSP. DATE: June 19, 2018	INSP. TIME: 13:30
OPERATOR: CRG Mining, LLC	OPERATOR REPRESENTATIVE: Jake Wilkinson	TYPE OF OPERATION: 110(2) - Hard Rock Limited Impact

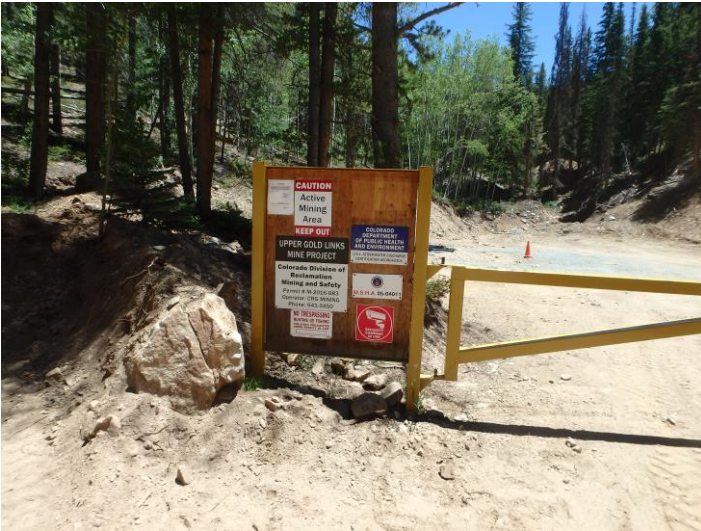
Adequate mine identification signage was noted at the entrance to the site.

Entrance to mine site

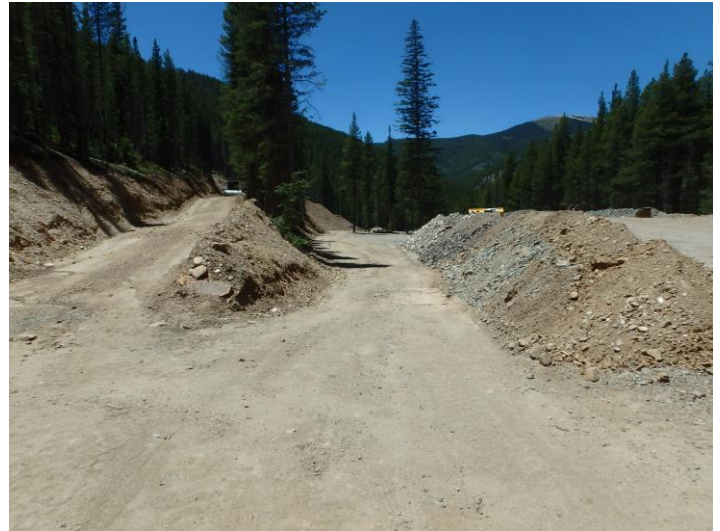
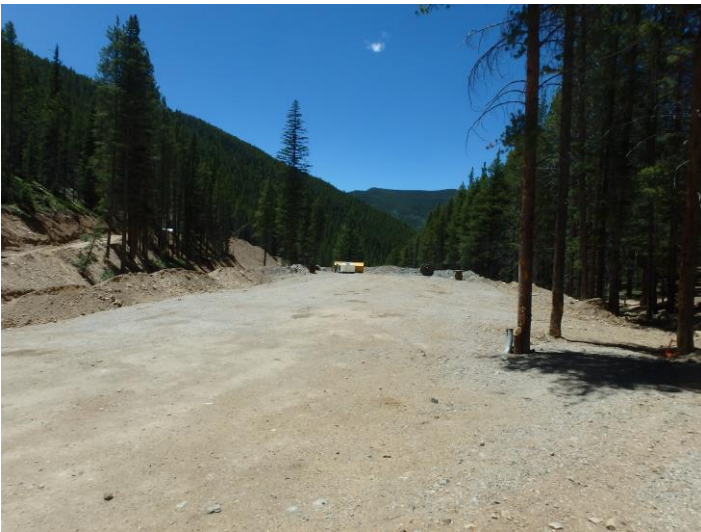
Site development has commenced at the site. The 24" CMP has been installed in the "dry" gulch, underneath the waste rock pad, and the stormwater retention pond has been constructed. These features appear adequate and in compliance with the approved mine plan. However, at the upper end of the gulch, the reclamation material/topsoil salvaged from the site has been buried and used to create a flat pad area. This is noted above as a problem with corresponding corrective actions. Pursuant to C.R.S. 34-32-116 (7)(f) and the approved mine plan, topsoil is to be segregated from other spoil and salvaged for later use during reclamation. The approved mine plan map clearly shows the stockpile storage location for the salvaged topsoil.

View of the constructed waste rock dump

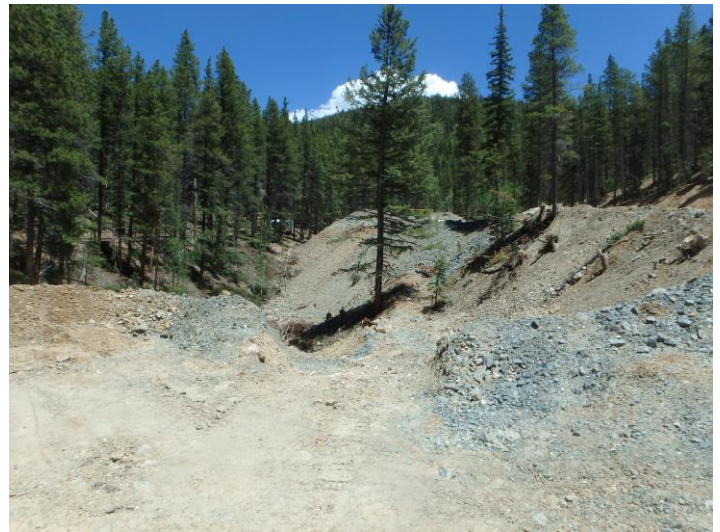
Looking up the gulch from below the waste rock dump

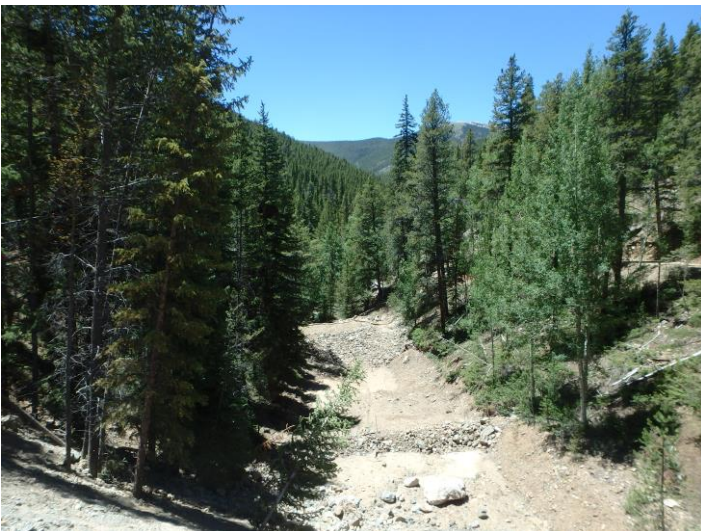
Looking down from the waste rock dump to the stormwater pond

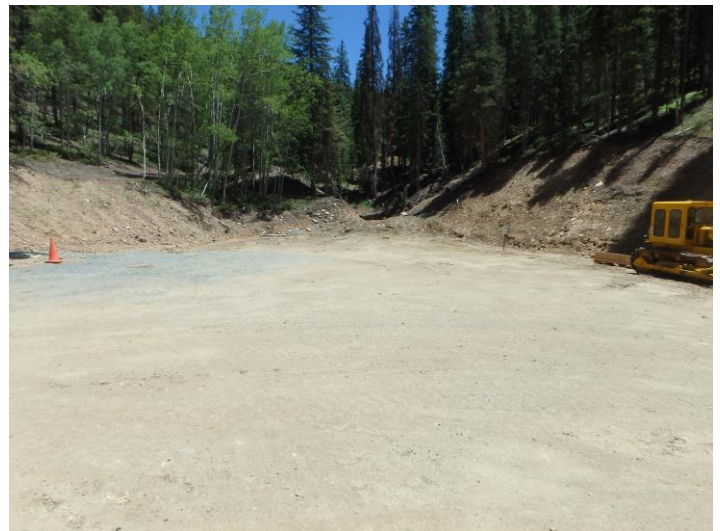
PROBLEM/POSSIBLE VIOLATION: Problem: The top soil/reclamation material has been buried in a pad area at the east end of the permit area. Pursuant to the Act, Rules and approved mine plan topsoil is to be salvaged and stored in a configuration where it will be protected from erosion and disturbance from ongoing mining operations.

Pad area constructed with buried topsoil/reclamation material

CORRECTIVE ACTIONS: The operator shall remove the topsoil from where it is currently buried and place it in the topsoil storage location shown on the Exhibit E Mine Plan map. Once the topsoil is stockpiled, a vegetative cover should be established on it in order to minimize wind and rain erosion, and further deterioration of the topsoil.

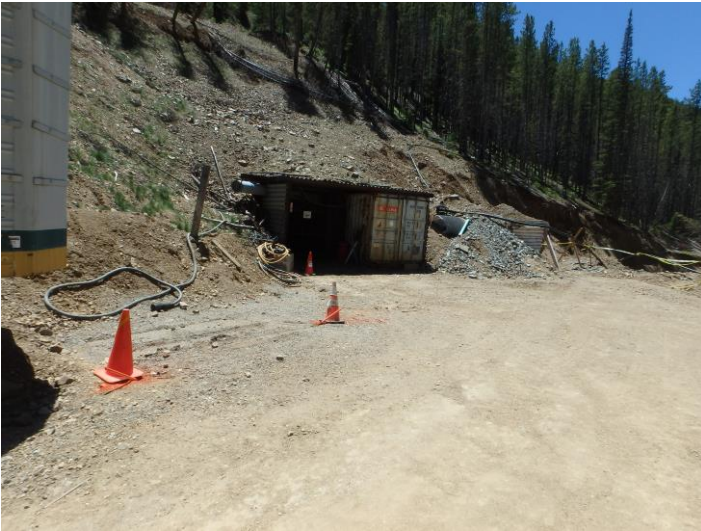
400 Level Portal

The 400 Level portal is secured with a locked steel gate.

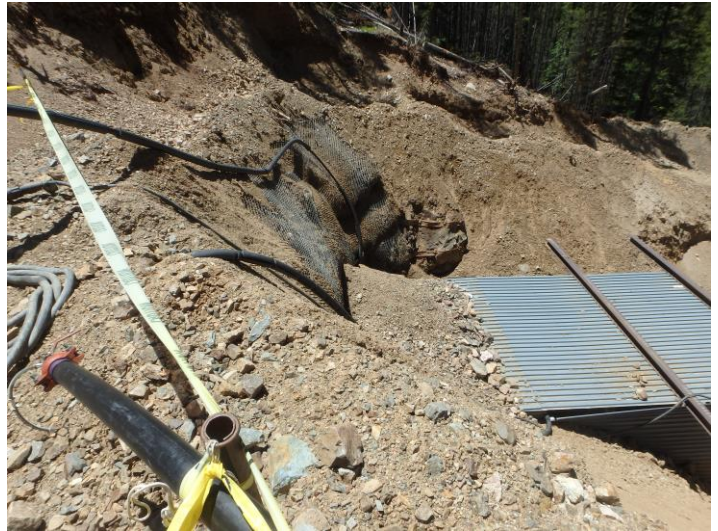
PROBLEM/POSSIBLE VIOLATION: Problem: The approved mine plan allowed for a new portal and tunnel to be driven at the 300 Level with dimensions 8-ft height by 7-ft width. The portal and tunnel constructed by the operator are approximately 15-ft high by 15 ft wide, and therefore do not comply with the approved mine plan.

The 300 Level portal has been reopened. The approved mine plan allowed for reopening the portal with dimensions 8-ft high by 7-ft wide. The operator has constructed the portal and driven tunnel with dimensions approximately 15-ft high by 15-ft wide. This is noted above as a problem with corresponding corrective actions. Due to the size of the portal opening the Division has concerns regarding the stability of the portal itself, as well as the slope surrounding the portal. These stability issues, portal construction and reclamation measures will need to be addressed through a technical revision to the permit.

Looking down on the 300 Level Portal

CORRECTIVE ACTIONS: Submit a technical revision to the permit that addressess the 300 Level portal construction and reclamation. The revision should include design criteria and final construction details for the constructed portal, geotechnical stability analysis for the portal, geotechnical stability analysis for the slope surrounding the portal, and final closure details, reclamation plan and long-term stability analysis for the reclaimed portal.

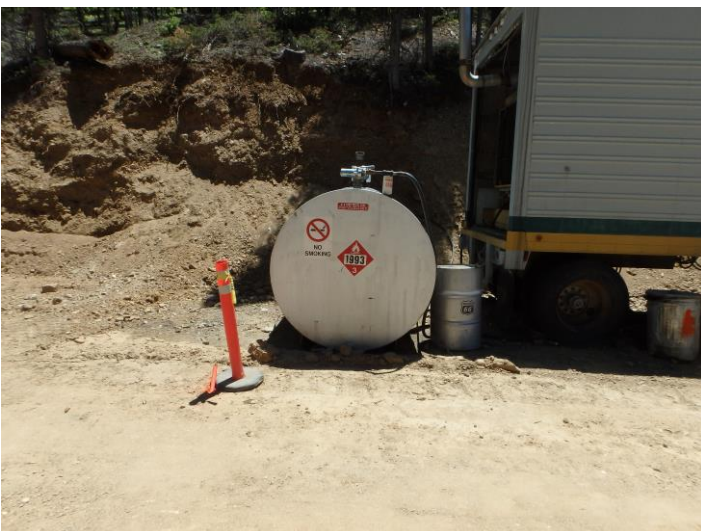
Fuel observed on site was stored in a double-wall container.

Fuel storage in double wall container
