Permit Number: C-1981-028 Mine Name: Keenesburg Strip Mine Operator: Coors Energy Company Operator Address: Mr. Danny Kipp P.O Box 467 Golden , CO 80402	County: Weld Operation Type: Surface Permit Status: Active Ownership: Private
	Operator Representative Present: Mark Quinby
Operator Representative Signature: (Field Issuance Only)

Inspection Start Date: July 18, 2018 Inspection Start Time: 08:00 Inspection End Date: July 18, 2018 Inspection End Time: 12:15		Inspection Type: Coal Partial Inspection Inspection Reason: Normal I&E Program Weather: Clear	
Joint Inspection Agency: None		Joint Inspection Contacts: 	
Post Inspection Agency: None		Post Inspection Contacts: 	
Inspector(s): Robert D. Zuber, P.E.	Inspector's Signature:

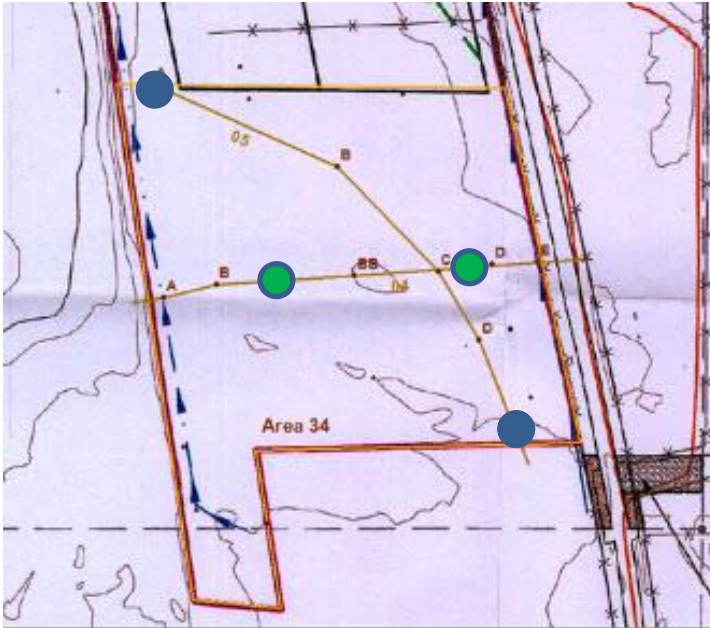
observation and walking the area, there are some undulations in the surface, but it is mostly flat. Using a TruePulse Laser Rangefinder to estimate slopes, the following was found:

- In west/east direction, the slope is less than 1 percent.
- From northwest to southeast, the slope is less than 1 percent.

The dots on the following figure show the approximate locations of end points for estimating the slopes. The green dots are the end points for the west to east slope measurement. The blue dots are the end points for the northwest to southeast slope measurement. (The lines with “A”, “B”, “C” etc. are transects from the SL-09 bond release analysis in GIS.)

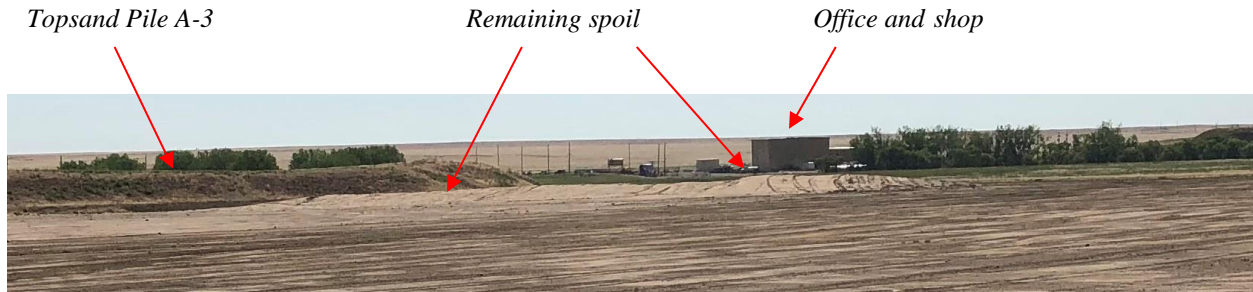
During the inspection, no backfill or grading operations were taking place. The spoil pile is considerably smaller than in previous months.

Remaining spoil pile

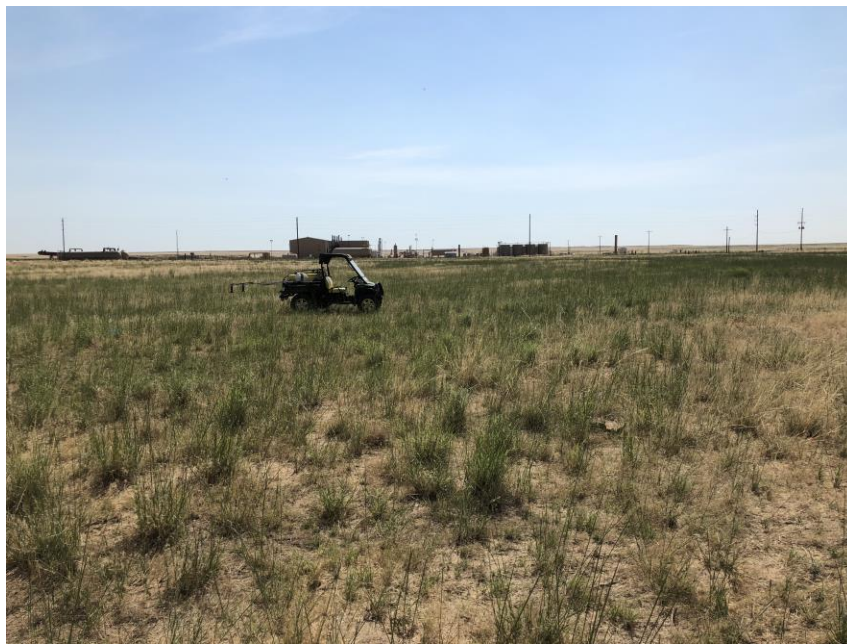
Area 34 (southeastern corner of the site) was inspected to evaluate the general grade of this area. Based on visual

Area 34, looking east from point near middle of western edge

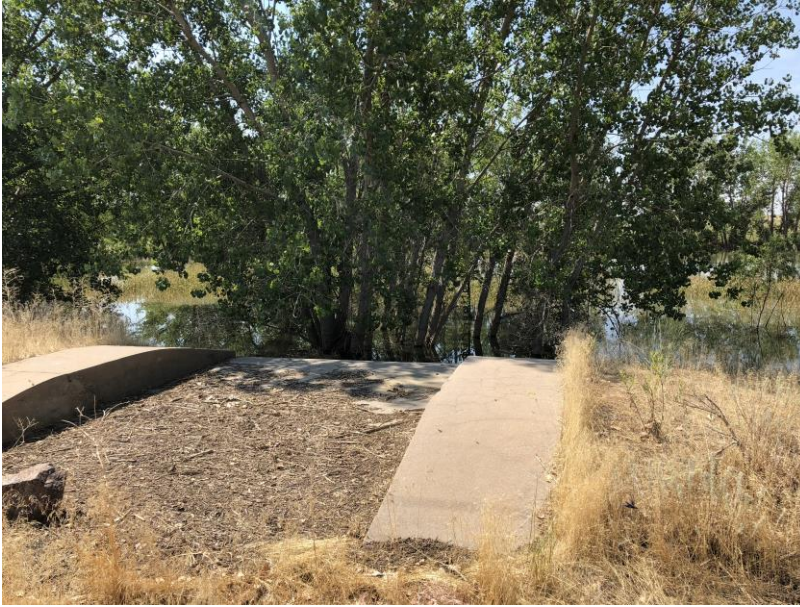
Standing water was observed in Sediment Pond 2 and the Dugout Pond. Neither pond was discharging during the inspection. No problems were observed with the two ponds.

Spillway for Sediment Pond 2

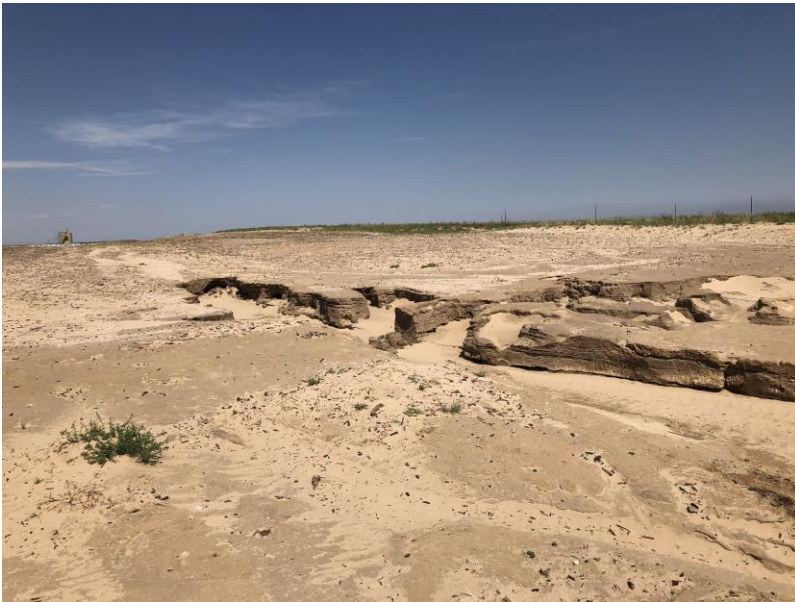
Erosion near north end of B Pit

Regarding the erosion at the northeast corner of the B Pit, CEC staff plan to repair this in near future, as noted in past inspection reports.
