**COLORADO**Division of Reclamation,
Mining and Safety

MINERALS PROGRAM INSPECTION REPORT**PHONE: (303) 866-3567**

MINE NAME: Moon Pit No 2	MINE/PROSPECTING ID#: M-1977-443	MINERAL: Sand and gravel	COUNTY: Moffat
INSPECTION TYPE: Monitoring	INSPECTOR(S): Amy C. Yeldell	INSP. DATE: July 10, 2018	INSP. TIME: 17:00
OPERATOR: Northwest Aggregates, Inc.	OPERATOR REPRESENTATIVE: None	TYPE OF OPERATION: 110c - Construction	
REASON FOR INSPECTION: Normal I&E Program	BOND CALCULATION TYPE: Complete Bond	BOND AMOUNT: \$16,357.00	
DATE OF COMPLAINT: NA	POST INSP. CONTACTS:	JOINT INSP. AGENCY: None	
WEATHER: Clear	INSPECTOR'S SIGNATURE:

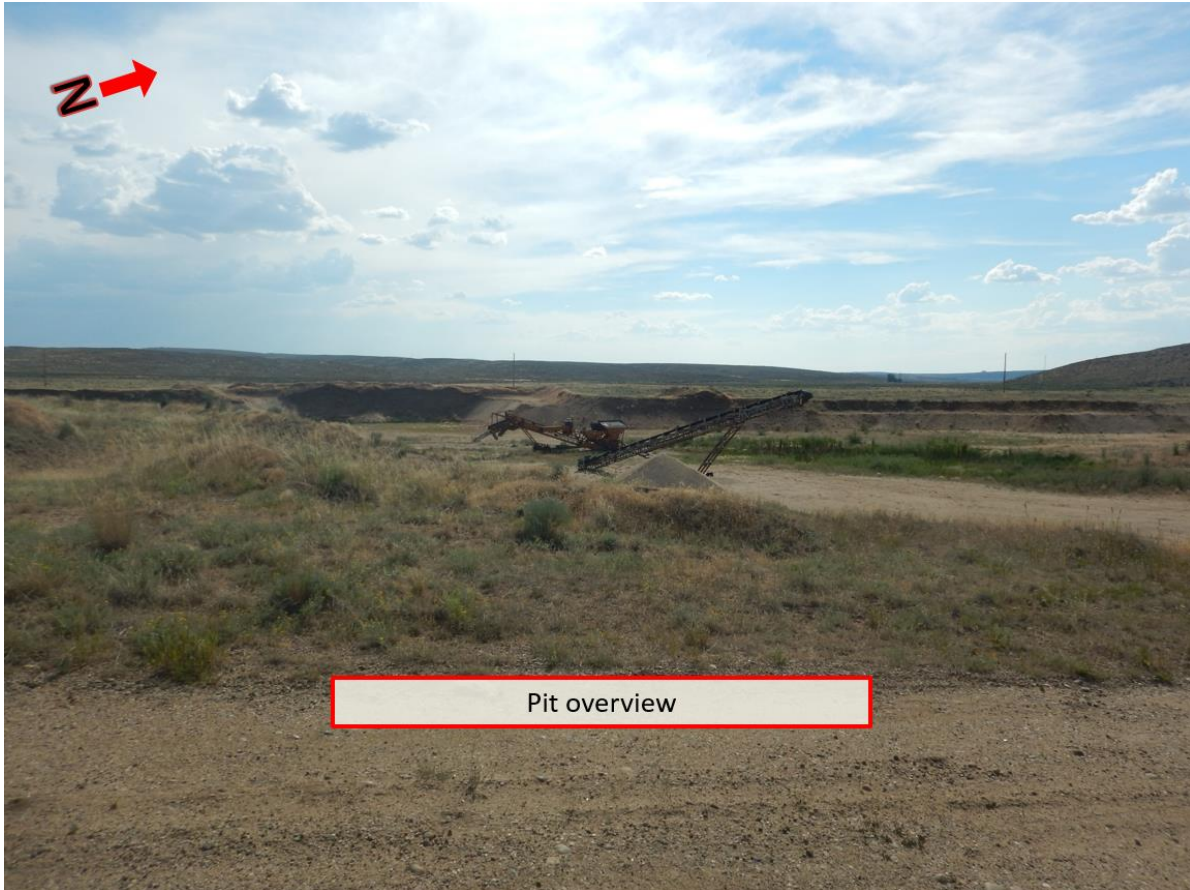
Pit overview

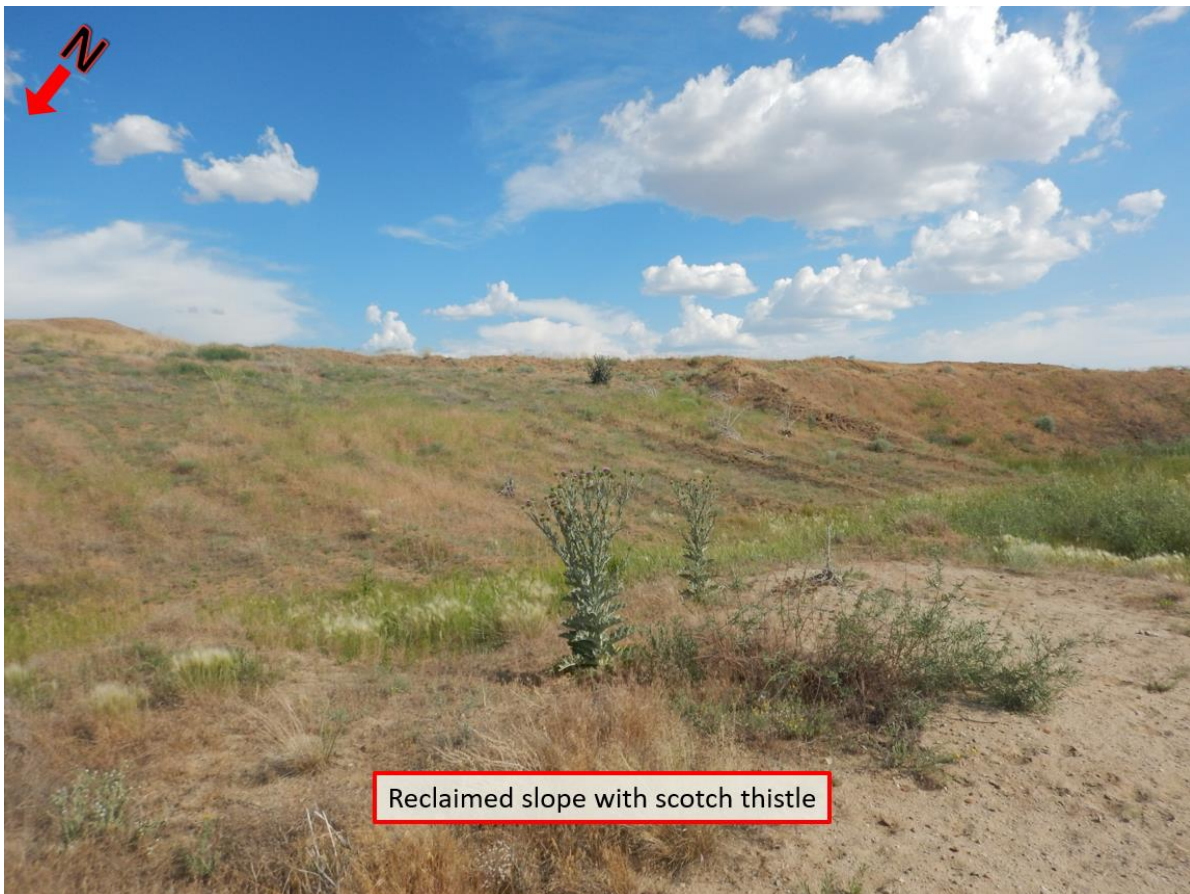
PROBLEM/POSSIBLE VIOLATION: Problem: There are state-listed noxious weeds present on site. This is a problem for failure to employ weed control methods for state listed noxious weed species within the permitted area, and to reduce the spread of weeds to nearby areas as required by Section 3.1.10 (6) of the rule.

The site was infested with Scotch thistle. Tamarisk and knapweed were also present. This is cited as a problem. 1) The operator should treat all weeds by the corrective action date. 2) A follow up treatment of all noxious weeds should be conducted 30 days following the first treatment to evaluate the effectiveness and treat any resistant weeds. 3) Develop a noxious weed management plan and submit it in the form of a technical revision

by the corrective action date. The majority of this infestation was in the recently reclaimed areas. These reclaimed areas should be aggressively monitored and treated as needed to prevent a delay in reclamation release.

Reclaimed slope with scotch thistle

CORRECTIVE ACTIONS: 1) The operator should treat all weeds by the corrective action date and submit photo documentation proof. 2) A follow up treatment of all noxious weeds should be conducted 30 days following the first treatment to evaluate the effectiveness and treat any resistant weeds. Submit notification upon completion. 3) The operator shall develop a weed control and management plan in accordance with Section 3.1.10 (6) of the Rule. This plan should be developed in consultation with the county extension agency, or weed control district office and should include specific control measures to be applied, a schedule for when control measures will be applied and a post-treatment monitoring plan. This weed control plan shall be submitted to the Division as a Technical Revision to the approved plan with the appropriate Technical Revision fee of \$216.00 by the corrective action date.

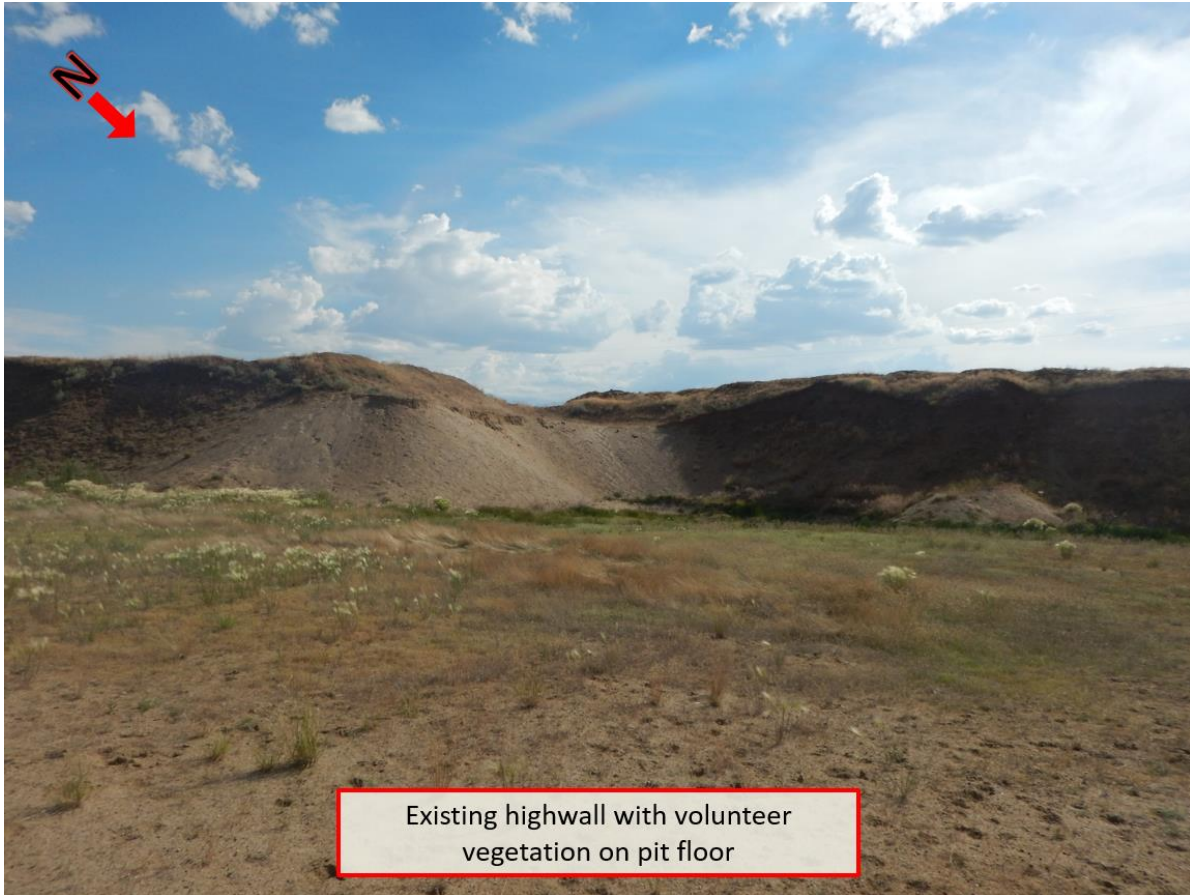
A processing plant and conveyor remain on site in the same position as the 2015 inspection. The highwall also appears to be in a similar manner as in previous inspections. Well established vegetation exists at the base of the highwall due to lack of traffic. No fuel, buildings or misc. debris were on site.

Existing highwall with volunteer
vegetation on pit floor

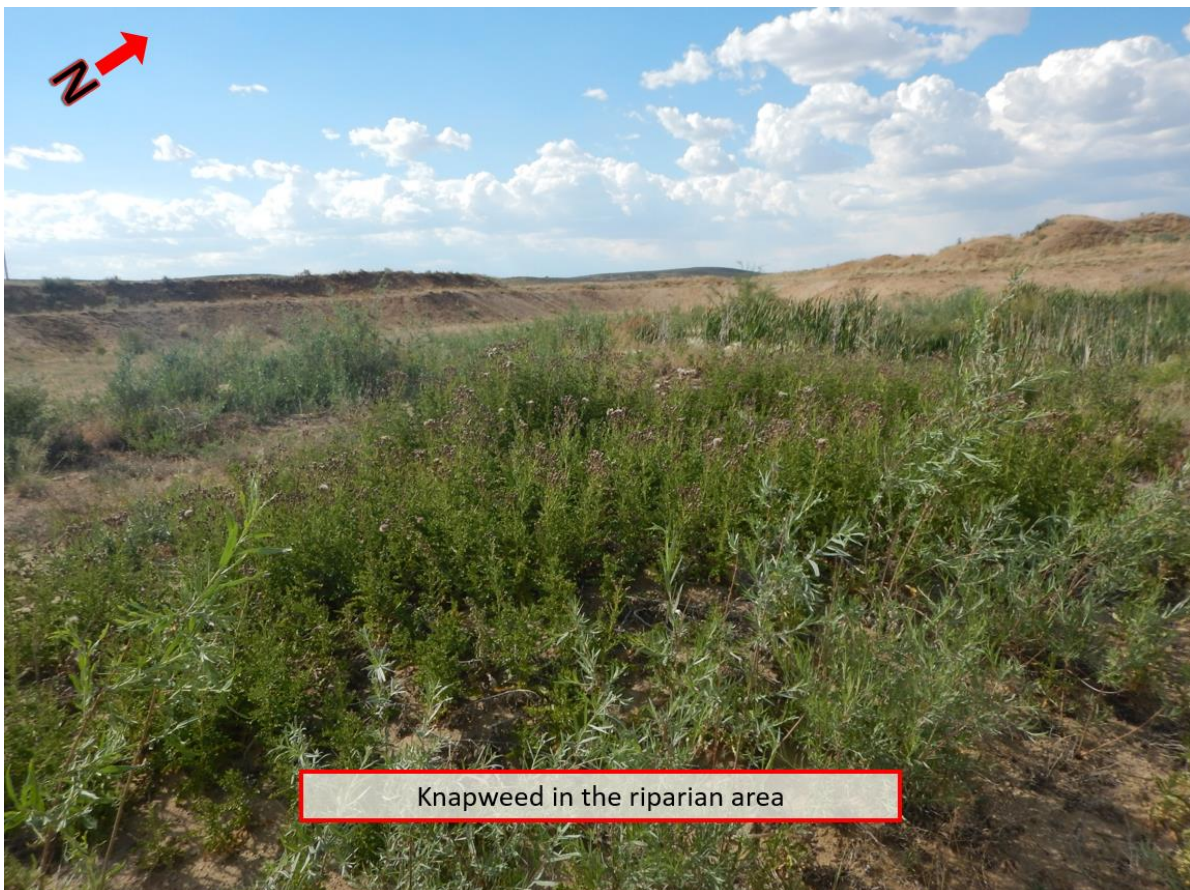
Knapweed in the riparian area
