MINERALS PROGRAM INSPECTION REPORT

MINE NAME: Arnold Pit	MINE/PROSPECTING ID#: M-2018-019	MINERAL: Sand and gravel	COUNTY: Las Animas
INSPECTION TYPE: Preoperation Inspection	INSPECTOR(S): Timothy A. Cazier	INSP. DATE: June 19, 2018	INSP. TIME: 11:00
OPERATOR: Las Animas County	OPERATOR REPRESENTATIVE: Clell Goode	TYPE OF OPERATION: 112c - Construction Regular Operation	
REASON FOR INSPECTION: Preoperation Inspection	BOND CALCULATION TYPE: None	BOND AMOUNT: No Bond Held	
DATE OF COMPLAINT: NA	POST INSP. CONTACTS: None	JOINT INSP. AGENCY: None	
WEATHER: Clear	INSPECTOR'S SIGNATURE:

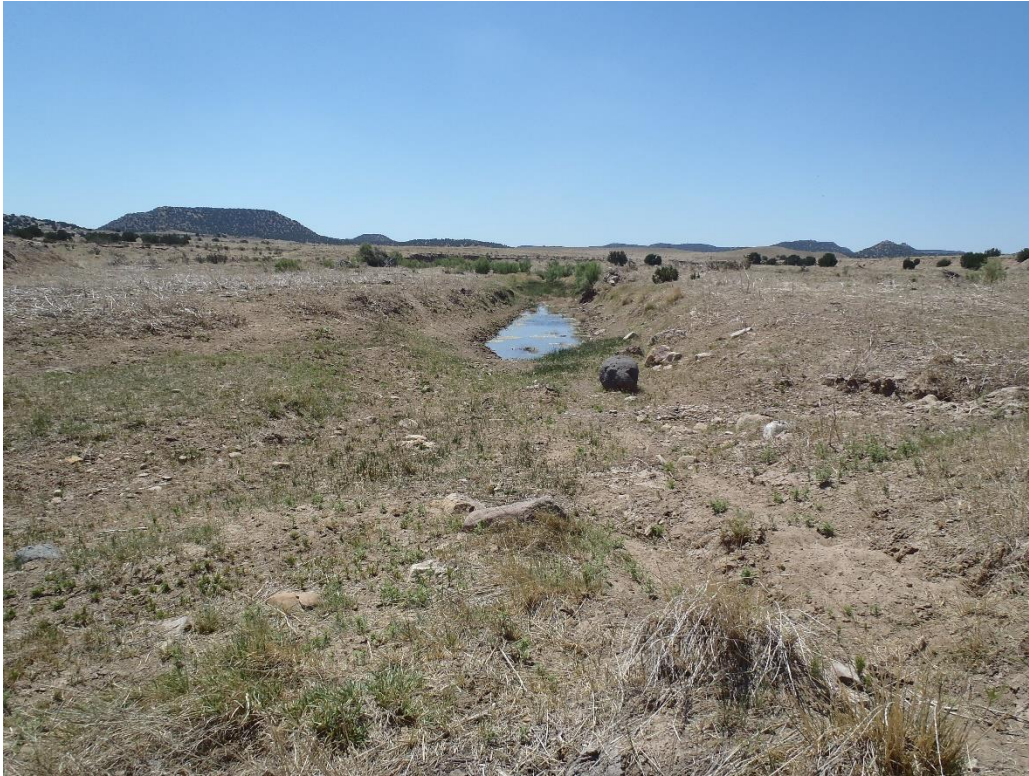
The drainage through the site is intermittent and only flows after significant precipitation events, according to Mr. Goode. It was not flowing at the time of the inspection. Some standing water was observed in the creek bed (see **Photo 1**). Mr. Goode indicated the water level had dropped in the pool significantly in the last month.

Photo 1. Standing water observed in the creek bed (looking south) .

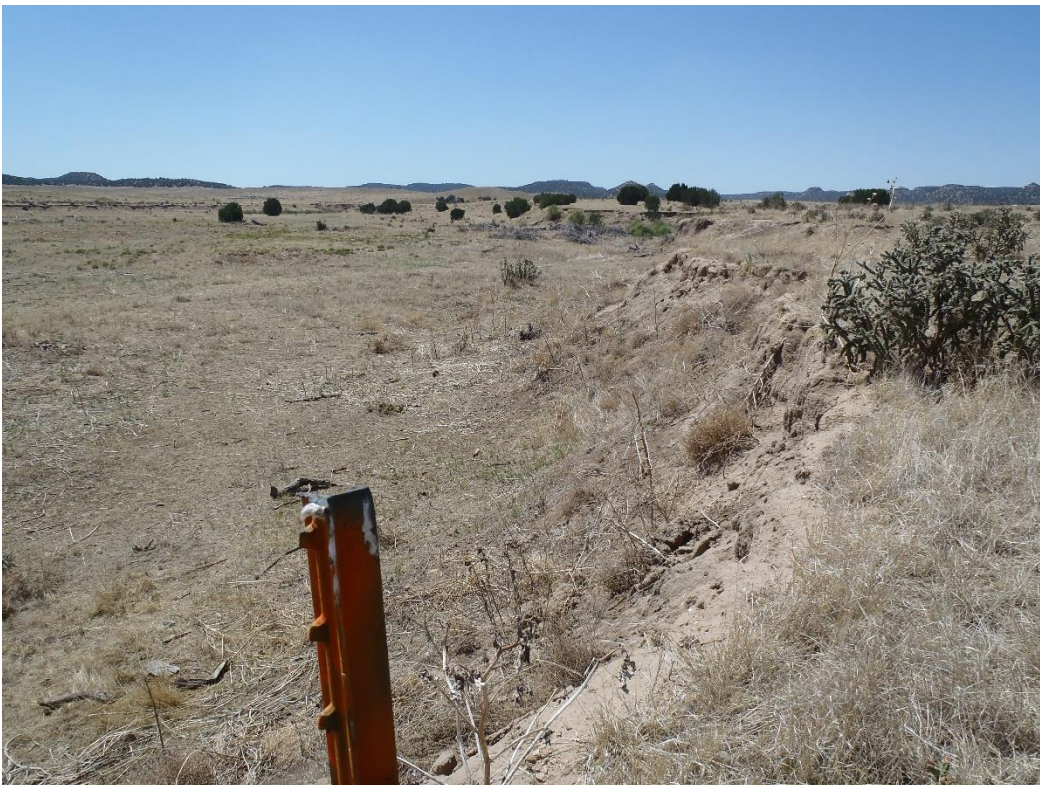
Mr. Goode indicated the majority of the mining would take place on the west side of the drainage and east of the steep existing bank along the west side of the permit boundary (see **Photo 2**). The primary mining area is outlined in tan on the attached **Post Inspection Map**. This area was sketched on the map post inspection based on comments made by Mr. Goode during the inspection and ground features observable on the Google Earth image.

Photo 2. Primary mining area on lower terrace (left side of photo, looking south).

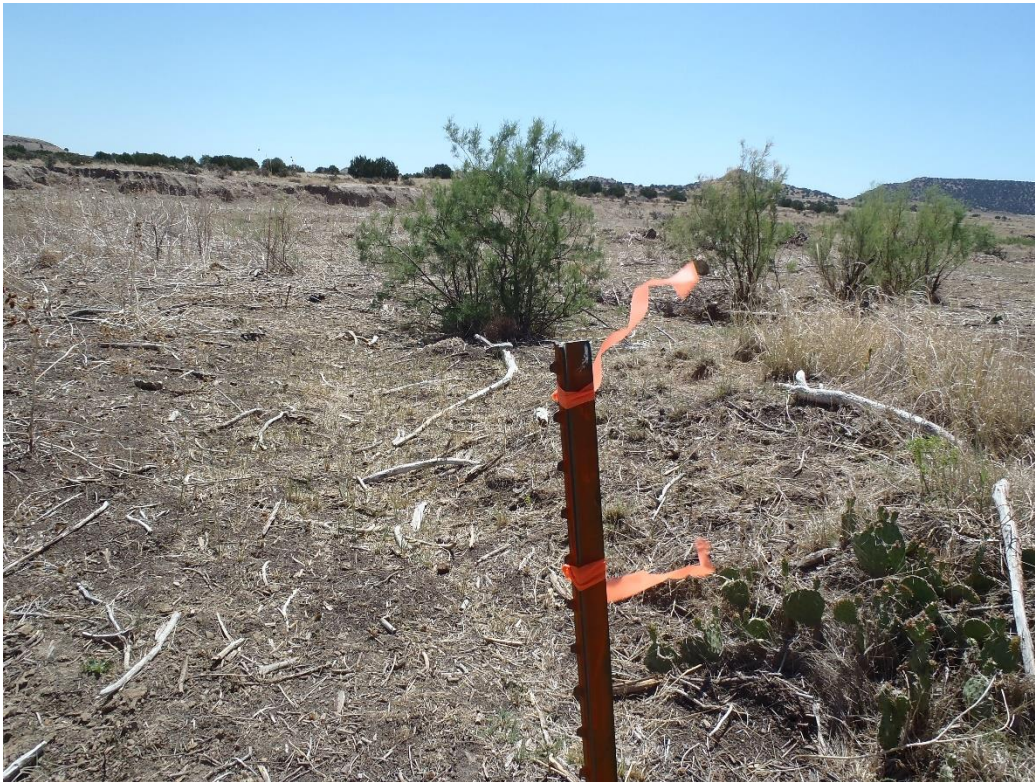
Some tamarisk (see **Photo 3**) were observed in the main channel of the drainage. Las Animas County should plan on treating these noxious weeds within the permit boundary to prevent them from becoming a problem.

Eight T-posts (see **Photo 3**) were in place marking the proposed permit boundary. All eight locations were collected using a Juno 3B hand held GPS unit. The attached **Post Inspection Map** shows the T-post locations, along with the public notice (see **Photo 5**) location, the nearby overhead utility line (nearest pole is just over 200 feet from the marked boundary), and the primary mining area.

Photo 3. Typical survey marker/T-post (note 3 tamarisk plants).

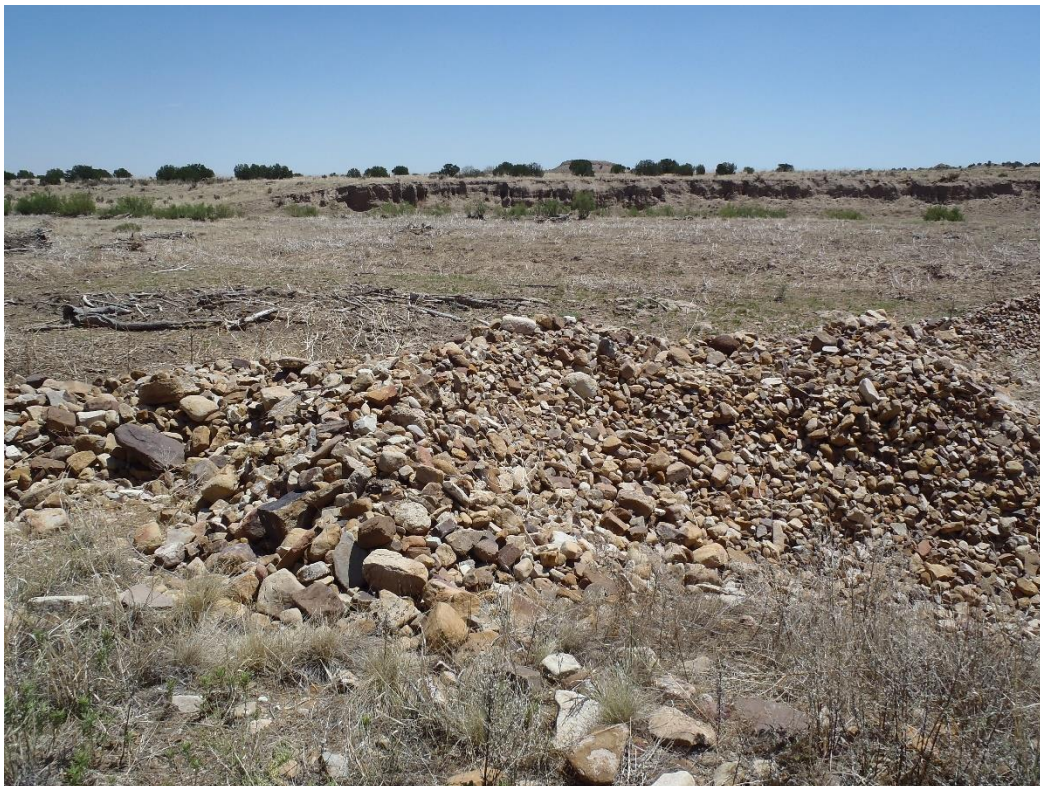
No support facilities were present at the time of the inspection. Mr. Goode indicated the County would bring in a crusher to utilize the oversize rock left from the previous operation (see **Photo 4**).

Photo 4. Oversize rock left from previous operation (lower terrace, looking east).

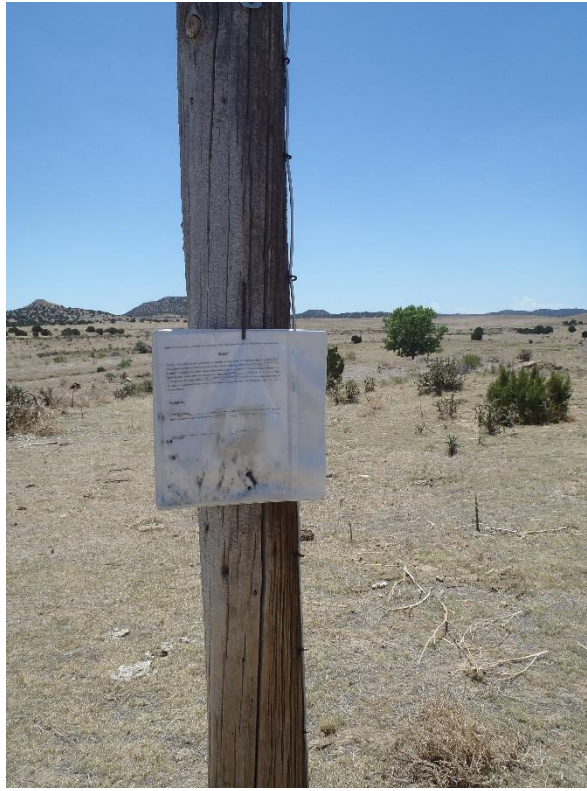
Photo 5. Public notice on utility pole (near proposed entrance).
