MINERALS PROGRAM INSPECTION REPORT

MINE NAME: Sunnyside Gold Mine	MINE/PROSPECTING ID#: M-1977-378	MINERAL: Pb, Zn Cu, Fe, Au	COUNTY: San Juan
INSPECTION TYPE: Surety Release Inspection	INSPECTOR(S): Lucas J. West	INSP. DATE: July 18, 2018	INSP. TIME: 08:00
OPERATOR: Sunnyside Gold Corp	OPERATOR REPRESENTATIVE: Larry Perino	TYPE OF OPERATION: 112 - Hard Rock Regular Operation	
REASON FOR INSPECTION: Surety Release Requested	BOND CALCULATION TYPE: None	BOND AMOUNT: \$60,534.00	
DATE OF COMPLAINT: NA	POST INSP. CONTACTS: None	JOINT INSP. AGENCY: None	
WEATHER: Clear	INSPECTOR'S SIGNATURE:

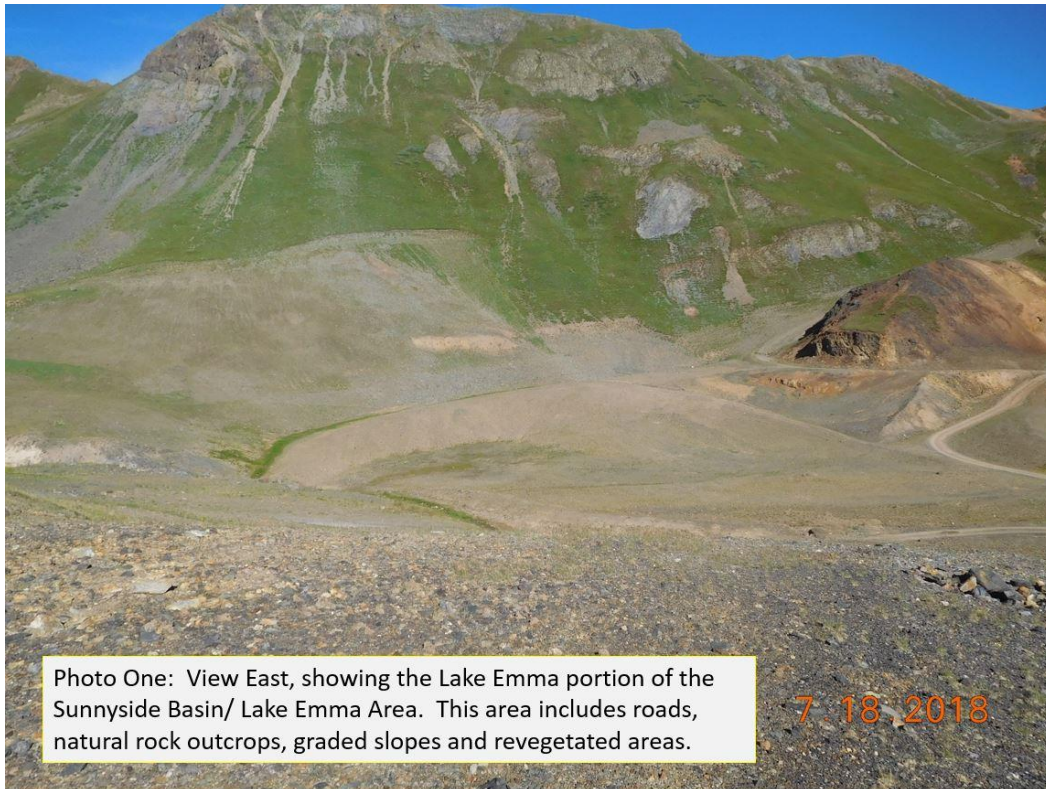
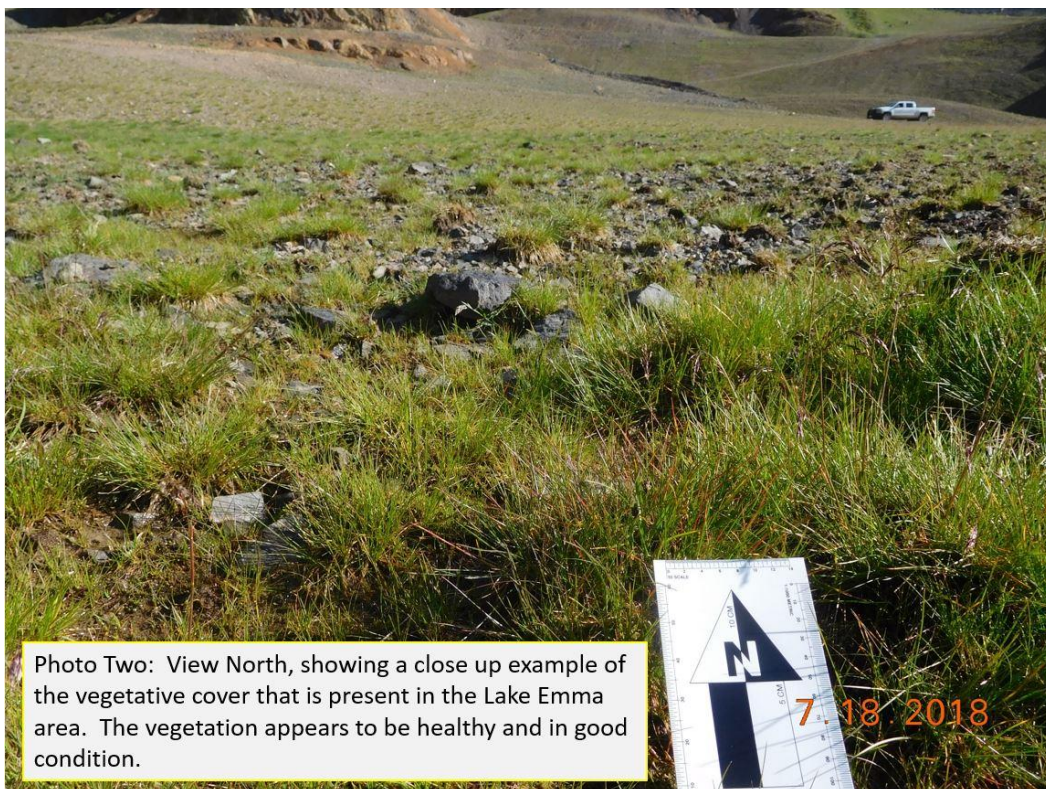
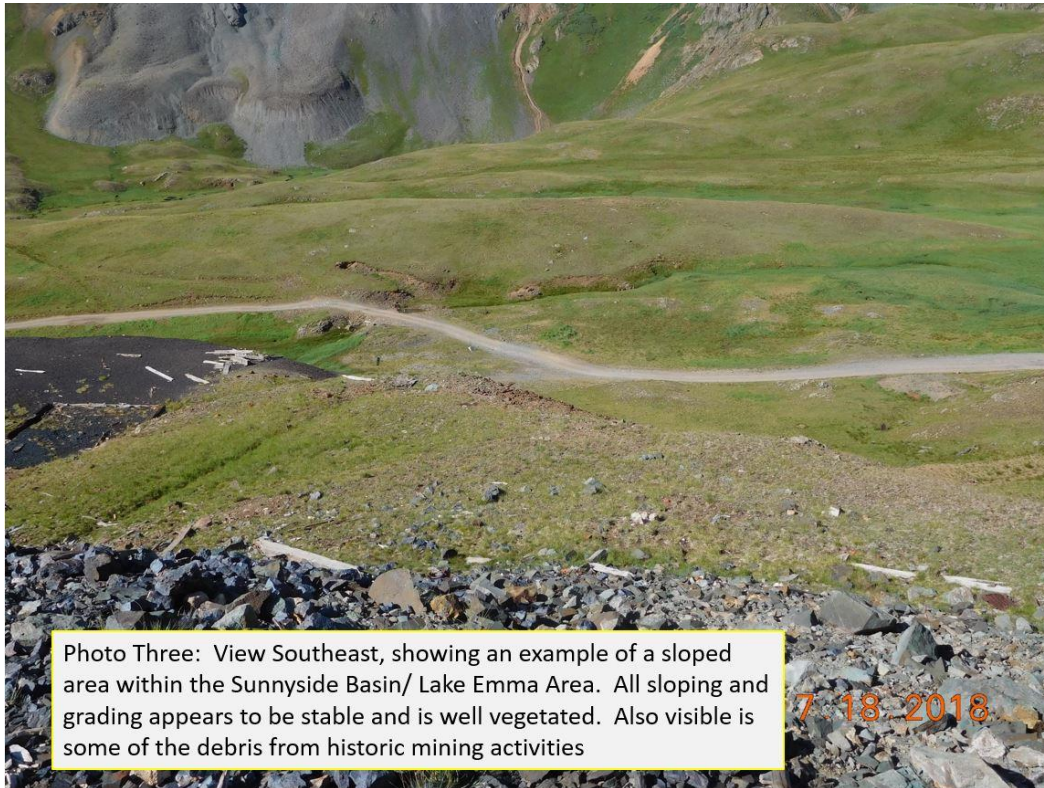
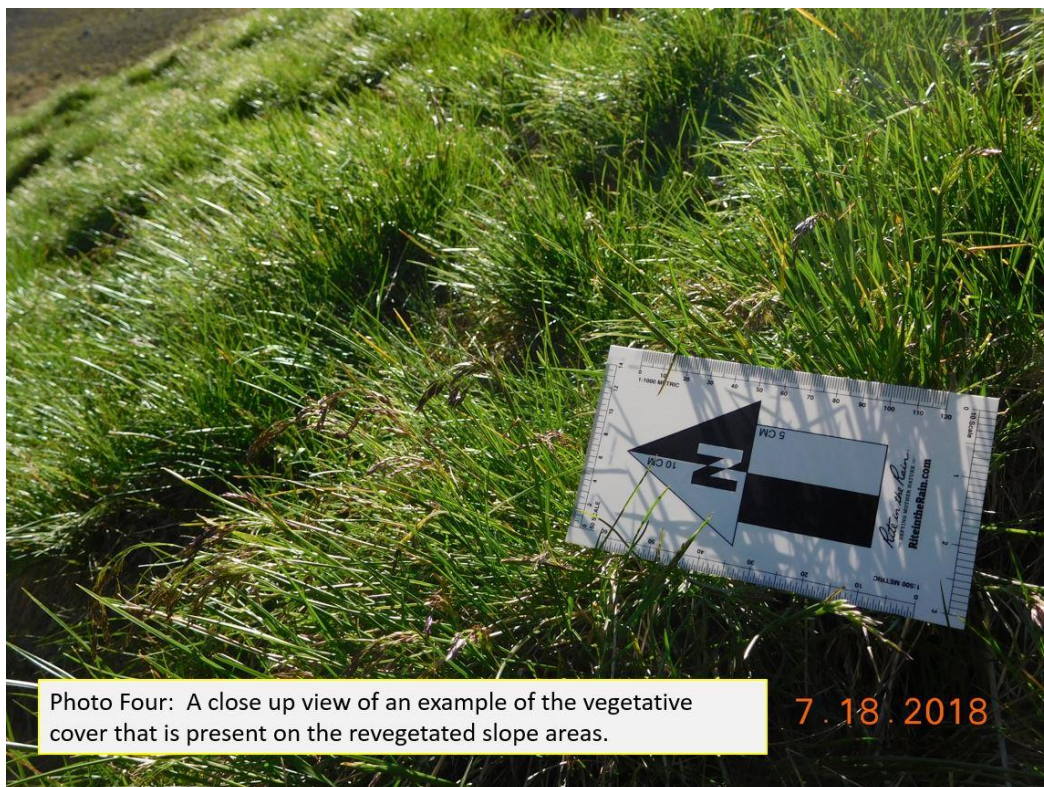
Lake Emma/Sunnyside Basin: The area consists of 66.5 acres and includes pre-law mining disturbances, some of which were not re-affected by the permitted operation. Historic features, which will remain after final reclamation, include roads, rock outcrops, and remnants of buildings and tram stations. Reclamation tasks were completed in approximately 1992 and have been monitored ever since. Earthwork at the Sunnyside Basin focused primarily on the backfilling and stabilization of the Lake Emma subsidence feature. Backfilled and graded areas appeared stable; evidence of slumping, settling or excessive erosion was not observed. Vegetative cover ranges from sparse to dense and diverse, however where present was well established, diverse, capable of self-regeneration, and at least equal in extent of cover as the surrounding native vegetation. Due to the high elevation, short growing season and grazing by livestock the vegetation establishment has been challenging. Density of the reclamation vegetation was greatest nearby the natural springs and seeps. No regulated noxious weeds were observed. The conditions of the Lake Emma and Sunnyside Basin area are illustrated in Photos One through Four.

Recommendation on AR-05: Observations made during the inspection and recorded in this report indicate the Operator has completed reclamation of all affected lands at the Lake Emma/Sunnyside Basin and Terry Tunnel areas in accordance with the conditions of the approved reclamation plan and the Hard Rock Act and Rules. Pursuant to Rule 4.17.2(5), the Division recommends approval of AR-05.

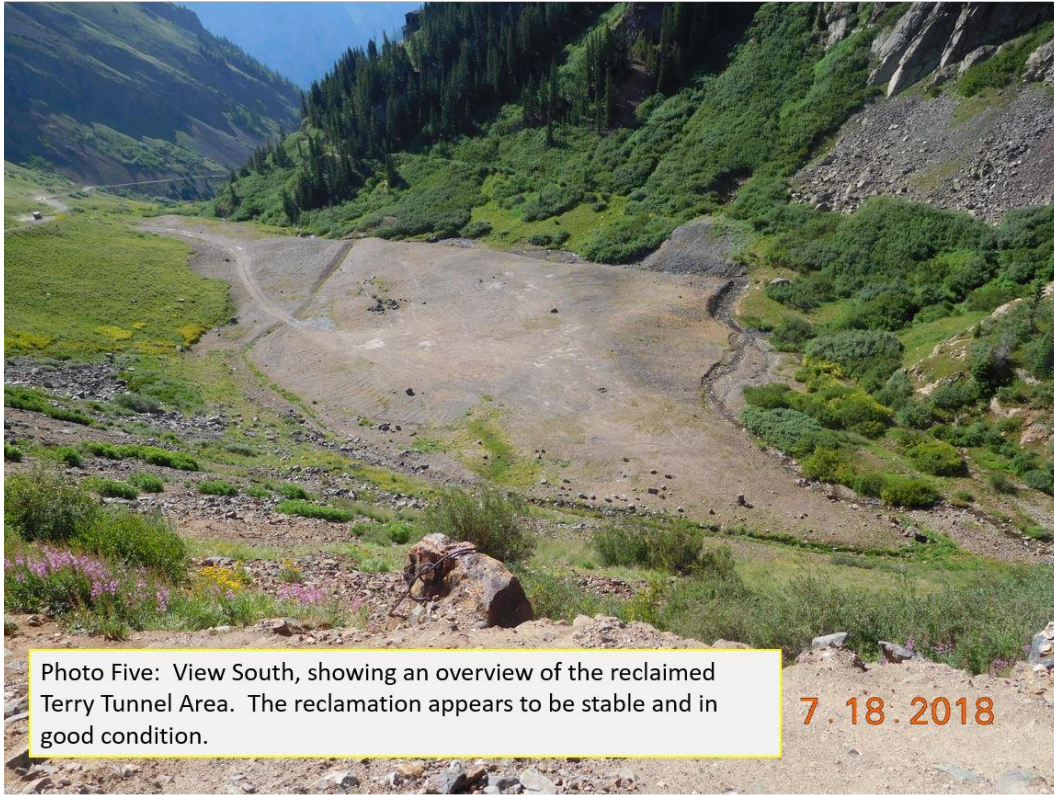
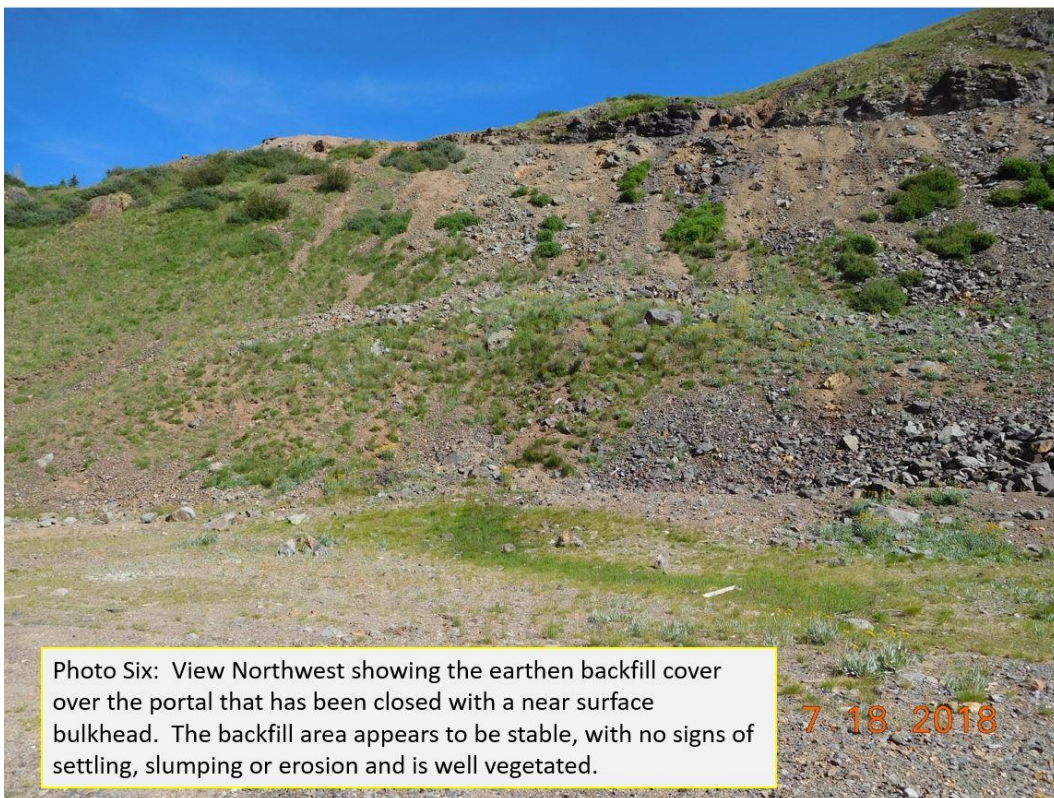
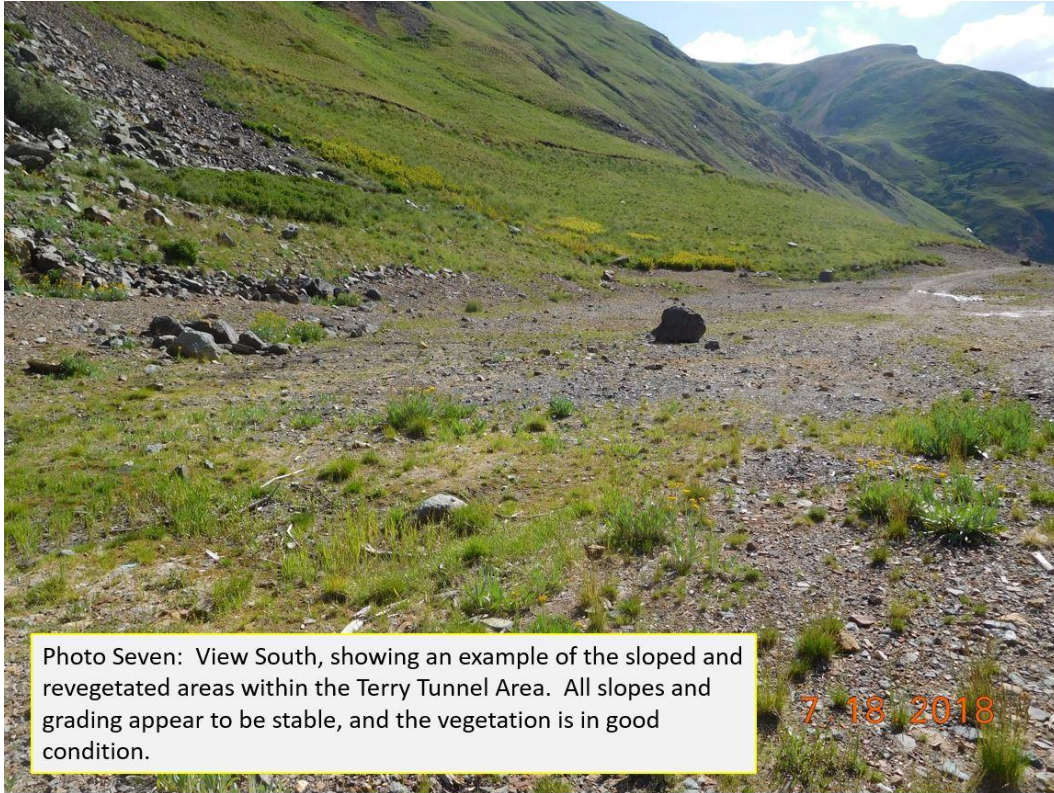
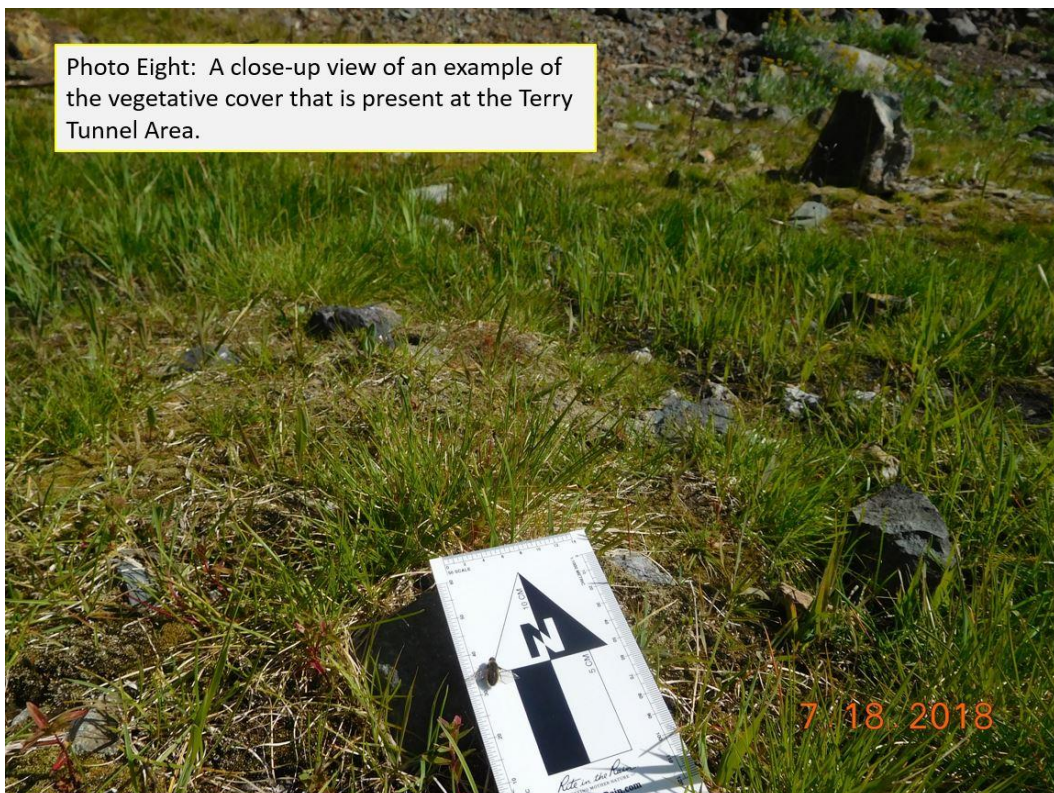
Terry Tunnel: This area consists of 7.12 acres and includes the pre-law portal (Terry Tunnel) and waste rock stockpile. The pre-law features were re-affected and reclaimed by the permitted operation. Reclamation tasks were completed in approximately 2001. The portal was closed with hydraulic bulkhead and backfilled at the surface. The waste rock stockpile was graded, covered with imported growth medium, and revegetated. Backfilled and graded areas appeared stable; evidence of slumping, settling or excessive erosion was not observed. Vegetative cover ranges from sparse to dense and diverse, however where present was well established, diverse, capable of self-regeneration, and at least equal in extent of cover as the surrounding native vegetation. Due to the high elevation, short growing season, the rocky nature of the waste rock, and grazing by livestock the vegetation establishment has been challenging. No regulated noxious weeds were observed. The conditions of the Terry Tunnel area are illustrated in Photos Five through Eight.
