PERMIT INFORMATION

Permit Number: C-1981-035 Mine Name: King Coal Mine Operator: GCC Energy, LLC Operator Address: Mr. Tom Bird 6473 County Road 120 Hesperus, CO 81326	County: La Plata Operation Type: Underground Permit Status: Active Ownership: Federal
	Operator Representative Present: Tom Bird
Operator Representative Signature: (Field Issuance Only)

INSPECTION INFORMATION

Inspection Start Date: July 17, 2018 Inspection Start Time: 08:00 Inspection End Date: July 17, 2018 Inspection End Time: 13:00		Inspection Type: Coal Complete Inspection Inspection Reason: Normal I&E Program Weather: Clear	
Joint Inspection Agency: None		Joint Inspection Contacts: 	
Post Inspection Agency: None		Post Inspection Contacts: 	
Inspector(s): Brock F. Bowles	Inspector's Signature:

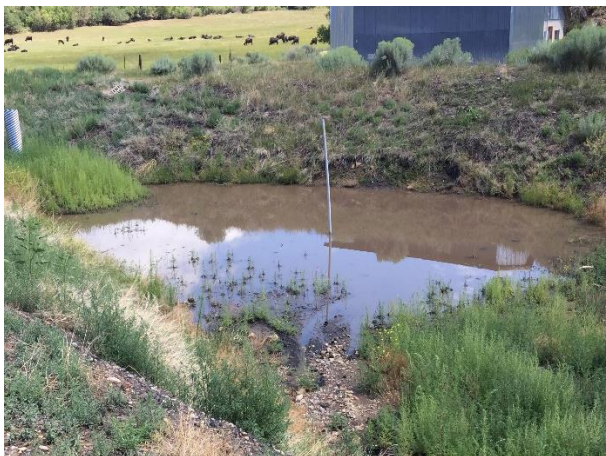
Photo 1 – East Pond

East and West Ponds contained water but were not discharging. The mud and debris lines indicate that both ponds contained all the water from the recent rain event (photo 1).

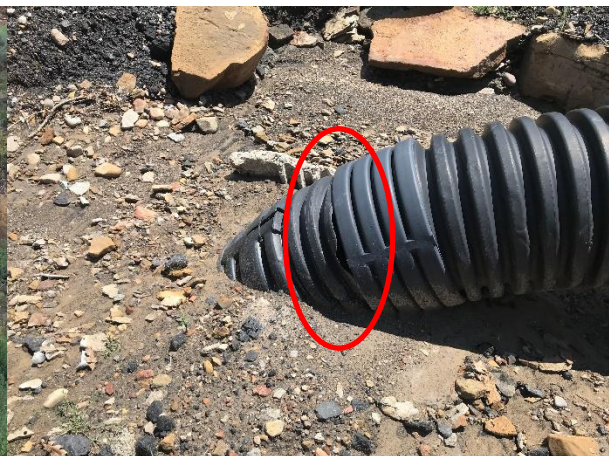
Photo 2 – Pipe Separation on Reach 3

A pipe joint on Reach 3 (clear water) has separated and needs to be repaired (photo 2).

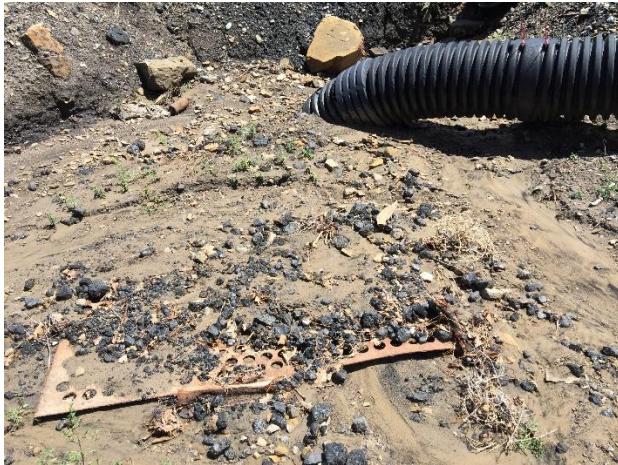
Photo 3 – Reach 7 Inlet Needs Cleaning

Both inlets for Reach 7 were filled with debris and need to be cleaned (photo 3).

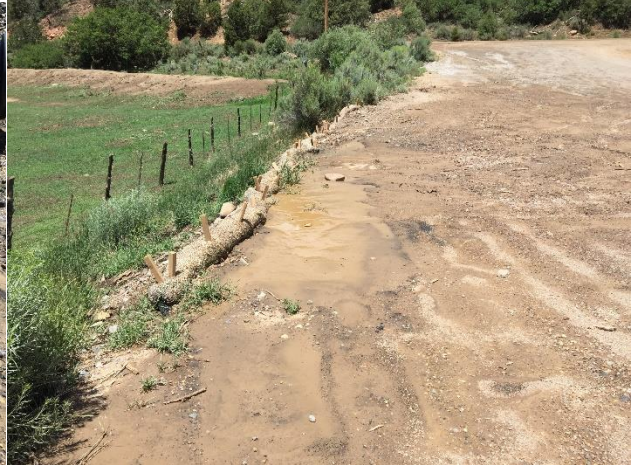
Photo 4 – Berm Needs to be Re-Built

The sediment control structures along the SAE #1 haul road were working. The berms in this area are not well defined and need to be re-built (photo 4).

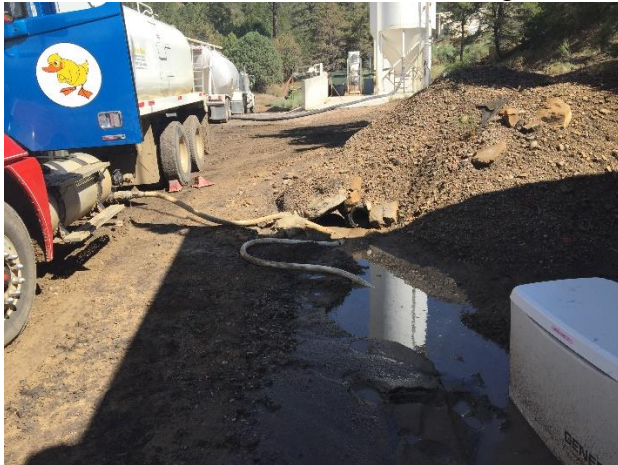
Photo 5 – Culvert C16 Being Cleaned

Culvert C16 was blocked by sediment and was being cleaned with pressurized water from a truck (photo 5).

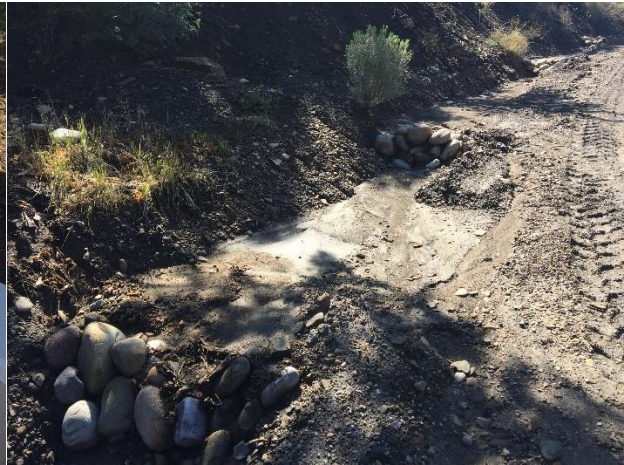
Photo 6 – Check Dams in Ditch ID-3

The check dams in ditch ID-3, along the road to the main fan, were full of sediment and need to be cleaned (photo 6).

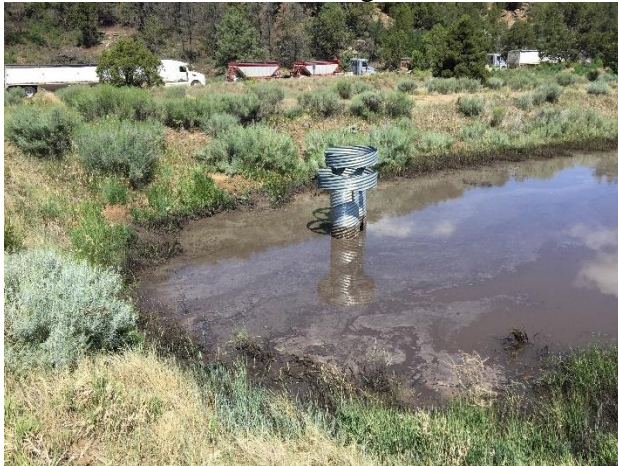
Photo 7 – Sediment Pond

The sediment pond contained water but was not discharging. The mud and debris line indicated that the pond contained all the water from the storm (photo 7). A gully has formed on the northeast corner of the sediment pond where water flowed from the facilities area into the pond. The gully needs to be reinforced to prevent further erosion (photo 8).

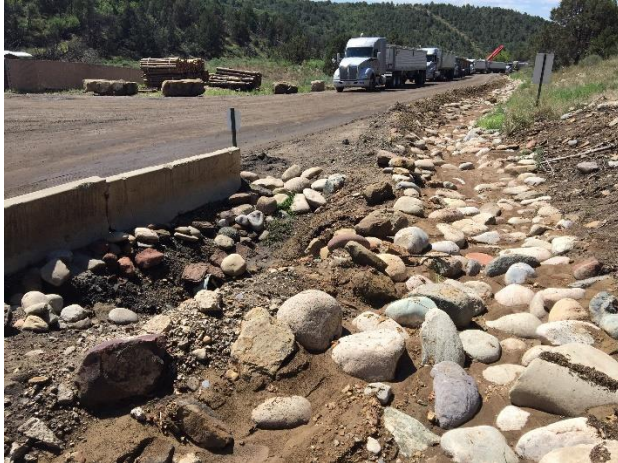
Photo 9 – Inlet to Culvert C5

The clear water ditch CWD-1A was filled with sediment by culvert C5 and overflowed into culvert C5 (photo 9).

This section of the clear water ditch needs to be cleaned and the berm repaired.

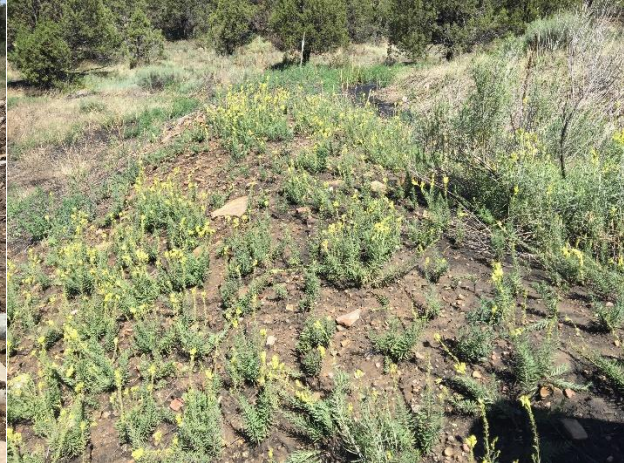
Photo 10 – Toadflax on Topsoil Pile 2 Berm

A patch of toadflax was noted growing on the west end of the topsoil pile #2 (photo 10). Toadflax is a List B noxious weed and needs to be treated.
