PERMIT INFORMATION

Permit Number: C-1981-008 Mine Name: New Horizon Mine Operator: Elk Ridge Mining and Reclamation, LLC Operator Address: Mr. Tony Tennyson 5731 State Highway 13 Meeker, CO 81641	County: Montrose Operation Type: Surface Permit Status: Active Ownership: Private
	Operator Representative Present: Frank Ferris
Operator Representative Signature: (Field Issuance Only)

Inspection Start Date: July 18, 2018 Inspection Start Time: 08:00 Inspection End Date: July 18, 2018 Inspection End Time: 16:00		Inspection Type: Coal Partial Inspection Inspection Reason: Normal I&E Program Weather: Clear	
Joint Inspection Agency: None		Joint Inspection Contacts: 	
Post Inspection Agency: None		Post Inspection Contacts: 	
Inspector(s): Brock F. Bowles	Inspector's Signature:

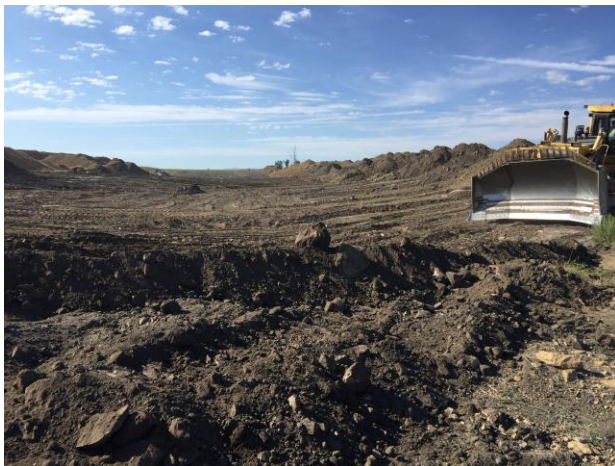
Photo 1 – Bulldozer Work by Pond 16

A bulldozer was shaping the subsoil north of Pond 16 to the final configuration (photo 1)

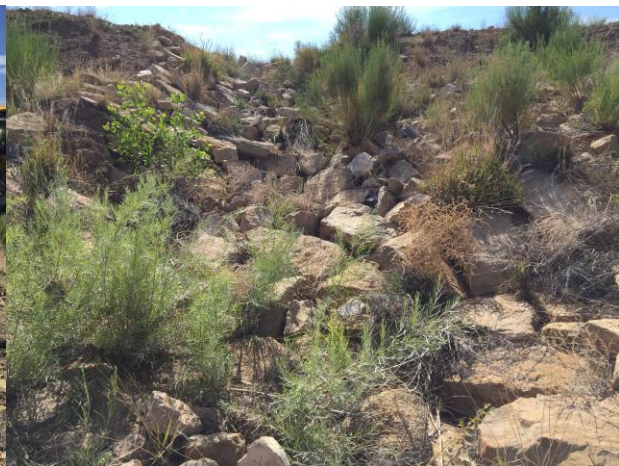
Photo 2 – Pond 12 East Inlet

Pond 12 contained some water but was not discharging. The tamarisk trees noted in the last inspection report (June 13, 2018) have been removed. The inlet structures were in good condition (photo 2).

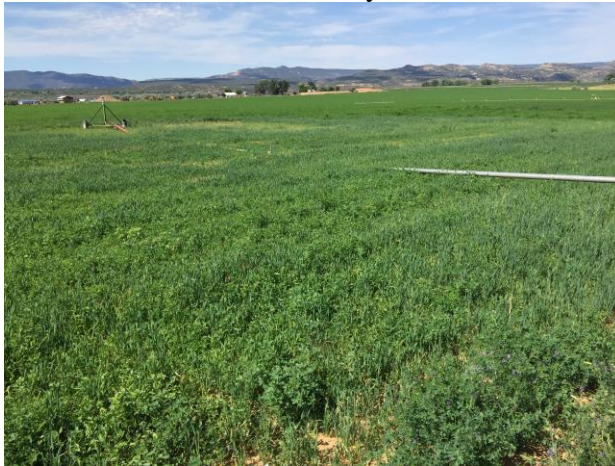
Photo 3 – Repair Area On Morgan Property

The area on the Morgan property that was repaired and re-seeded in the April 12, 2018 inspection report was in good condition. The vegetation was approximately 12 inches high and dense, similar to the surrounding vegetation (photo 3). The repaired area has not been harvested.
