COLORADO
Division of Reclamation,
Mining and Safety
Department of Natural Resources

Permit Number: C-2010-089 Mine Name: New Horizon North Mine Operator: Elk Ridge Mining and Reclamation, LLC Operator Address: Mr. Tony Tennyson 5731 State Highway 13 Meeker, CO 81641	County: Montrose Operation Type: Surface Permit Status: Active Ownership: Private
	Operator Representative Present: Frank Ferris and Tom Fry
Operator Representative Signature: (Field Issuance Only)

Inspection Start Date: July 18, 2018 Inspection Start Time: 11:00 Inspection End Date: July 18, 2018 Inspection End Time: 16:00		Inspection Type: Coal Partial Inspection Inspection Reason: Normal I&E Program Weather: Clear	
Joint Inspection Agency: None		Joint Inspection Contacts: 	
Post Inspection Agency: None		Post Inspection Contacts: 	
Inspector(s): Brock F. Bowles	Inspector's Signature:

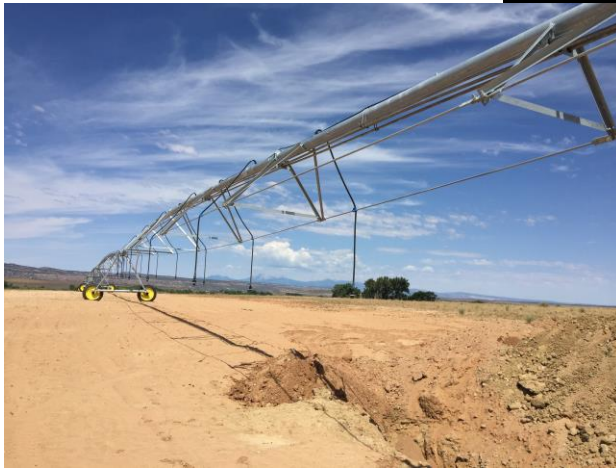
The center pivot irrigation structure has been erected (photo 1). The landowner, Dustin Garvey (photo 2), was digging up the underground water line so it can be attached to the center pivot. The electrical lines have not been installed yet.

Photo 1 – Center Pivot Irrigation Structure

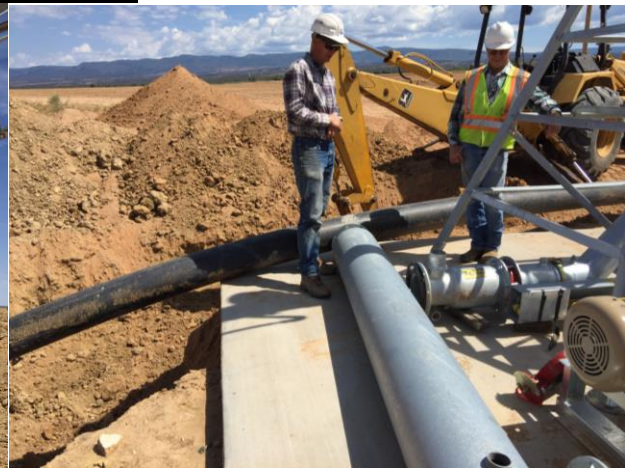
Photo 2 – The Black Underground Water Line

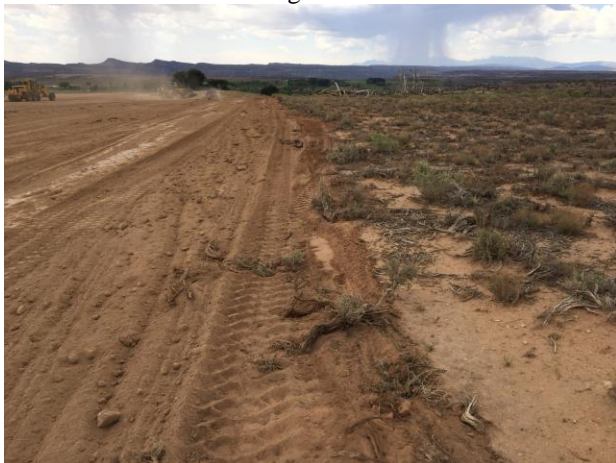
Topsoil was replaced up to the undisturbed area and was graded to match the approximate original contour of the surrounding area (photo 3).

Photo 3 – Topsoil Replacement Next to Undisturbed Area
