**COLORADO**Division of Reclamation,
Mining and Safety

MINERALS PROGRAM INSPECTION REPORT**PHONE: (303) 866-3567**

MINE NAME: Bootleg Quarry	MINE/PROSPECTING ID#: M-2015-022	MINERAL: Sand and overburden	COUNTY: Adams
INSPECTION TYPE: Monitoring	INSPECTOR(S): Jared L. Ebert	INSP. DATE: July 19, 2018	INSP. TIME: 09:00
OPERATOR: Lazy H Inc	OPERATOR REPRESENTATIVE: Bill and Sandie Havengar	TYPE OF OPERATION: 111 - Construction by Government Agency

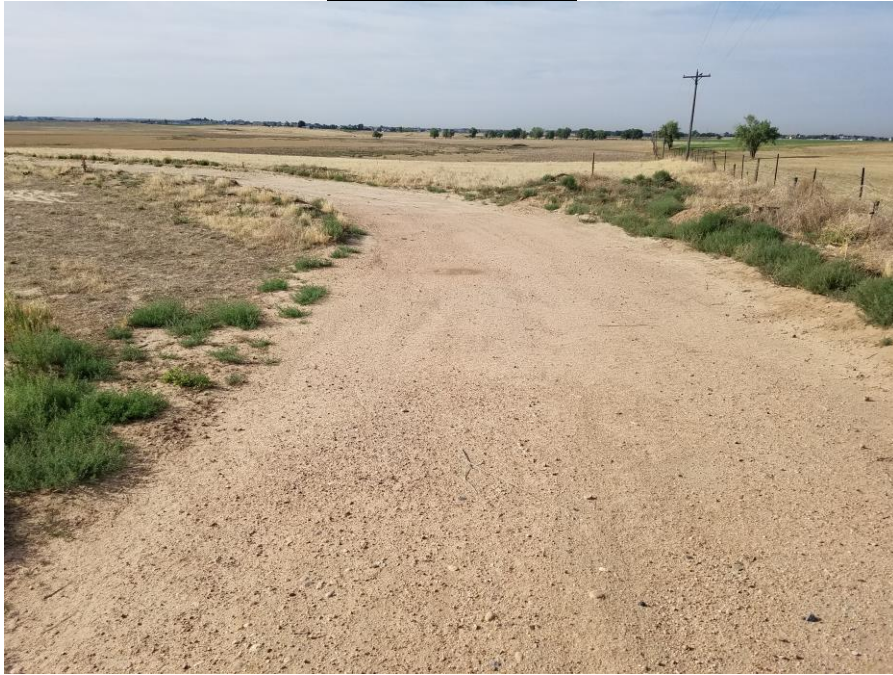
Figure 1. Access road into the site.

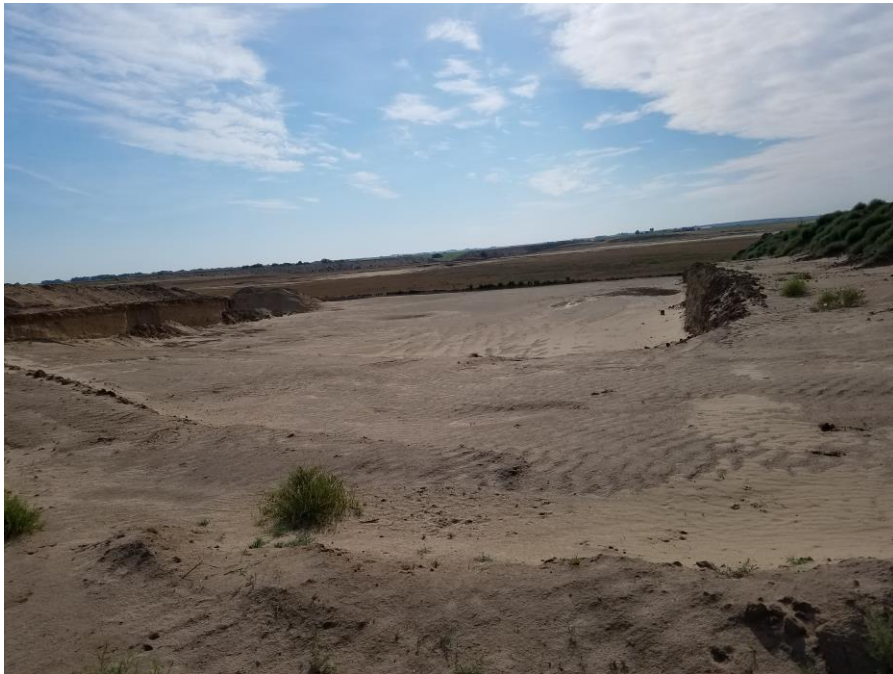
Figure 2. From the southwest corner of the pit looking northeast.

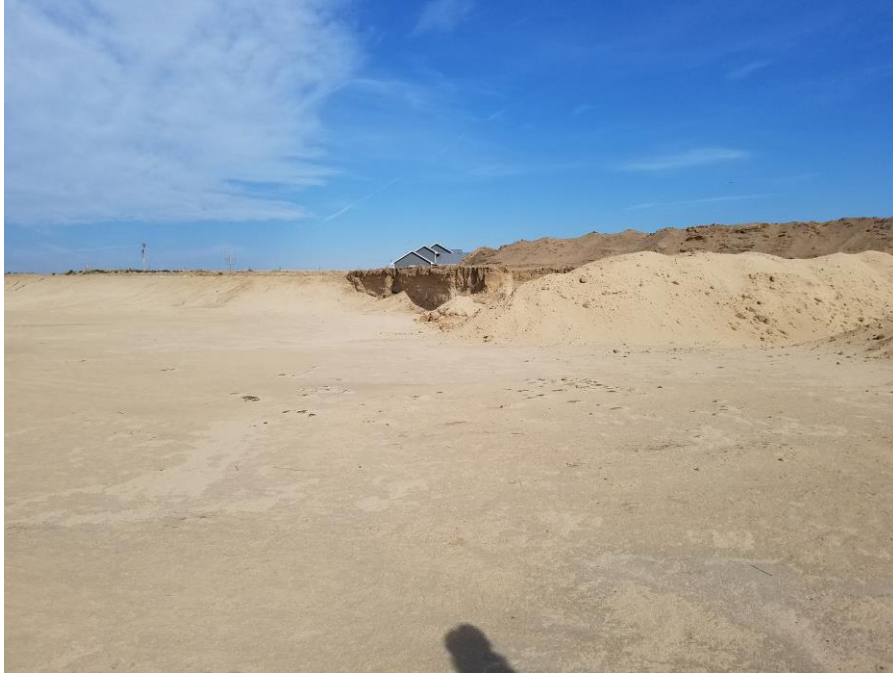
Figure 3. From the northeast corner of the pit looking west.

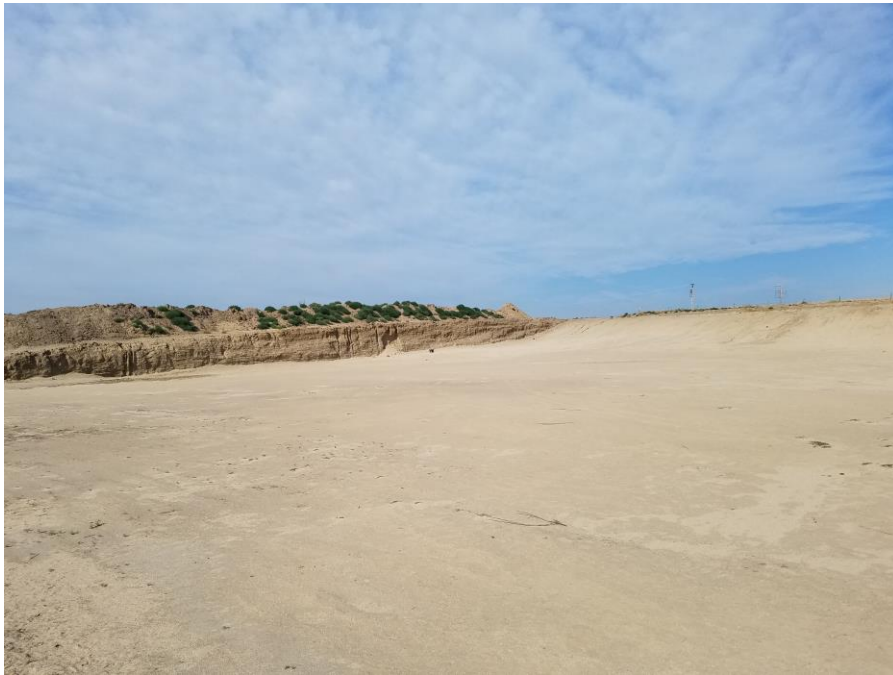
Figure 4. From the northeast corner of the pit looking southwest.
