MINERALS PROGRAM INSPECTION REPORT
PHONE: (303) 866-3567

MINE NAME: Memphis	MINE/PROSPECTING ID#: M-1997-084	MINERAL: Alluvial Fan	COUNTY: Ouray
INSPECTION TYPE: Monitoring	INSPECTOR(S): Travis H. Marshall	INSP. DATE: June 12, 2018	INSP. TIME: 10:30
OPERATOR: Keystone Portfolio Management	OPERATOR REPRESENTATIVE: NA	TYPE OF OPERATION: 110c - Construction Limited Impact	
REASON FOR INSPECTION: Normal I&E Program	BOND CALCULATION TYPE: Complete Bond	BOND AMOUNT: \$2,341.23	
DATE OF COMPLAINT: NA	POST INSP. CONTACTS: None	JOINT INSP. AGENCY: None	
WEATHER: Clear	INSPECTOR'S SIGNATURE:

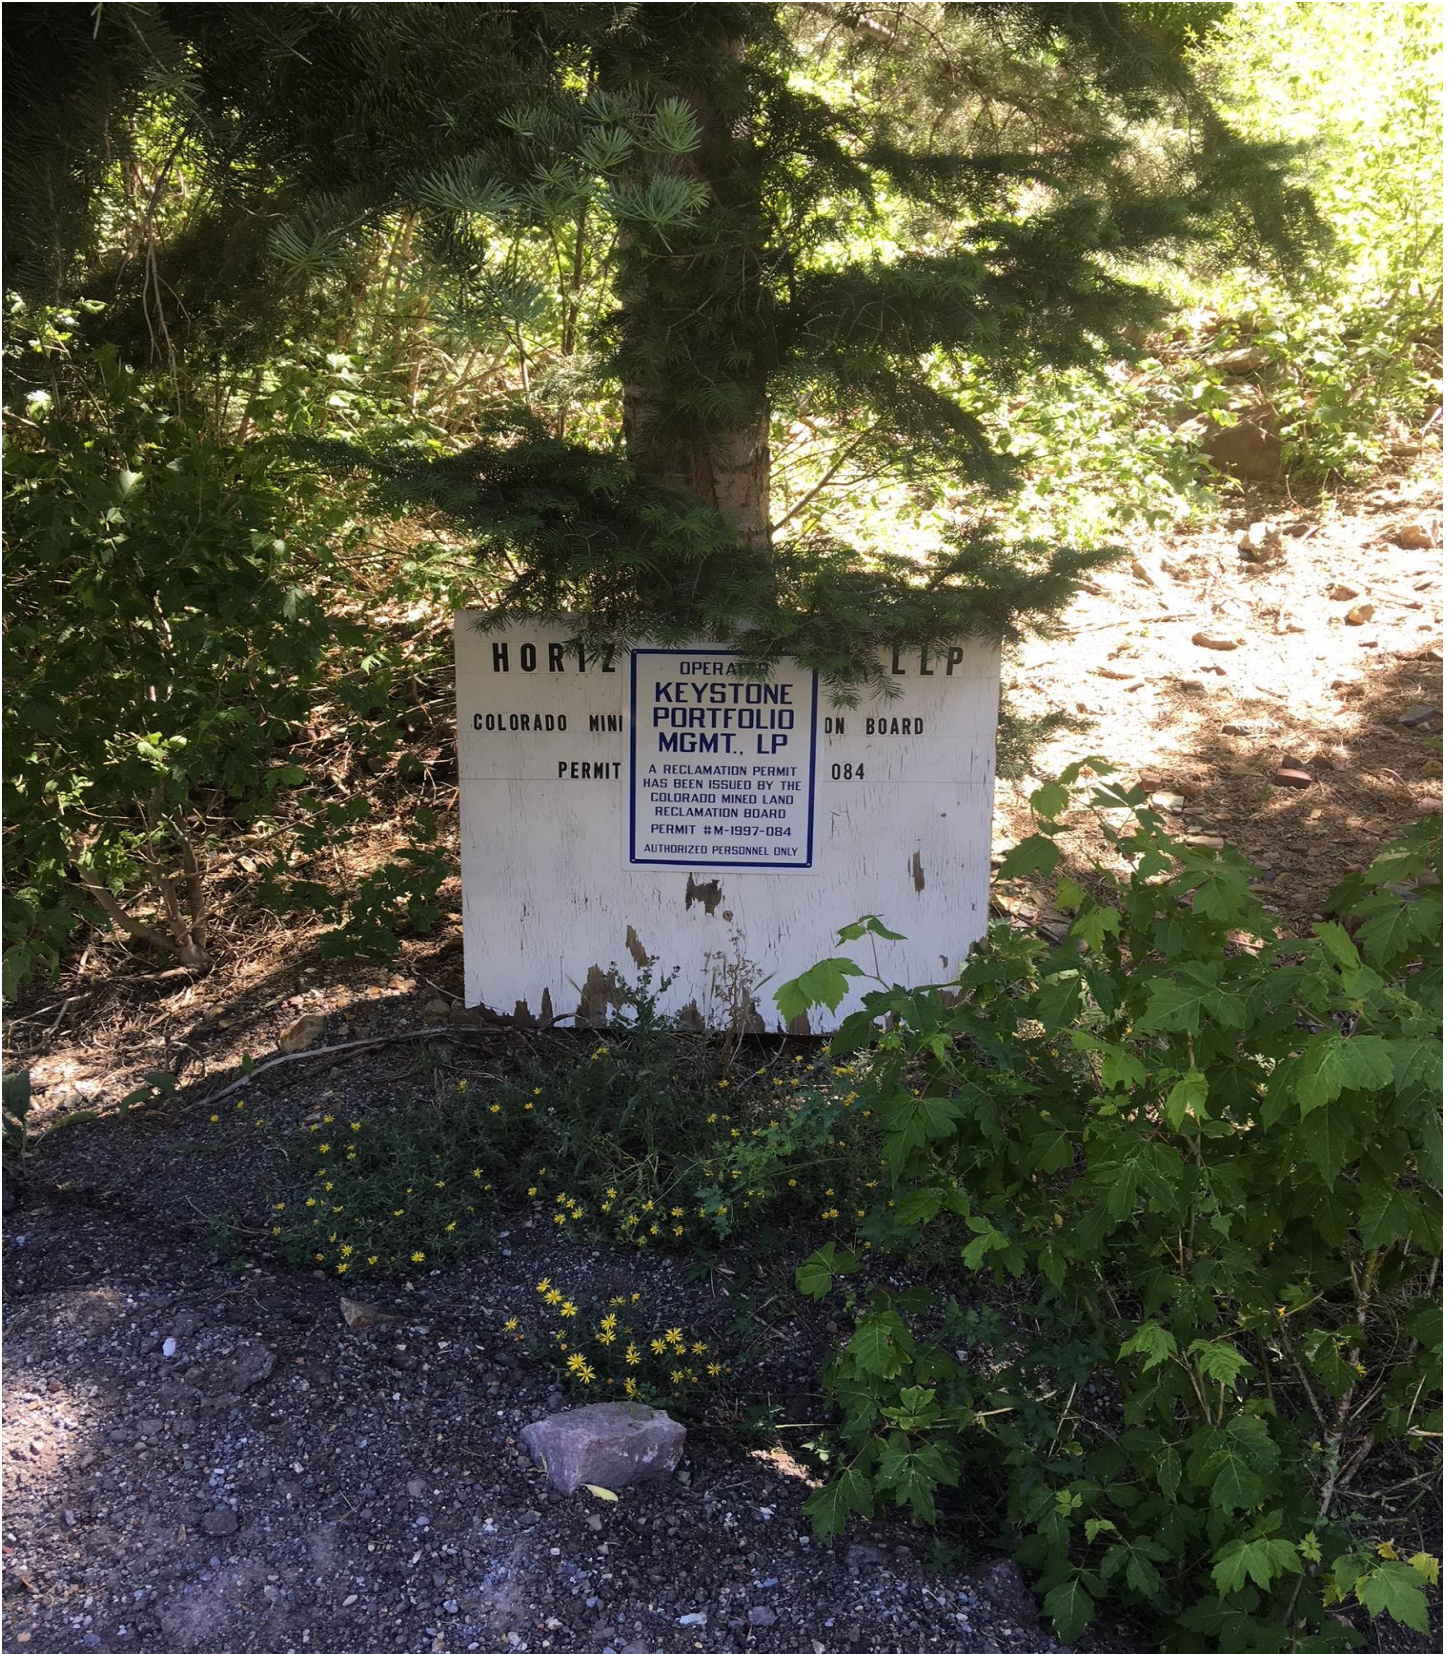
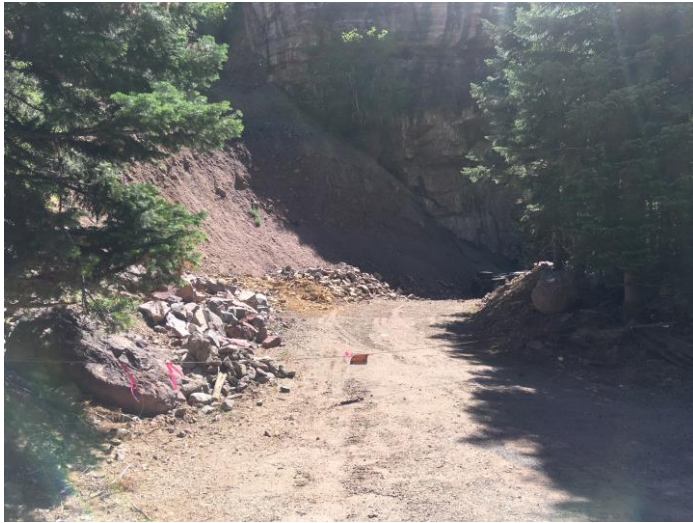
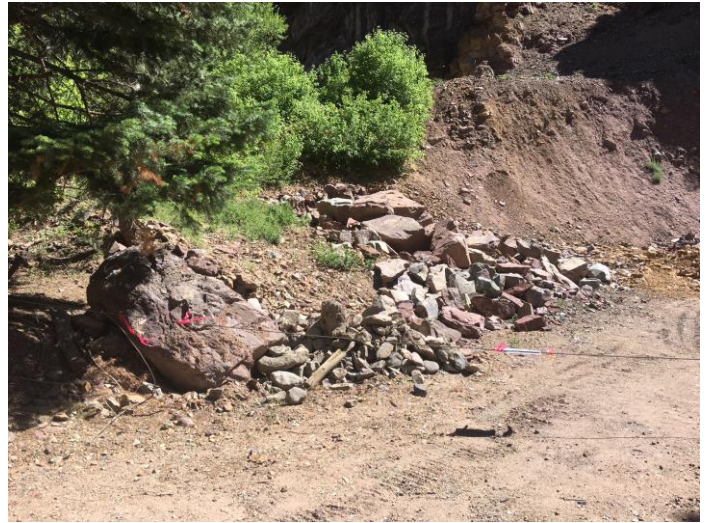
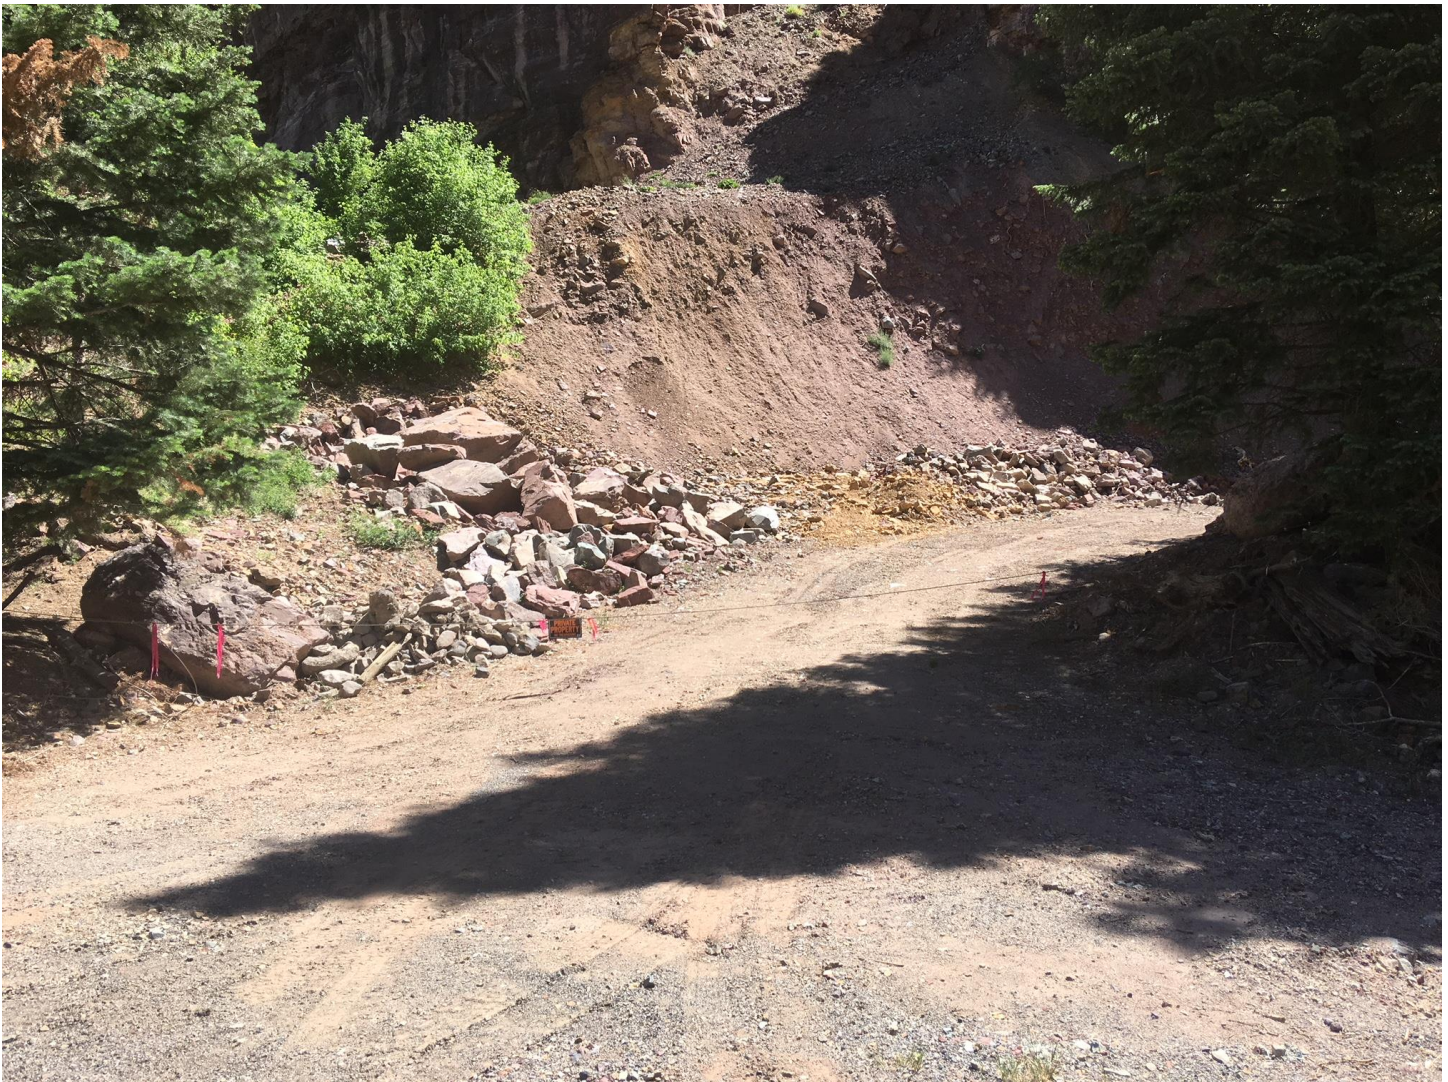
PHOTOGRAPHS

The mine identification sign was observed at the entrance to the mine site.

No mining related activity was observed during the inspection.

Overall the site was in good condition and no unnecessary debris or trash was observed during the inspection.

No erosion or sedimentation issues were noted. There are no major or minor drainage issues within the permit area that warrant addressing.
