MINERALS PROGRAM INSPECTION REPORT
PHONE: (303) 866-3567

MINE NAME: Red Mountain Exploration Drilling	MINE/PROSPECTING ID#: P-2011-014	MINERAL: Molybdenum	COUNTY: Clear Creek
INSPECTION TYPE: Monitoring	INSPECTOR(S): Peter S. Hays	INSP. DATE: July 26, 2018	INSP. TIME: 11:00
OPERATOR: Climax Molybdenum Company	OPERATOR REPRESENTATIVE: Alex Ungers	TYPE OF OPERATION: MP - Mineral Prospecting	
REASON FOR INSPECTION: Normal I&E Program	BOND CALCULATION TYPE: Complete Bond	BOND AMOUNT: \$108,000.00	
DATE OF COMPLAINT: NA	POST INSP. CONTACTS: None	JOINT INSP. AGENCY: None	
WEATHER: Clear	INSPECTOR'S SIGNATURE:

SIGNATURE DATE: July 27, 2018

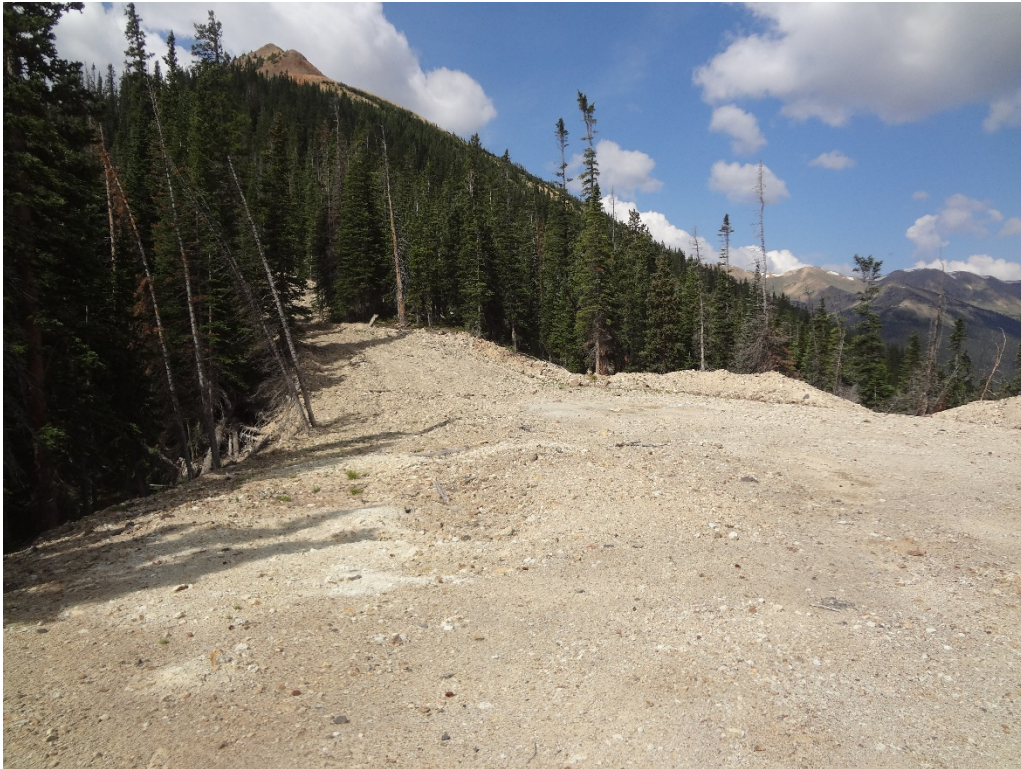
View of drill pad #3 looking west

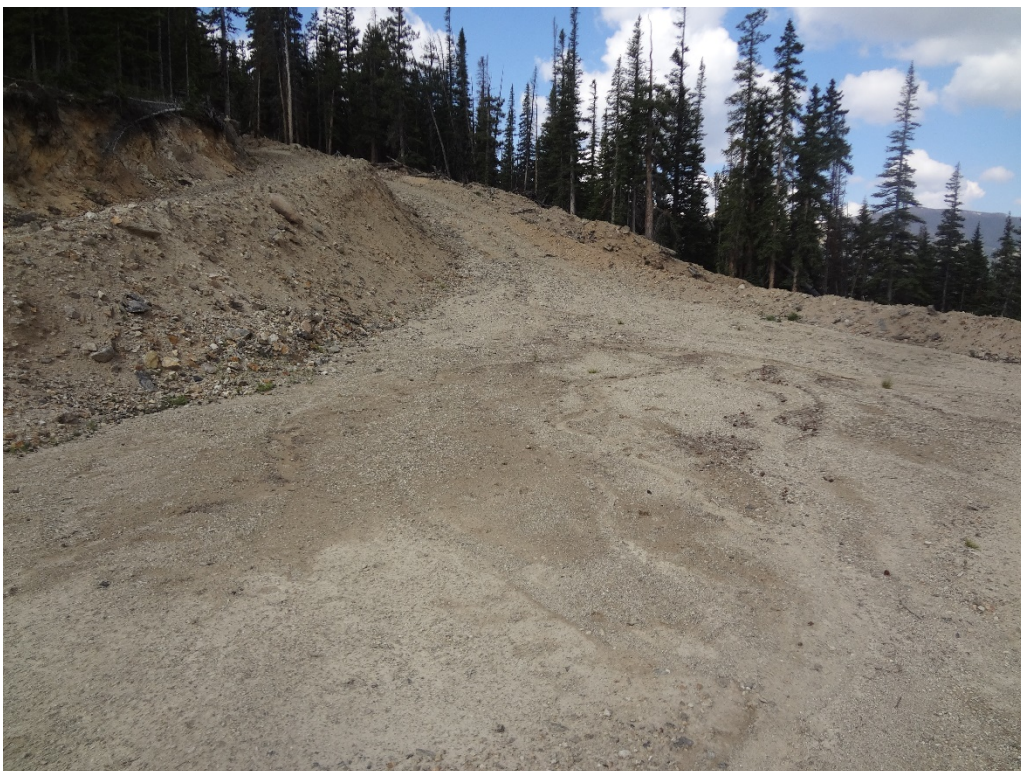
View of drill pad #4 looking west

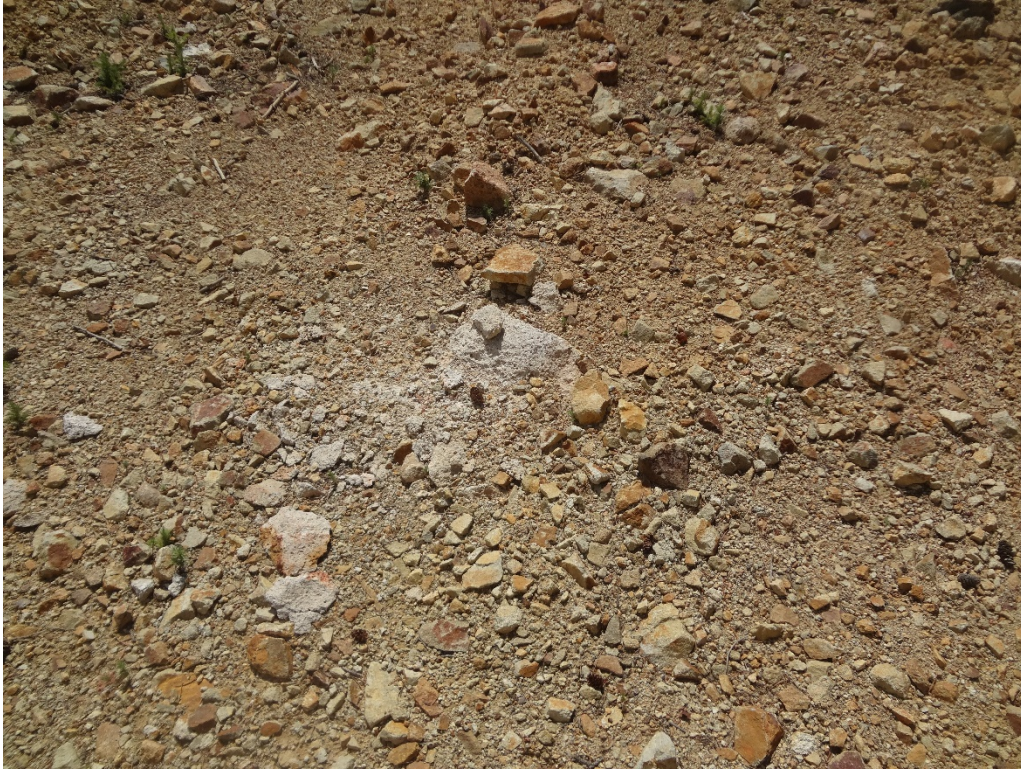
View of capped drill hole on drill pad #2

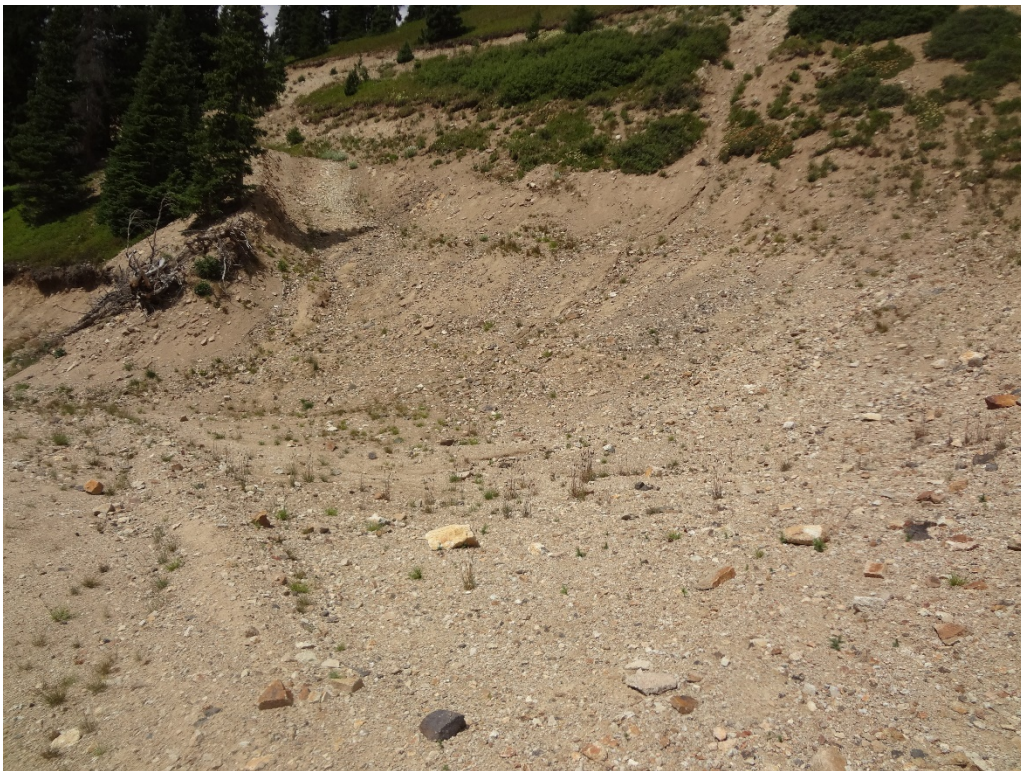
View of drill pad #5 looking west
