**COLORADO**  
Division of Reclamation,  
Mining and Safety  
Department of Natural Resources

<b>Permit Number:</b> C-1981-012 <b>Mine Name:</b> New Elk Mine <b>Operator:</b> New Elk Coal Company, LLC <b>Operator Address:</b> Mr. Louis Head 12250 Highway 12 Weston, CO 81091	<b>County:</b> Las Animas <b>Operation Type:</b> Underground <b>Permit Status:</b> Active <b>Ownership:</b> Private
	<b>Operator Representative Present:</b>  Vince Massarotti
<b>Operator Representative Signature: (Field Issuance Only)</b>

<b>Inspection Start Date:</b> July 31, 2018 <b>Inspection Start Time:</b> 07:45 <b>Inspection End Date:</b> July 31, 2018 <b>Inspection End Time:</b> 11:50		<b>Inspection Type:</b> Coal Partial Inspection <b>Inspection Reason:</b> Normal I&E Program <b>Weather:</b> Clear	
<b>Joint Inspection Agency:</b>  None		<b>Joint Inspection Contacts:</b>  	
<b>Post Inspection Agency:</b>  None		<b>Post Inspection Contacts:</b>  	
<b>Inspector(s):</b>  Robert D. Zuber, P.E.	<b>Inspector's Signature:</b>

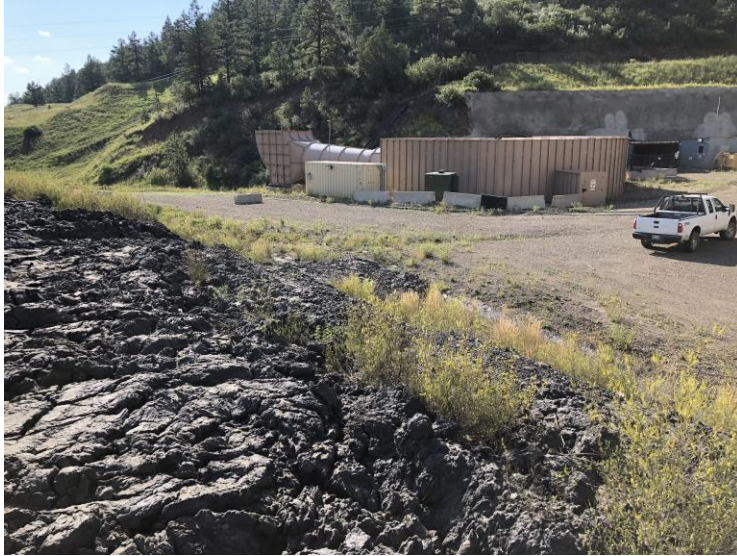
The retaining wall by the Bates Portals appears stable. No problems were seen at the coal storage areas. A very large amount of sediment from Pond 08 has been left to dry on the clean coal storage area. Some of this material slumped into Ditch D24; NECC staff cleaned this during the inspection.

**Pond cleaning material seeping off of clean coal storage area**

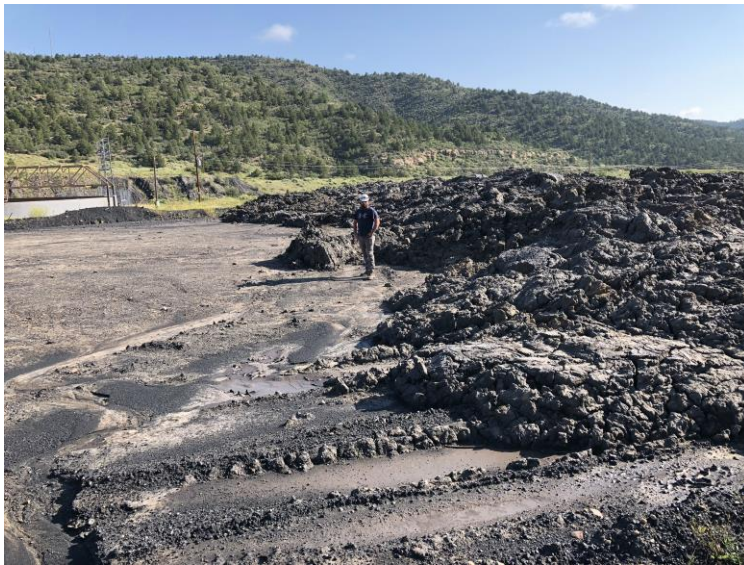
**Pond cleaning material on clean coal storage area**

Erosion on DWDA#2 persists, although the structure is generally stable. The sump below DWDA#2 did not appear to need immediate maintenance. Pond cleaning material at the west end of DWDA#2 needs to be hauled to the RDA as soon as it is dry enough. The placement of this material could be altered to facilitate drying; there was at least one puddle of water within this material.

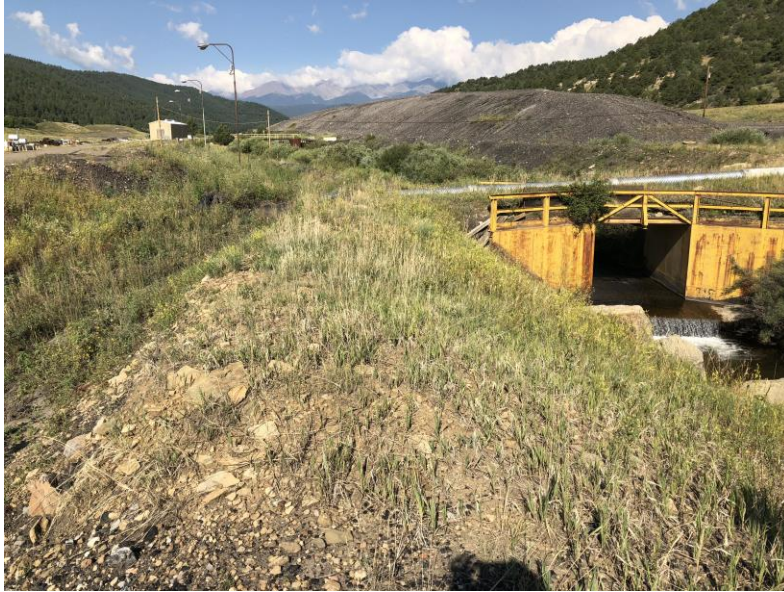
**Ditch D15 with DWDA#2 in background**

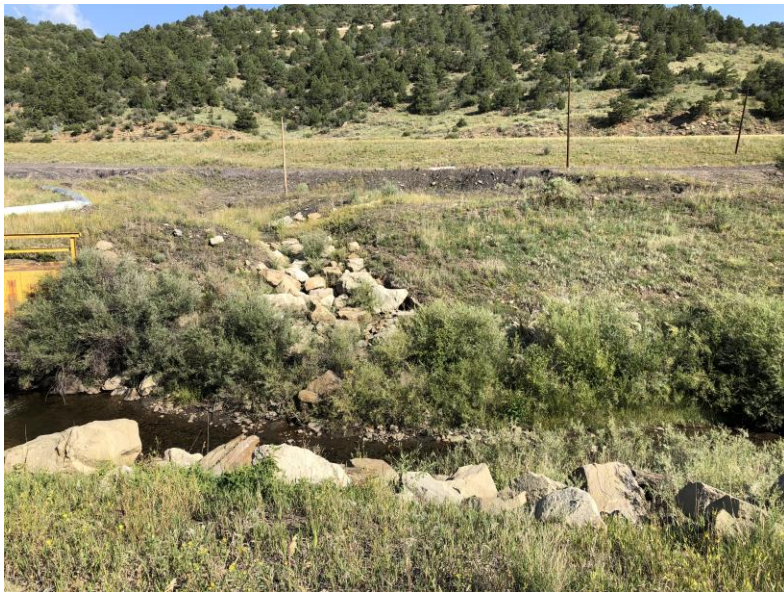
The riprap outfall below the SAE east of DWDA#2 appeared to be stable, with no erosion or other problems.

**Outfall below SAE that is east of DWDA#2**

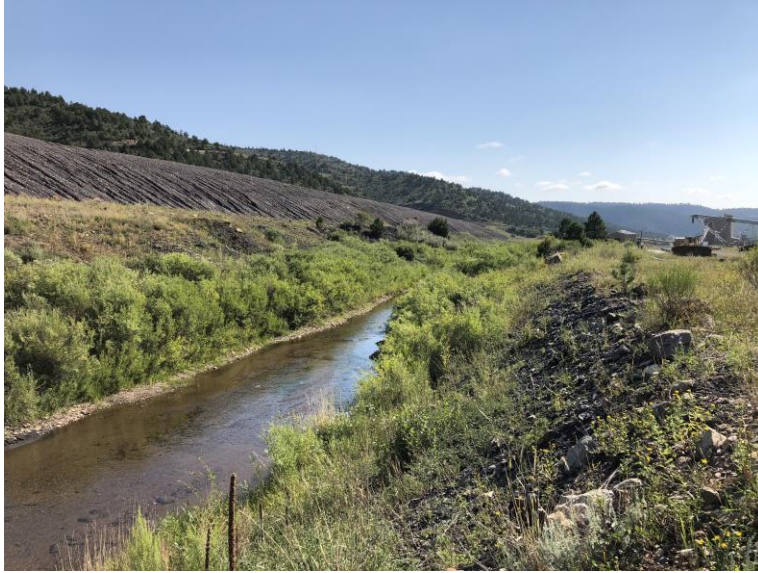
The Middle Fork of the Purgatoire River was inspected, and no eroding banks or signs of pollutant loading from the New Elk Mine were seen. Particular areas that were inspected include:

**Middle Fork of Purgatoire River, adjacent to DWDA#2**

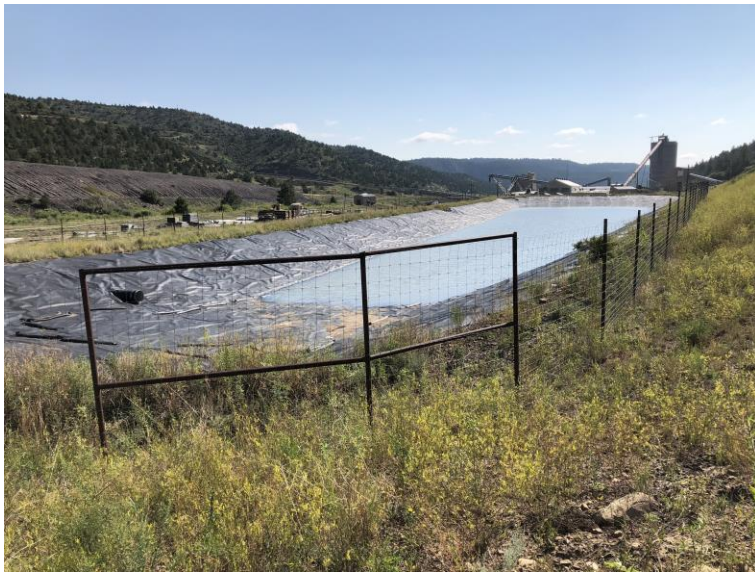
**Pond 001A**

Ponds 001A, 006A, 007A, and 08 were inspected. None of them were discharging, but all held at least a small amount of water. This water was mostly turbid due to recent rain/runoff events. NECC staff were not pumping water between ponds during the inspection. No significant issues were seen with the embankments or spillways of any ponds, although the top of the Pond 08 dam is still very bare. The banks of Pond 08 should be watched closely for sluffing or other erosion problems; if problems develop, additional stabilization practices may be warranted.

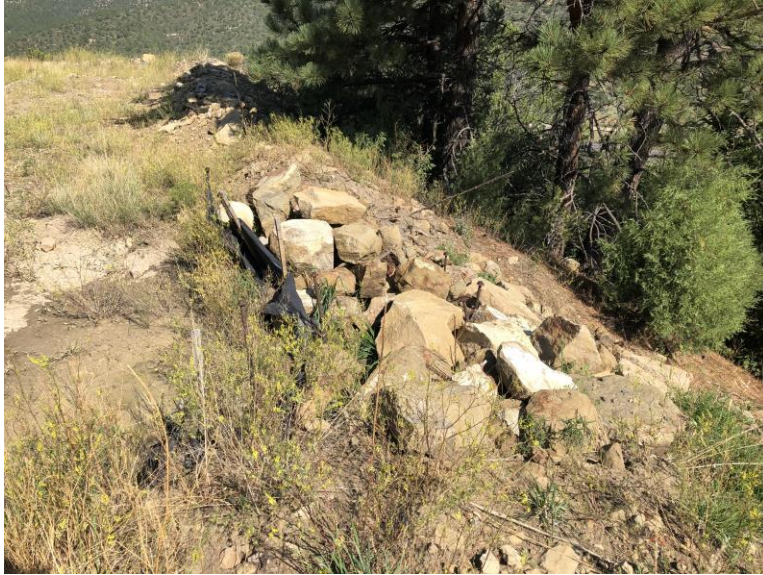
The water tank pad and the hill below the water tanks was observed, and no erosion or other problems were seen. At the point where runoff exits the pad, NECC staff have added riprap (replacing silt fence and straw bales), and this improvement appears to be working well. Along the road up to the tank pad, the cut slope was hydromulched, but very little grass is growing on it.

**Riprap at runoff point for water tank pad**

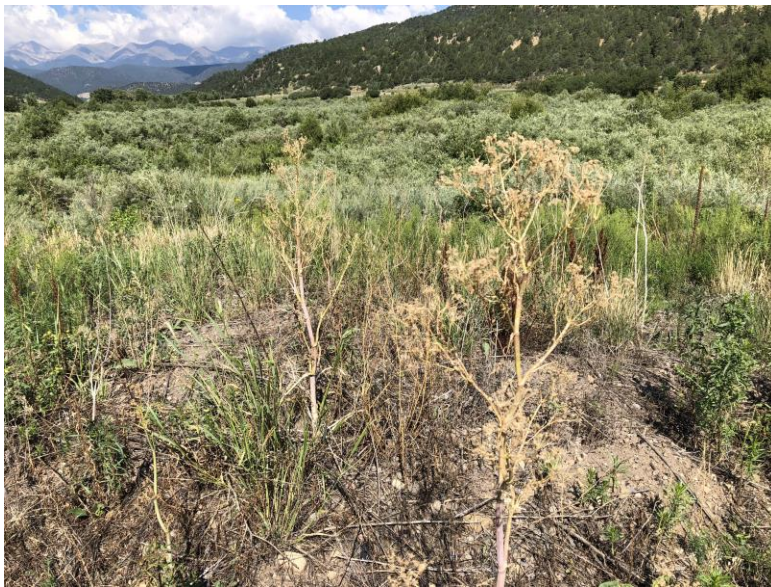
- Poison hemlock west of the C&W Shop.
- Bindweed along the road to the West Portal.

**Poison Hemlock that has been treated (west of C&W Shop)**

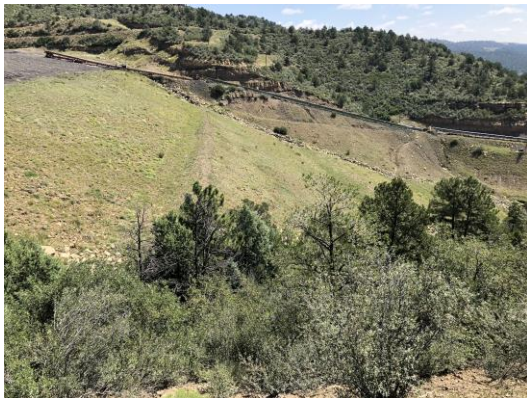
There is good vegetation cover on the majority of the reclaimed portion of the RDA.

**Lower RDA (reclaimed portion)**

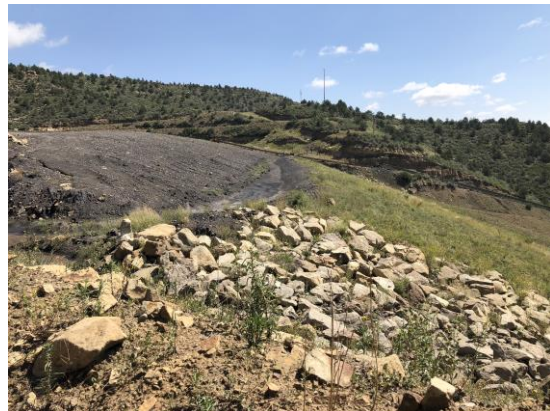
The interface between the upper and lower portions of the RDA is in good shape: the ditch and sumps appear to be working well to prevent sediment from the upper part impacting the lower (reclaimed) part. In particular, the sumps appear to be preventing excess sediment movement into the riprap of the channels. A small problem is erosion at the east end of the ditch between the lower and upper portions of the RDA (beside the east side channel); some riprap should be added to this segment to prevent further erosion.

**Interface of RDA – reclaimed area to right**

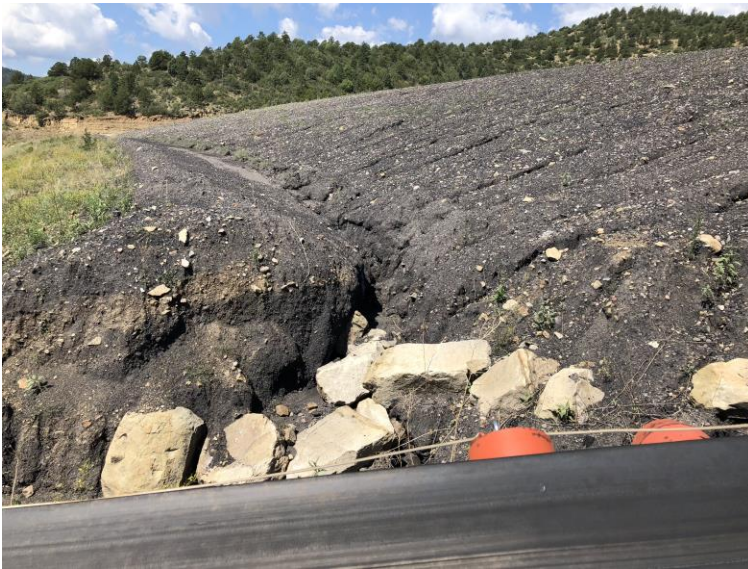
**Interface of upper and lower portions of RDA -  
East side where additional riprap should be placed**

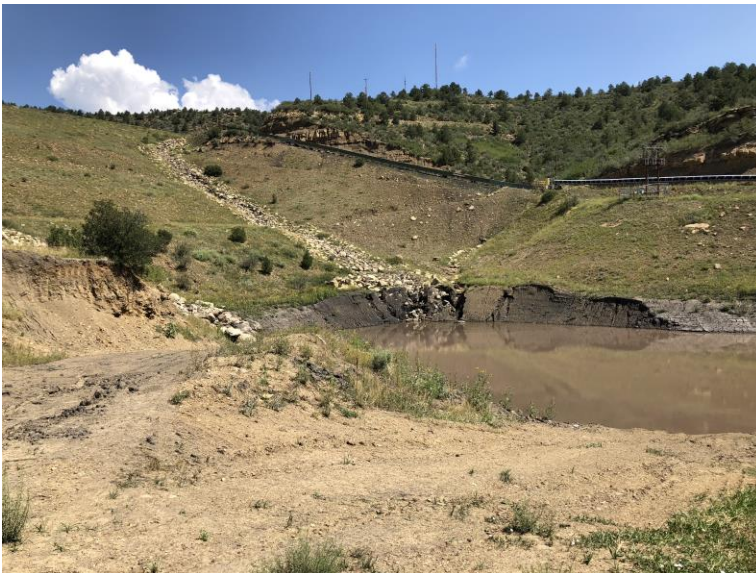
The water in Pond 08 was approximately 17 feet below the invert (aka spill point) of the emergency spillway; this water level is several feet lower than the maximum level for the pond to have capacity for a 10-year event (the pond met the compliance requirement with room to spare). The impounded water in Pond 007A was below six rows of holes in the primary spillway (indicating that water would flow through the lowest hole if the valve was opened), and Pond 007A was in compliance with need to have capacity for a 10-year event.

**RDA and Pond 08**
