MINERALS PROGRAM INSPECTION REPORT

MINE NAME: Apex Lode	MINE/PROSPECTING ID#: M-2014-011	MINERAL: Zinc and silver	COUNTY: Garfield
INSPECTION TYPE: Monitoring	INSPECTOR(S): Amy C. Yeldell	INSP. DATE: July 20, 2018	INSP. TIME: 10:30
OPERATOR: Strong Mining Company	OPERATOR REPRESENTATIVE: Ed & John Strong	TYPE OF OPERATION: 110(1) - Hard Rock Limited Impact	
REASON FOR INSPECTION: Memo Of Understanding	BOND CALCULATION TYPE: None	BOND AMOUNT: \$34,308.00	
DATE OF COMPLAINT: NA	POST INSP. CONTACTS: DRMS	JOINT INSP. AGENCY: U.S. Forest Service	
WEATHER: Clear	INSPECTOR'S SIGNATURE:

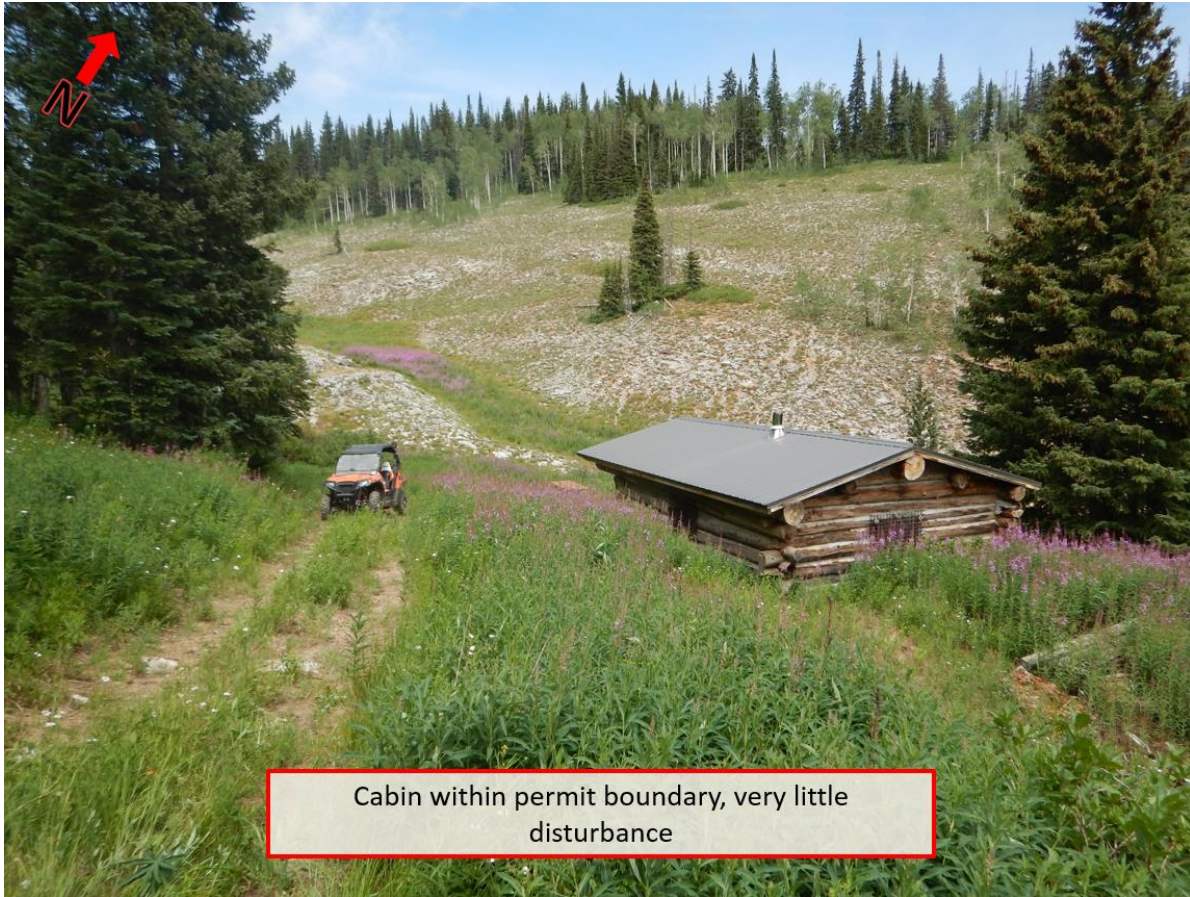
The access road to the mine site is largely overgrown with native vegetation due to limited use. Overall the site is very lush due to its location. There were no weeds present and a high density of vegetation with the exception of the rock outcrop areas. The road and areas surrounding the cabin have self-reclaimed with volunteer native vegetation. The cabin on site is approximately 20 by 30 feet. It appears to be neat and in good working order. There is no excess material or debris around the cabin area.

Cabin within permit boundary, very little disturbance

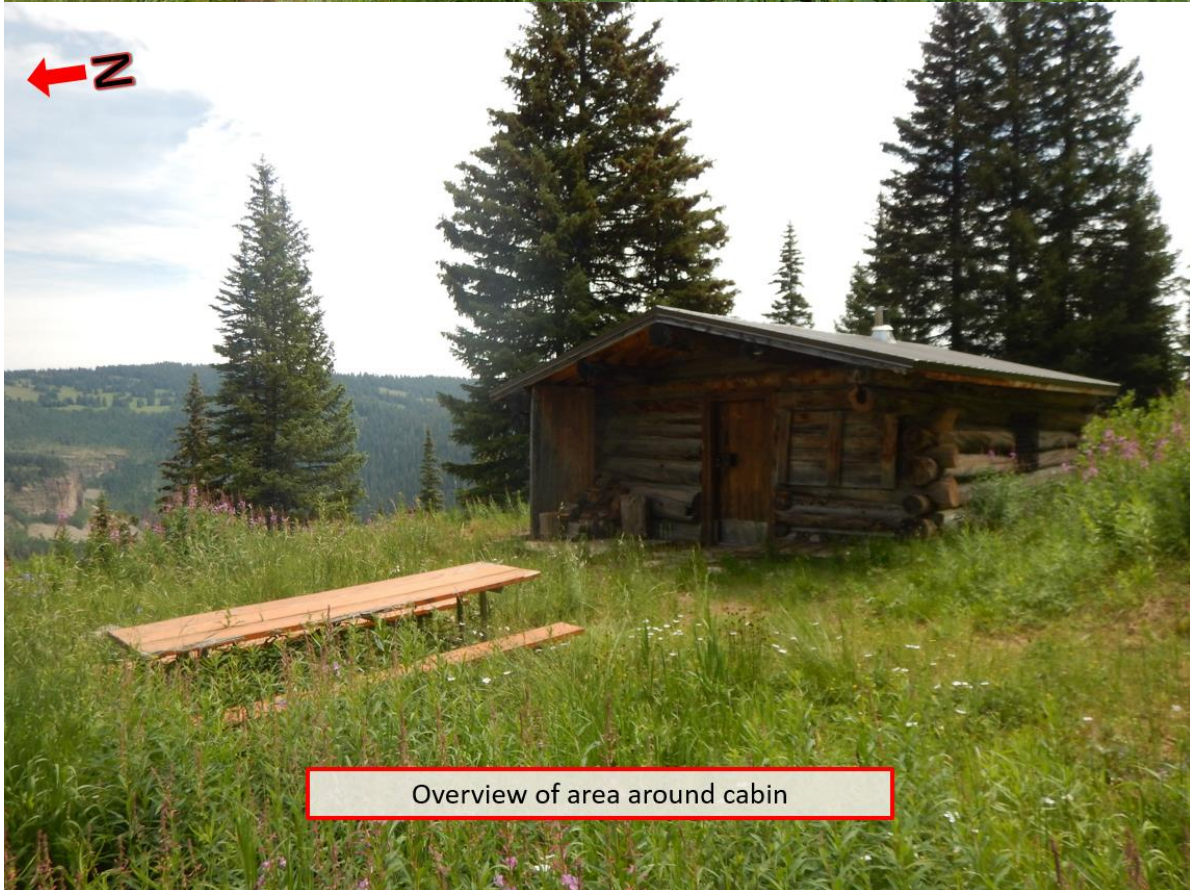
Overview of area around cabin

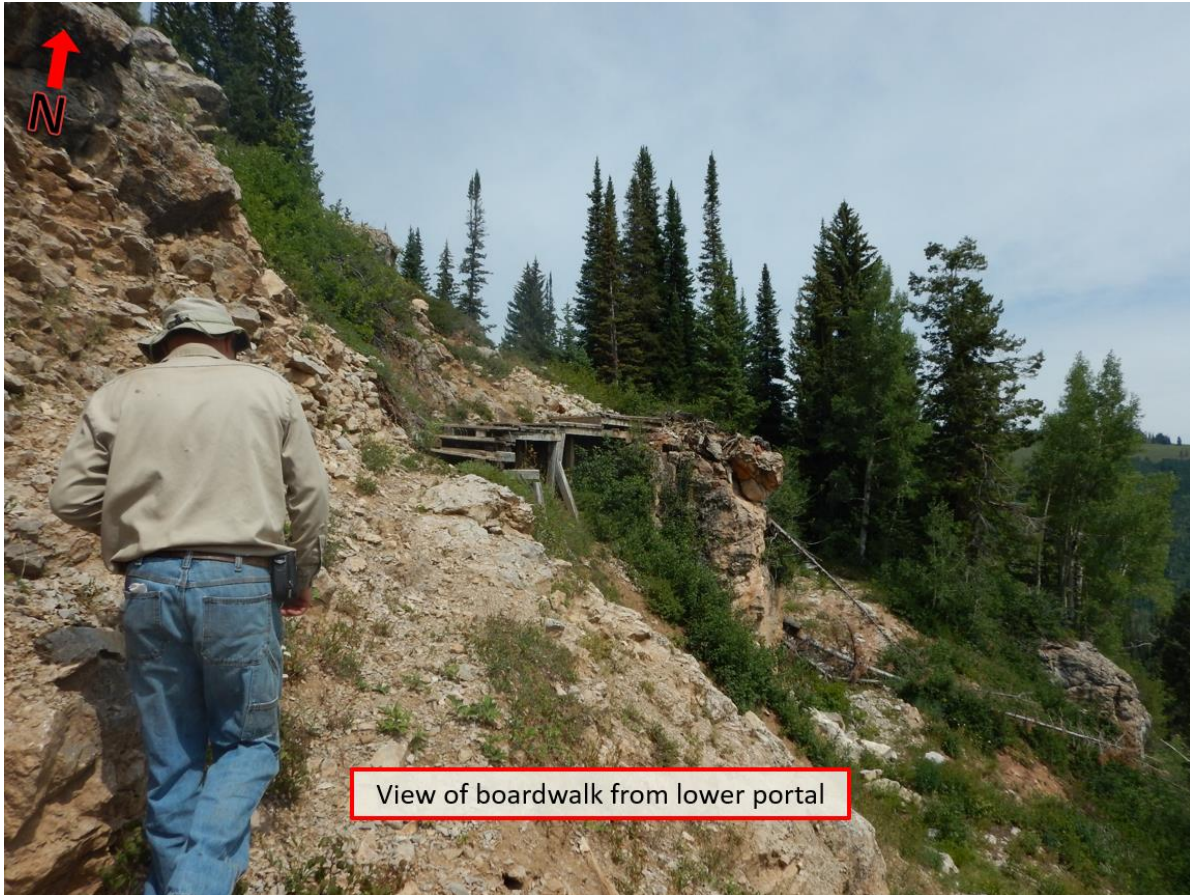
To access the lower portal one walks across a wooden boardwalk since the slope of the hill is quite steep. This boardwalk allows you easily traverse the hillside. There is limited working room at the mouth of the portal. An area approximately 6 by 10 feet is flat. Current work in this area has been to dig out the opening to the portal after the hillside slid and buried the portal. Excavated material is being pitched downhill but appears to be staying within the permit boundary. The Division would like to caution the operator in this activity given its potential to create an offsite impact. There are no stockpiles of ore on site at this time. The operator does not have Forest Service approval to mine, as there is no approved Plan of Operations in place. The portal opening work is being conducted under a Categorical Exclusion approval which expires this year.

View of boardwalk from lower portal

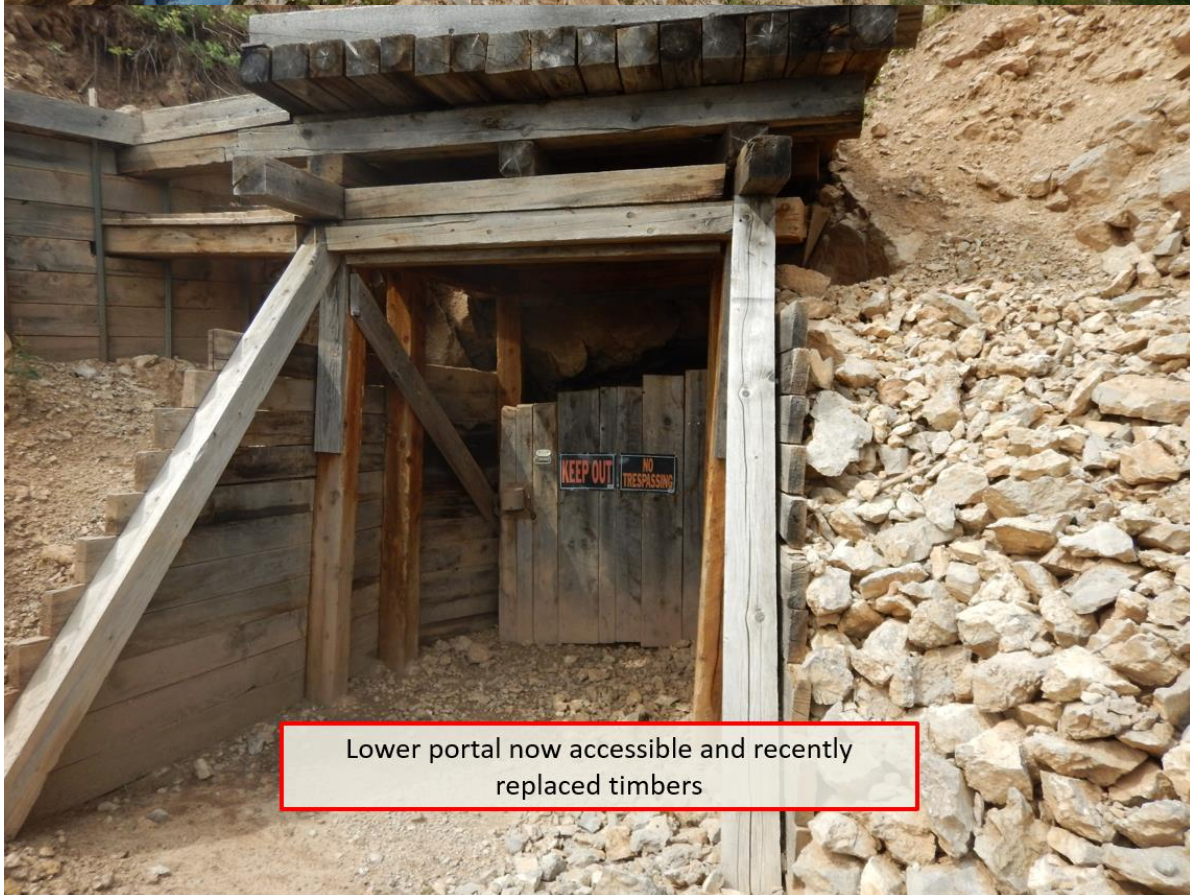
There are two portals located to the southeast of the cabins. There are timbers and metal stored on the flat area between the two portals. All materials is neatly stored and organized. The materials are being used to sure up the lower portal and make repairs from there the slope above the lower portal eroded.

Lower portal now accessible and recently replaced timbers
