MINERALS PROGRAM INSPECTION REPORT
PHONE: (303) 866-3567

MINE NAME: Garrett Pit	MINE/PROSPECTING ID#: M-1978-271	MINERAL: Sand and gravel	COUNTY: Conejos
INSPECTION TYPE: Preoperation Inspection	INSPECTOR(S): Lucas J. West	INSP. DATE: August 3, 2018	INSP. TIME: 10:45
OPERATOR: Asphalt Gravel Products, Inc.	OPERATOR REPRESENTATIVE: Alonzo Salazar	TYPE OF OPERATION: 112c - Construction Regular Operation	
REASON FOR INSPECTION: Preoperation Inspection	BOND CALCULATION TYPE: None	BOND AMOUNT: \$181,755.00	
DATE OF COMPLAINT: NA	POST INSP. CONTACTS: None	JOINT INSP. AGENCY: None	
WEATHER: Clear	INSPECTOR'S SIGNATURE:

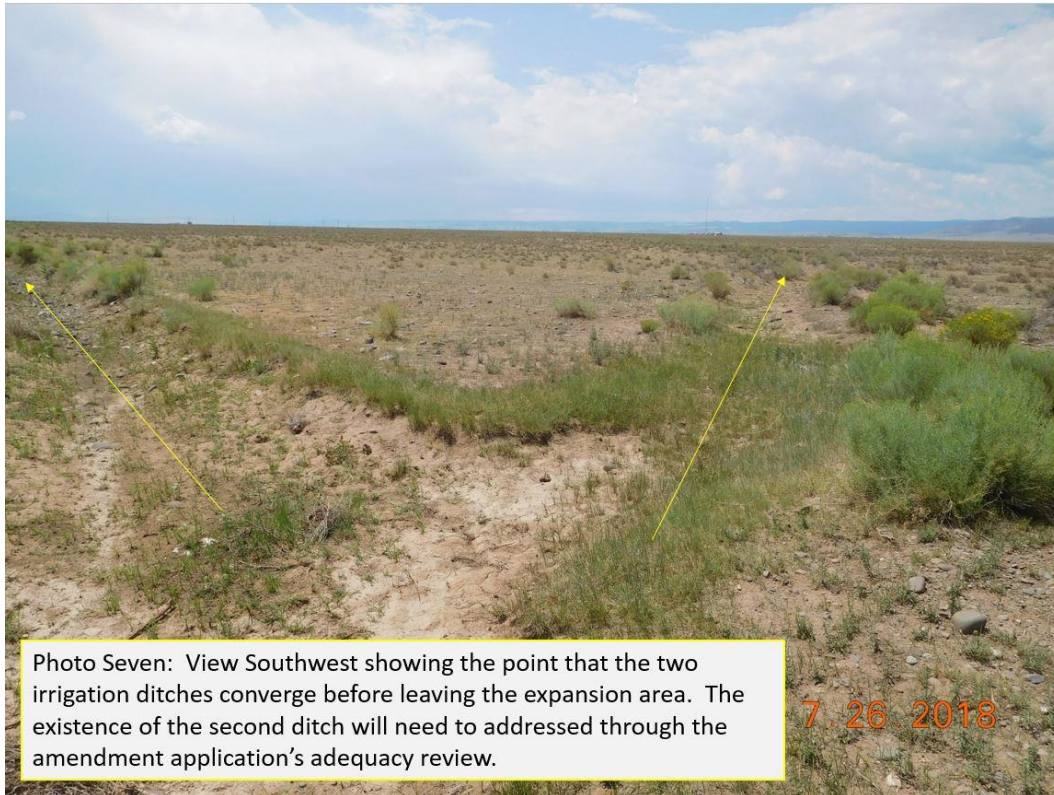
Photo Seven: View Southwest showing the point that the two irrigation ditches converge before leaving the expansion area. The existence of the second ditch will need to be addressed through the amendment application's adequacy review.
