## MINERALS PROGRAM INSPECTION REPORT

<b>MINE NAME:</b> Hartman Pit	<b>MINE/PROSPECTING ID#:</b> M-1997-087	<b>MINERAL:</b> Gravel	<b>COUNTY:</b> Pueblo
<b>INSPECTION TYPE:</b> Surety Release Inspection	<b>INSPECTOR(S):</b> Elliott R. Russell	<b>INSP. DATE:</b> May 24, 2018	<b>INSP. TIME:</b> 09:00
<b>OPERATOR:</b> Arnolds Custom Seeding, LLC	<b>OPERATOR REPRESENTATIVE:</b> None	<b>TYPE OF OPERATION:</b> 112c - Construction Regular Operation	
<b>REASON FOR INSPECTION:</b> Surety Release Requested	<b>BOND CALCULATION TYPE:</b> None	<b>BOND AMOUNT:</b> \$139,285.00	
<b>DATE OF COMPLAINT:</b> NA	<b>POST INSP. CONTACTS:</b> None	<b>JOINT INSP. AGENCY:</b> None	
<b>WEATHER:</b> Clear	<b>INSPECTOR'S SIGNATURE:</b>

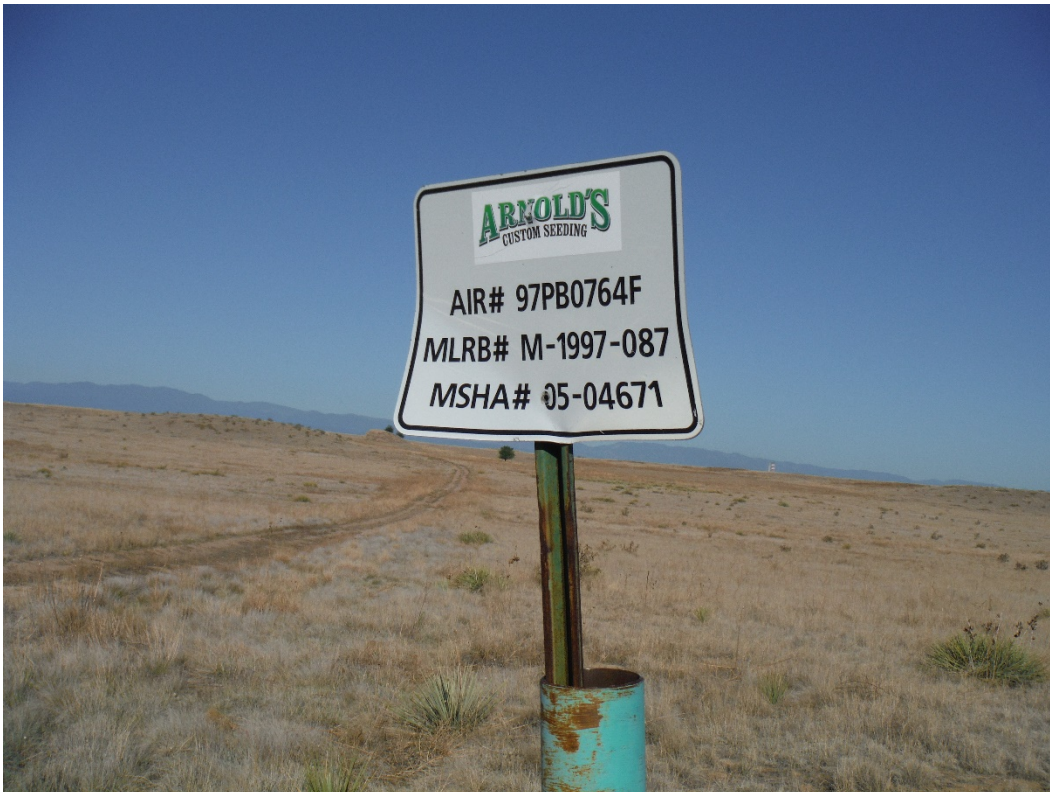
Mine identification sign posted at the entrance to the site; looking west.

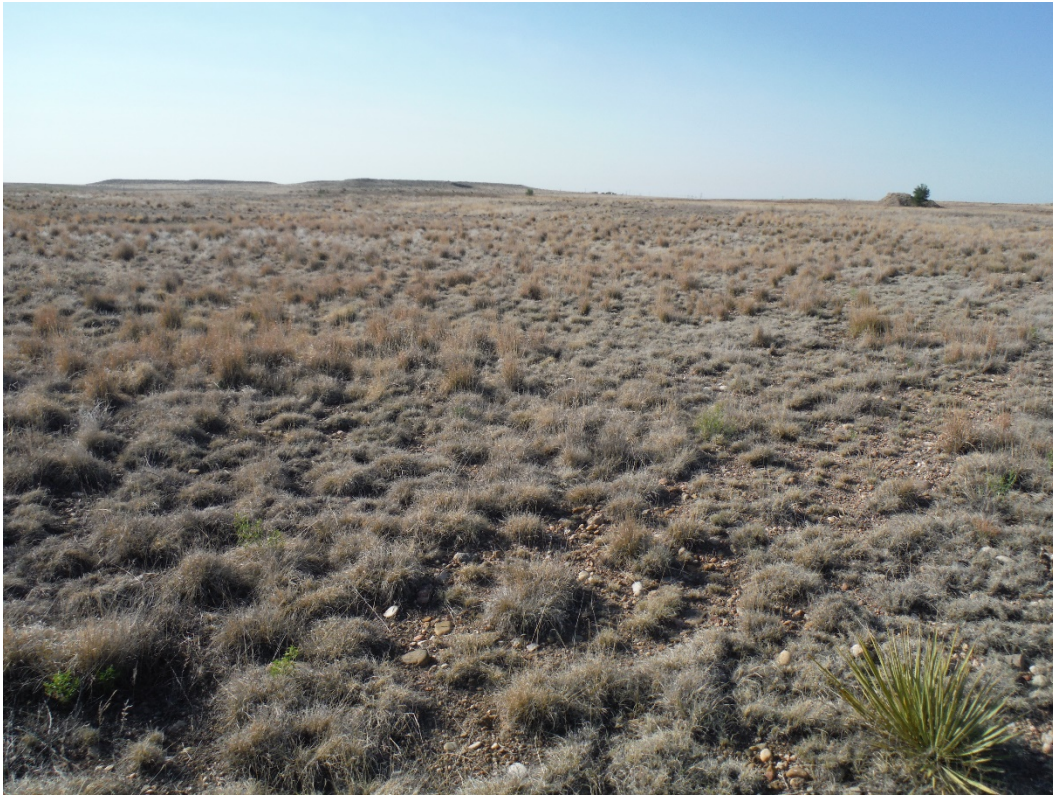
Sample photo of a portion of the permit with successful reclamation; looking south.

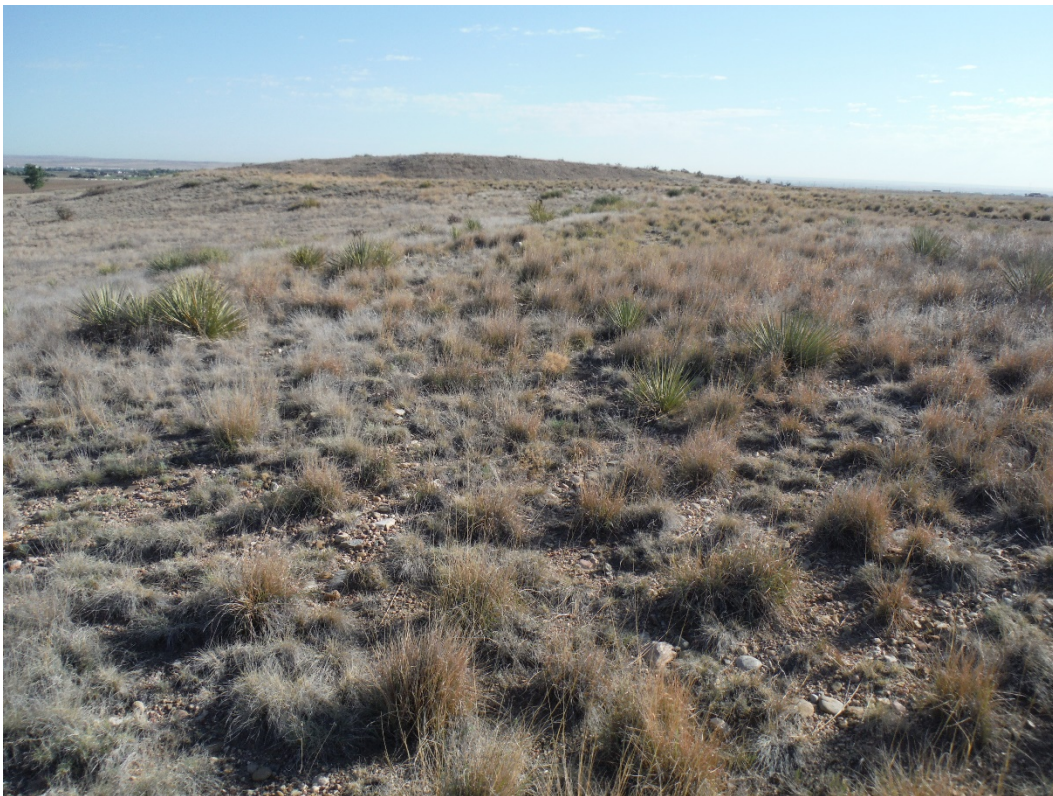
Sample photo of a portion of the permit with successful reclamation; looking north.

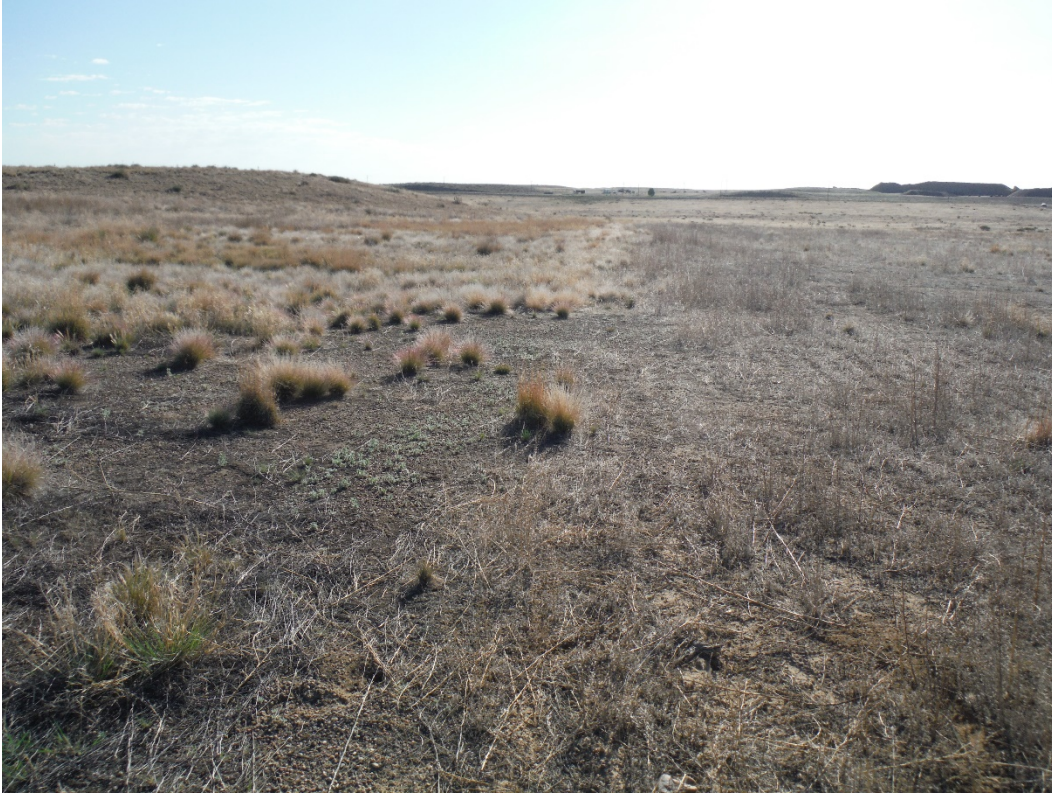
Sample photo of the difference between successful and unsuccessful reclamation; looking east.

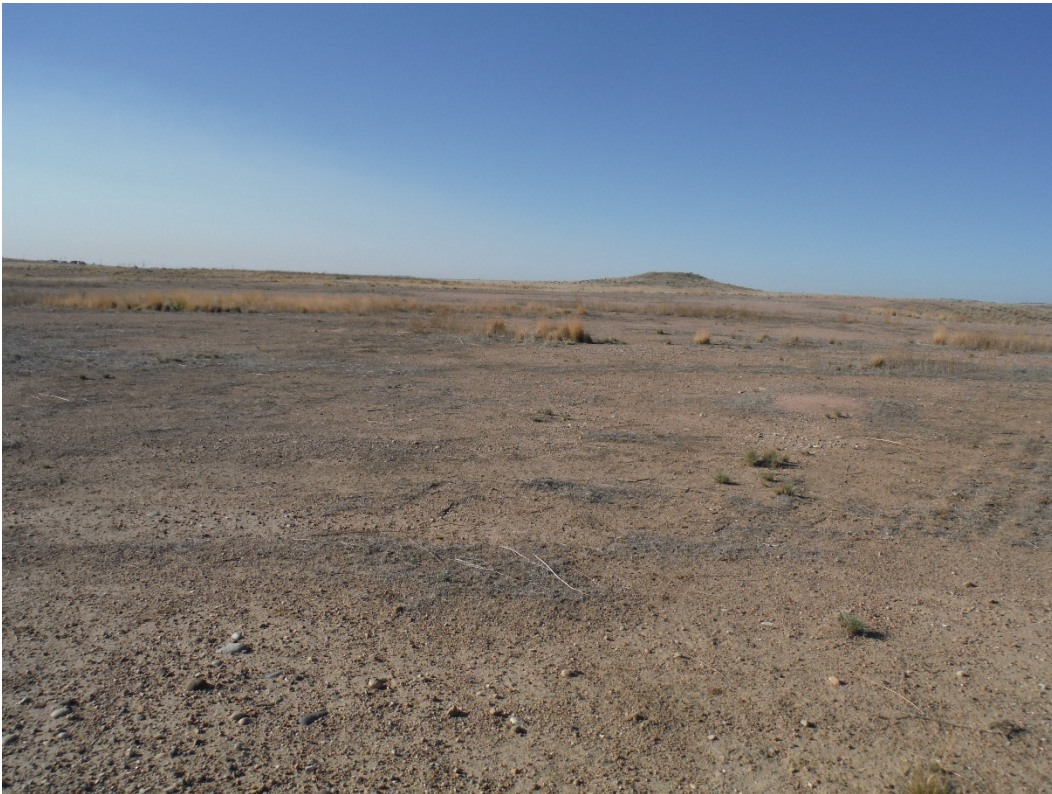
Reclamation Success: Reclamation efforts performed at the mining operation appear to have been partially successful. The site consists of a large barren area, approximately 19 acres in size, in the central portion of the disturbance that has yet to meet revegetation standards. Note, the access road and ½ acre stockpile is located within this area, however with the approval of TR-01 in 2007, these features will remain after reclamation is complete. The attached inspection report map depicts the approximate 19-acre barren area. The Division has included the coordinates of this area should the Operator wish to pursue an acreage reduction.

Sample photo of the large barren area; looking south.

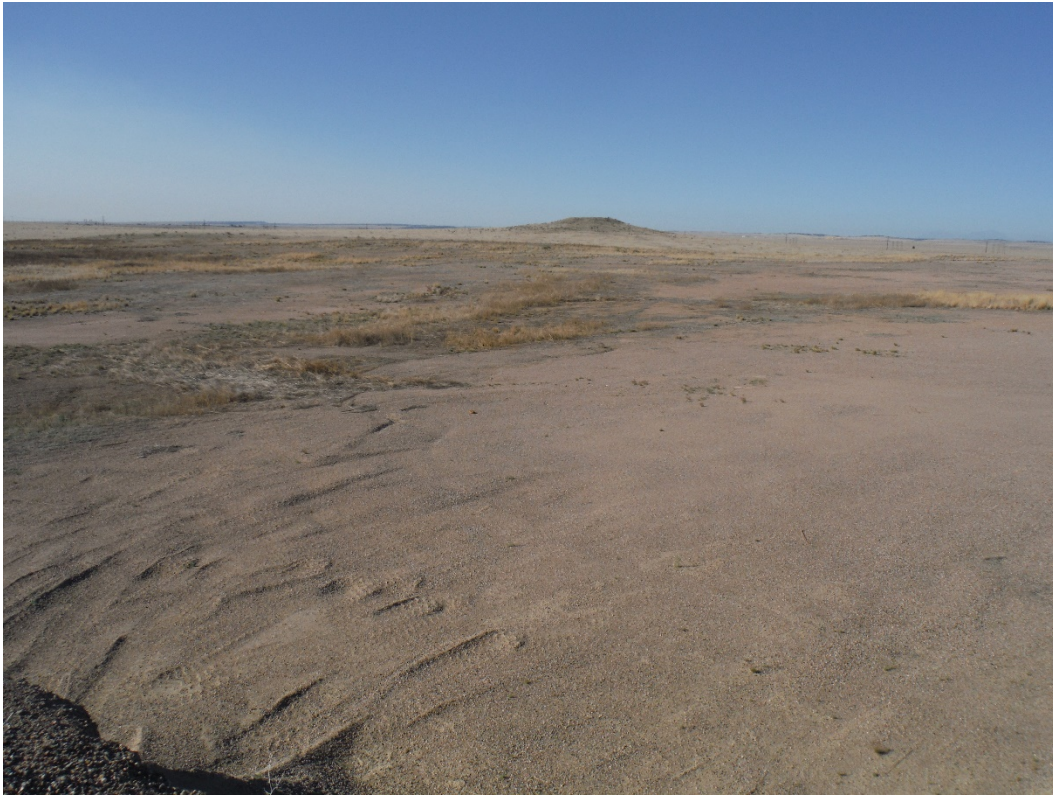
Sample photo of the large barren area; looking south.

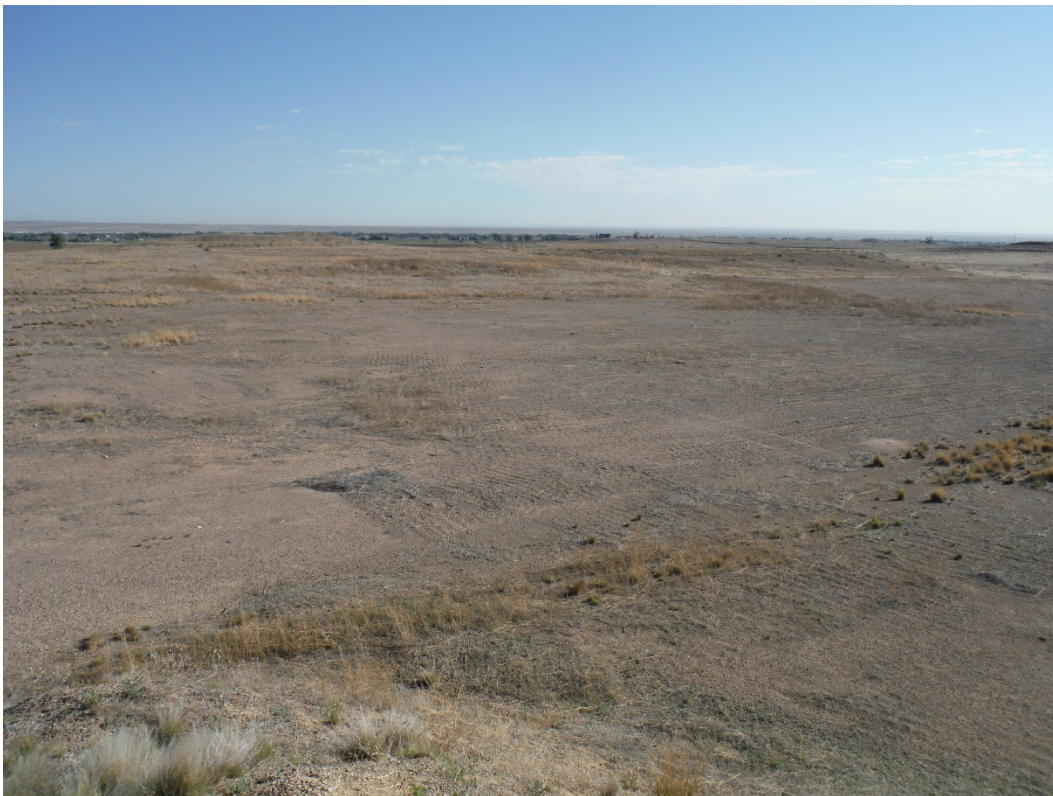
Sample photo of the large barren area; looking north.

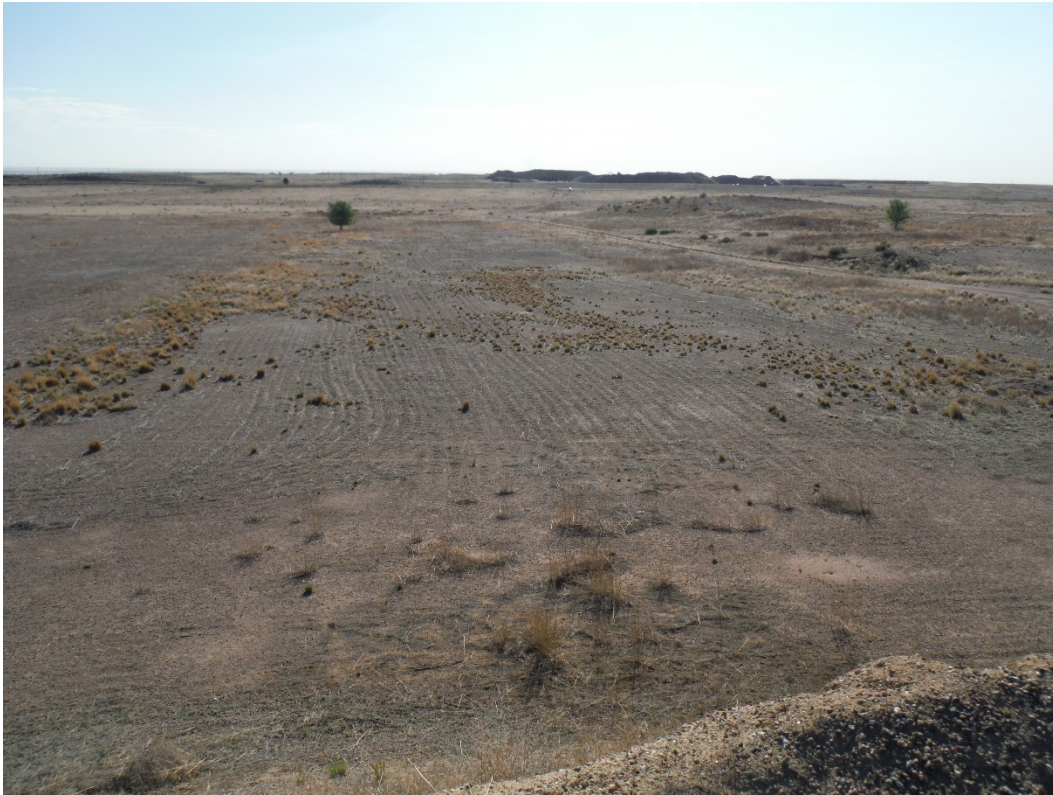
Sample photo of the large barren area; looking east.

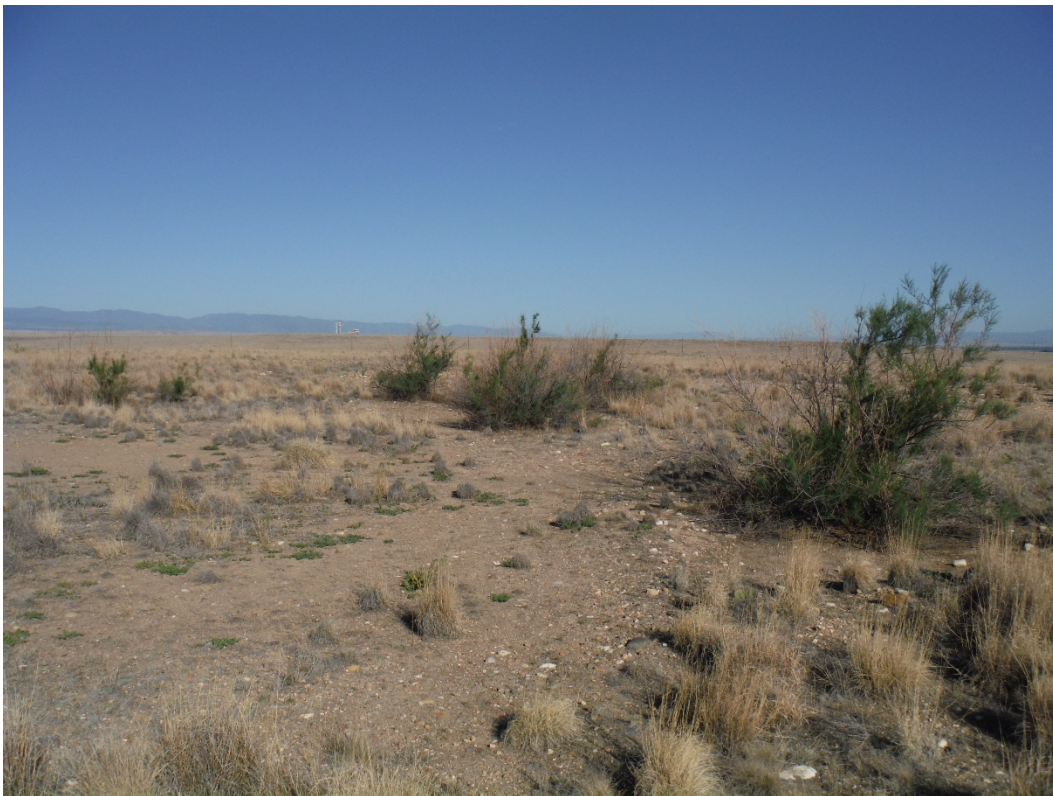
Revegetation: Outside of the barren area discussed above, the Division observed a healthy landscape with a diverse vegetative cover including blue grama, sideoats grama, switchgrass, and buffalo grasses. The vegetative cover appears to match adjacent off-site areas. Although the site was treated for tamarisk, a noxious weed List B species, in 2016, the Operator will need to re-treat the remaining tamarisk observed across the site.

Tamarisk needing to be controlled; looking northwest.

- **Submit the delinquent 2018 Annual Report, Map, and Fee.**
- **Submit TR-02 addressing a revision to the Reclamation Plan and Reclamation Plan Map to account for the three areas with 2H:1V slopes OR grade the areas flat.**
- **Re-treat and control the tamarisk on-site.**

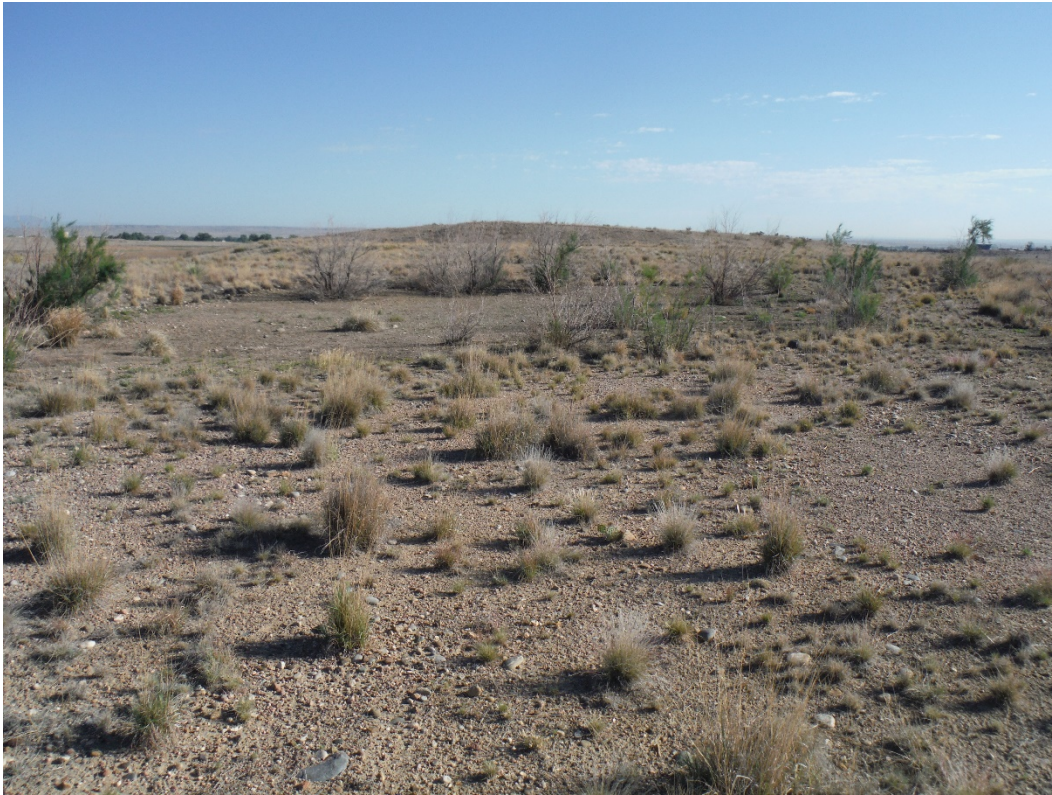
Tamarisk needing to be controlled; looking north.

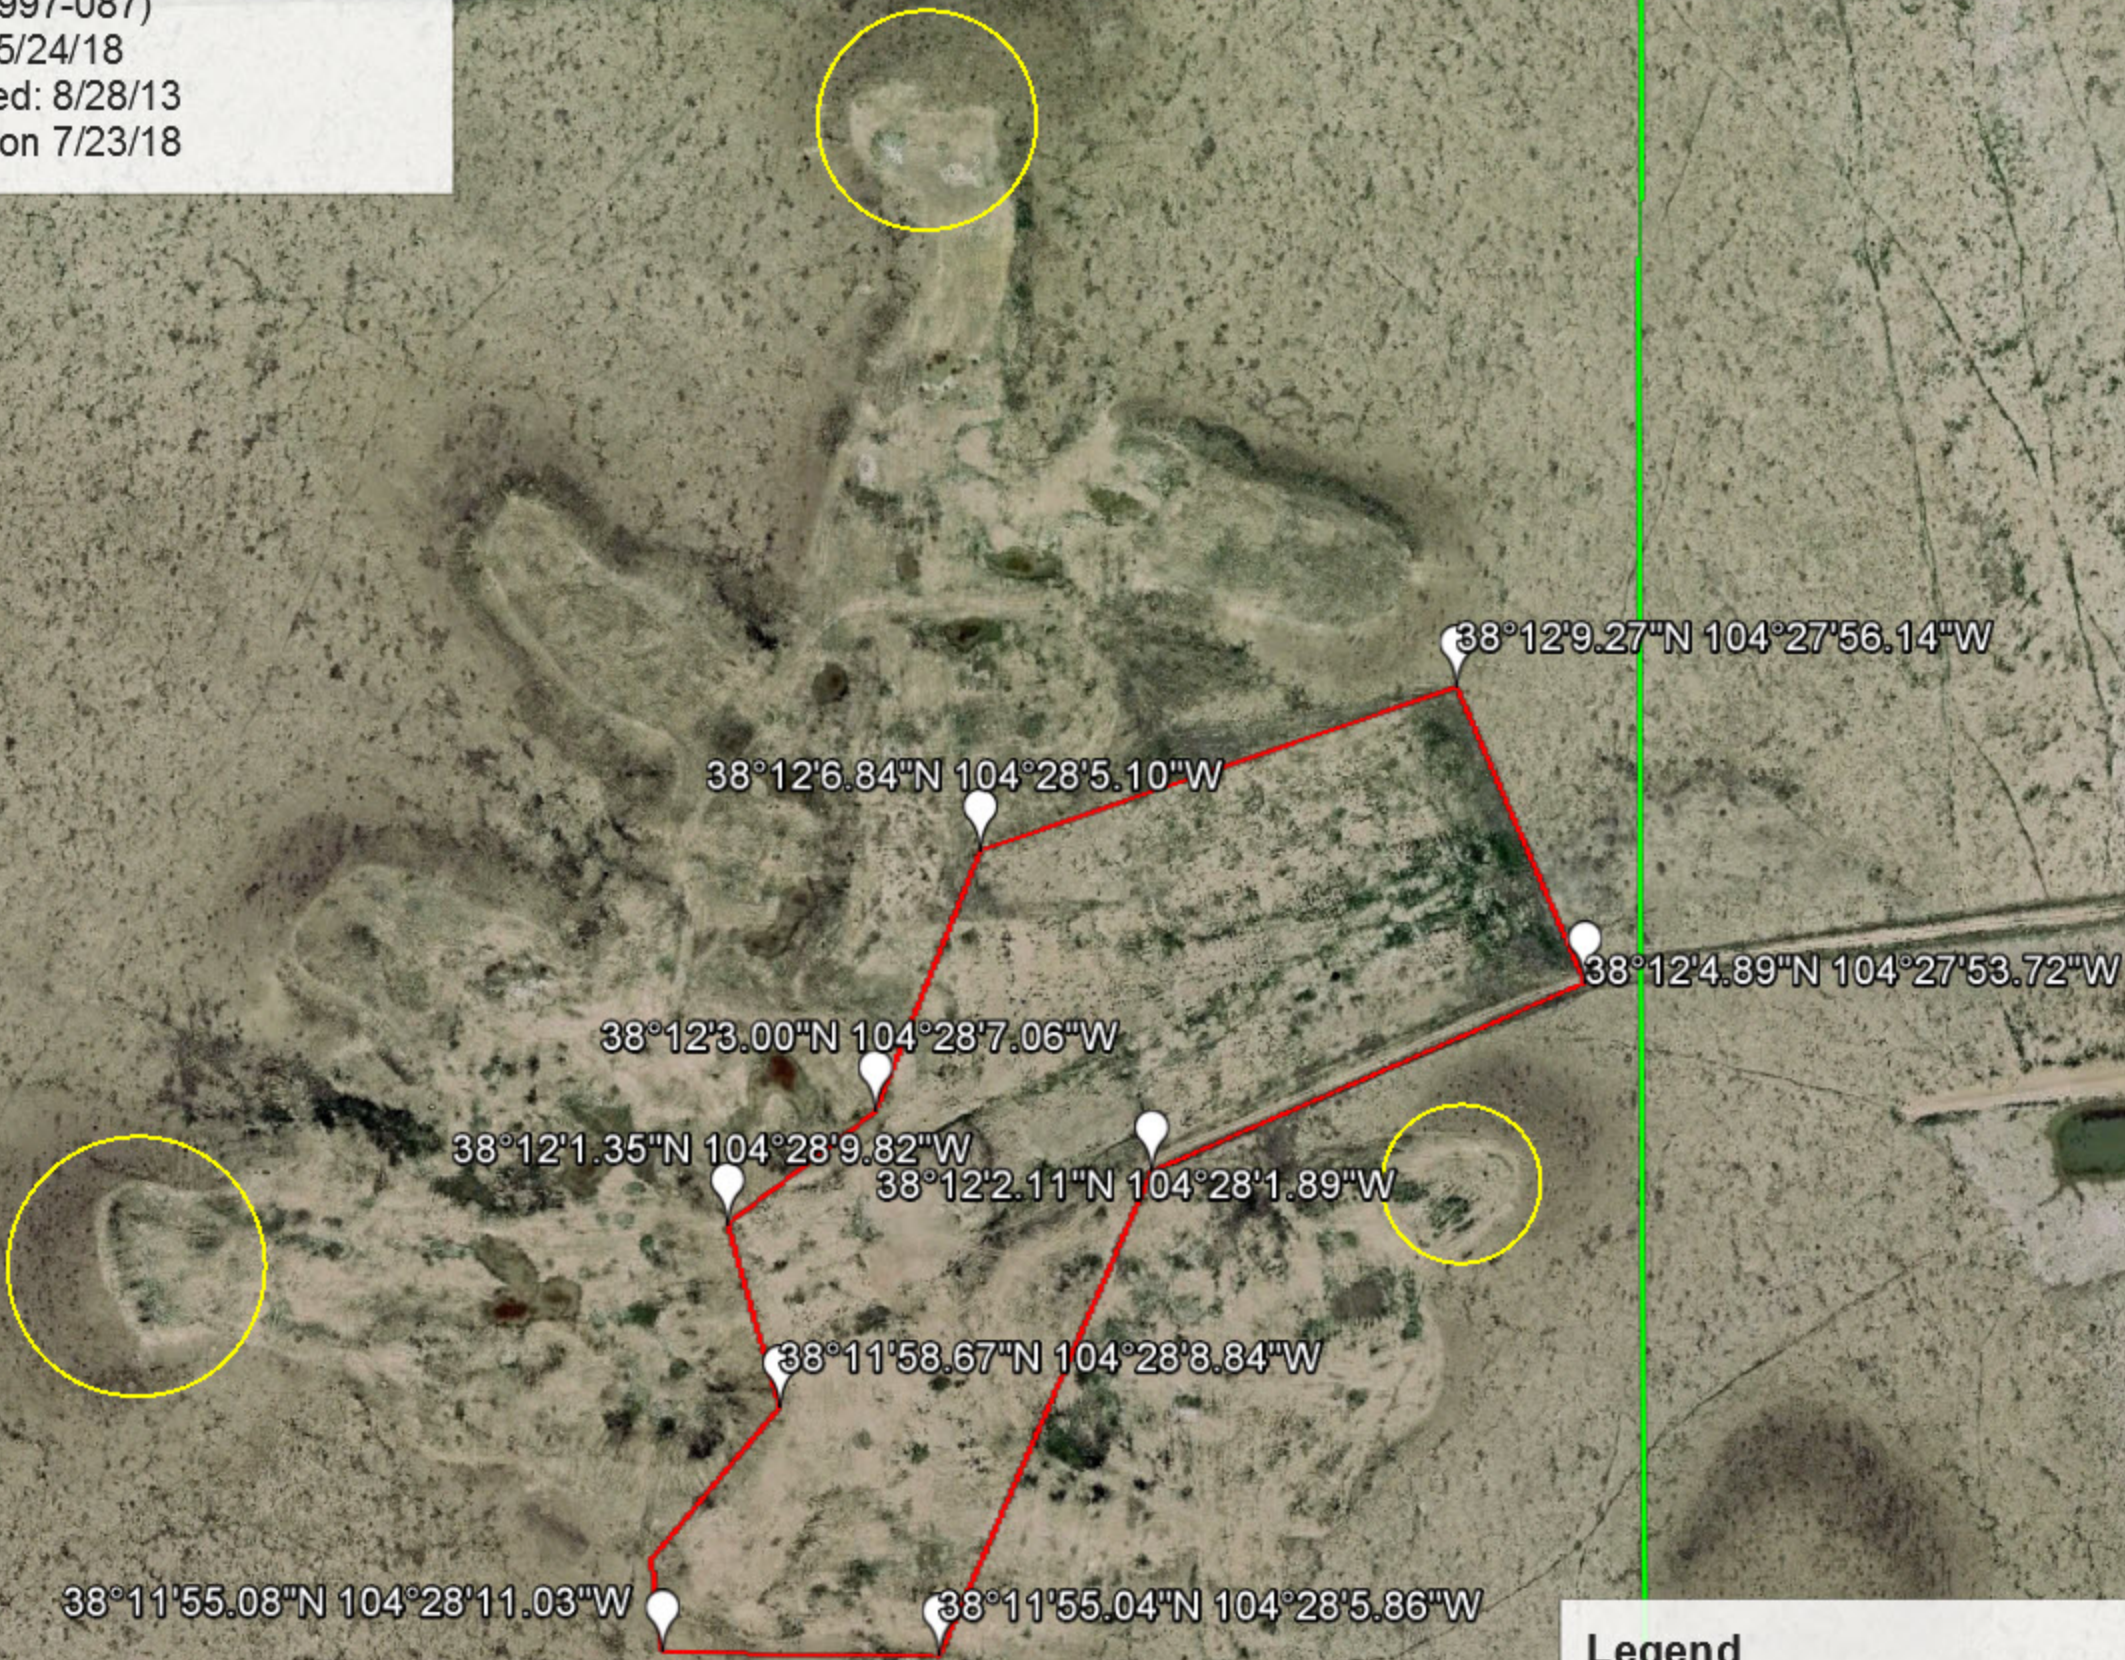
# Inspection Report Map

Backfilling and Grading: All slopes appeared to be appropriately backfilled and/or graded except the three areas, identified following the June 27, 2016 inspection, which still did not meet the approved Reclamation Plan. These three areas observed are located at the edges of three mined-out "gravelly fingers" and consist of approximately 2H:1V slopes starting at the pit floor up to undisturbed topography. Please refer to attached inspection report map for the specific location of these areas. The approved Reclamation Plan states that the mining operation will not create backslopes as the operation consists solely of removing the tops of the gravel knolls, creating a level pit floor. The approved Reclamation Plan Maps also reflects this with post-mining contours showing that the margins of the operation would day-light to existing topography. It appears the mining operation did not fully mine out the knolls, leaving these slopes. Since the approved Reclamation Plan and Map are different than the current conditions, the Operator will need to either grade these areas flat OR submit a Technical Revision (TR-02) to the permit revising the Reclamation Plan and Reclamation Plan Map. Attached is the Division's Technical Revision cover sheet, which can also be found on the Division website.
