**MINERALS PROGRAM INSPECTION REPORT**  
**PHONE: (303) 866-3567**

<b>MINE NAME:</b> Revenue Mine	<b>MINE/PROSPECTING ID#:</b> M-2012-032	<b>MINERAL:</b> Lead, silver and gold	<b>COUNTY:</b> Ouray
<b>INSPECTION TYPE:</b> Monitoring	<b>INSPECTOR(S):</b> Travis H. Marshall	<b>INSP. DATE:</b> July 31, 2018	<b>INSP. TIME:</b> 10:30
<b>OPERATOR:</b> Ouray Silver Mines Inc.	<b>OPERATOR REPRESENTATIVE:</b> Brian Briggs	<b>TYPE OF OPERATION:</b> 112d-1 - Designated Mining Operation	
<b>REASON FOR INSPECTION:</b> Normal I&E Program	<b>BOND CALCULATION TYPE:</b> Complete Bond	<b>BOND AMOUNT:</b> \$476,269.41	
<b>DATE OF COMPLAINT:</b> NA	<b>POST INSP. CONTACTS:</b> None	<b>JOINT INSP. AGENCY:</b> None	
<b>WEATHER:</b> Clear	<b>INSPECTOR'S SIGNATURE:</b>

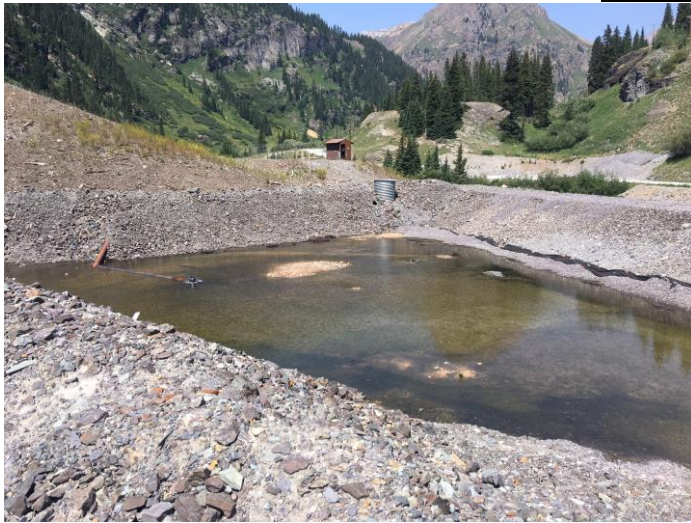
Infiltration Pond

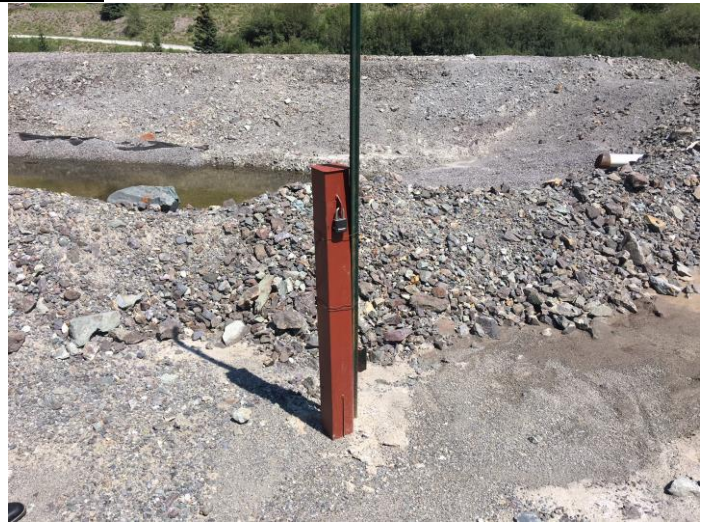
The replacement well for GW-3A well GW-3R was observed as well as the plugged and abandoned GW-3A well. The operator was notified that the that the abandoned well GW-3A must be in compliance with the Division of Water Resources Rules and Regulations for Water Well Construction, Pump Installation, Cistern Installation and Monitoring and Observation Hole / Well Construction. Specifically, Rule 16 Standards for Plugging, Sealing and Abandoning Wells and Boreholes. Cement was observed in abandoned GW-3A. Please provide the abandonment report required by DWR to DRMS for the Division's record.

Replacement Well GW-3R

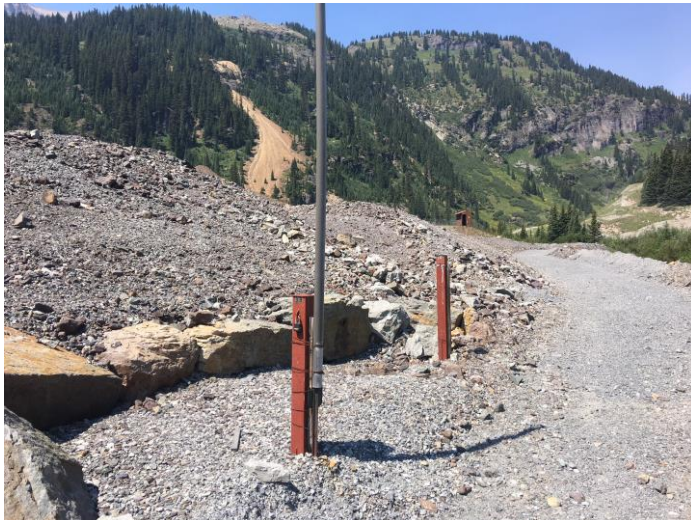
Well GW-3B and abandoned GW-3A in background.

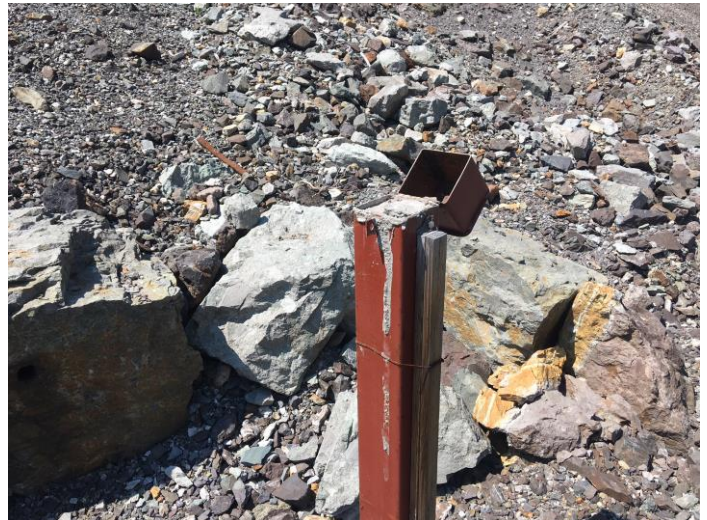
Abandoned Well GW-3A

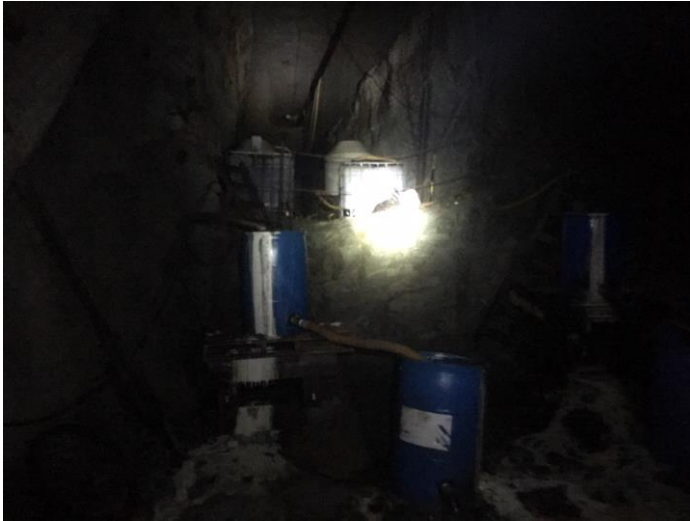
The underground pilot mine discharge passive water treatment system was observed. The operator stated that the system is working well enough to meet in stream standards. The system consists of a series of tanks with multiple cells to simulate the mine water pond, bioreactor and wetlands that will eventually be incorporated on a large scale through a technical revision. The operator stated that they have been working closely with the Colorado Department of Public Health and Environment regarding the design of the proposed full scale passive treatment system. The technical revision will likely be submitted August 2018.

Pilot passive water treatment system

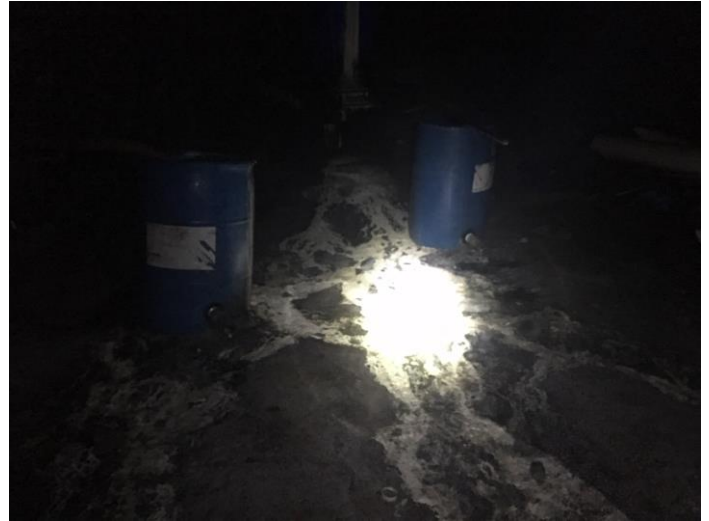
Pilot passive water treatment system
